City of Cordova

Multi-Building Condition Assessment: Ballfield Restroom and Concession

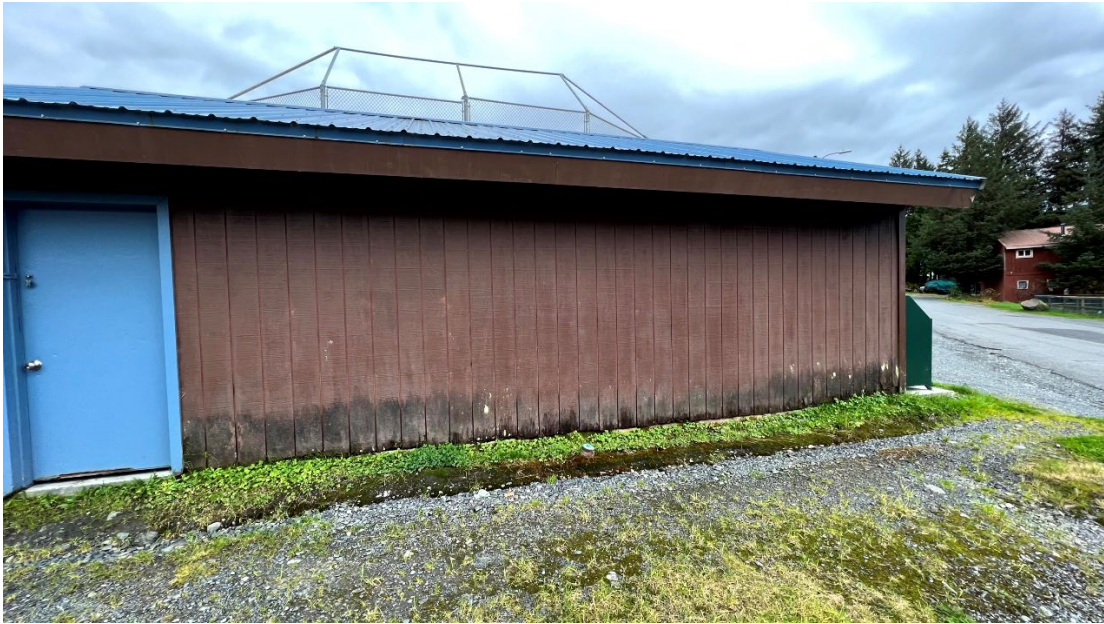
The building is clad with a T1-11 siding that is in poor condition. If corrective action is taken, recommendations are as follows:

- ▶ *All vegetation to be removed from the perimeter of the building, remove grade as necessary to keep from contacting the existing wood siding.*
- ▶ *There is evidence of rot and decay around the perimeter of the building, from grade to 16-18 inches above grade. The rear is the prevalent location of the damage. Our inspection was non-destructive but would assume that there might be wood stud damage behind this siding. Remove test piece to inspect. Verify that studs are in good condition, reside with new T1-11 siding and paint.*
- ▶ *Doors are damaged and replacement is warranted under any project.*

Fig. 1. Visible siding damage at rear elevation

1. **Siding Replacement.** Replace all siding with new painted T1-11, include allowance for stud replacement as needed. This is the first recommendation because there may be

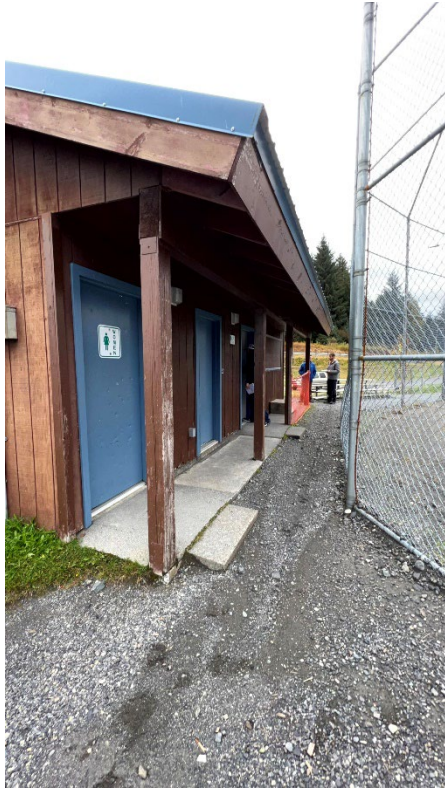
Fig. 4. Front Elevation

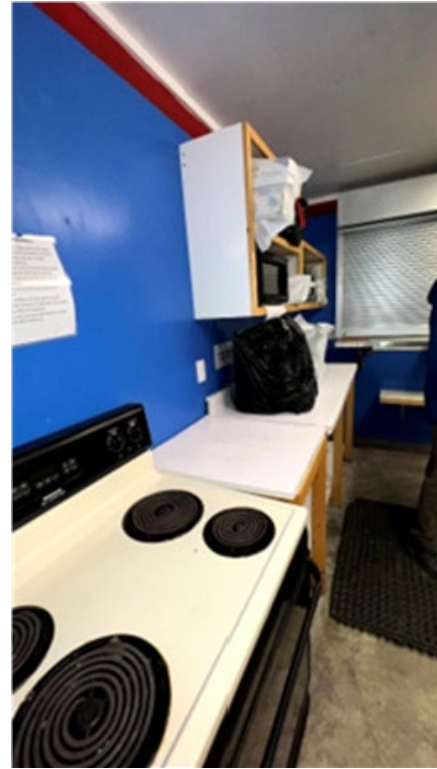
Fig. 5. Concessions Stand

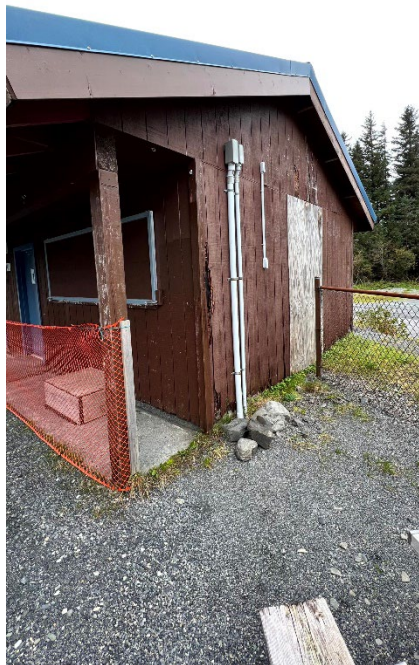
The ballfield buildings are typical wood frame structures constructed on thickened-edge concrete slab foundations. The concession stand and restroom building is approximately 15-ft wide by 30-ft long with a 3-ft roof extension over the doorways. The roof is framed with hand-built gable trusses consisting of 2x8 top chords, 2x6 bottom chords, and interior webs. Walls are 2x6 stud walls with T1-11 siding. The base of the siding is saturated with moisture content readings at 26%. A moisture content of more than 15% can cause dry rot and mold. We recommend the sheathing be replaced and the wall studs replaced if damaged.

Fig. 6. Concession Stand West Elevation

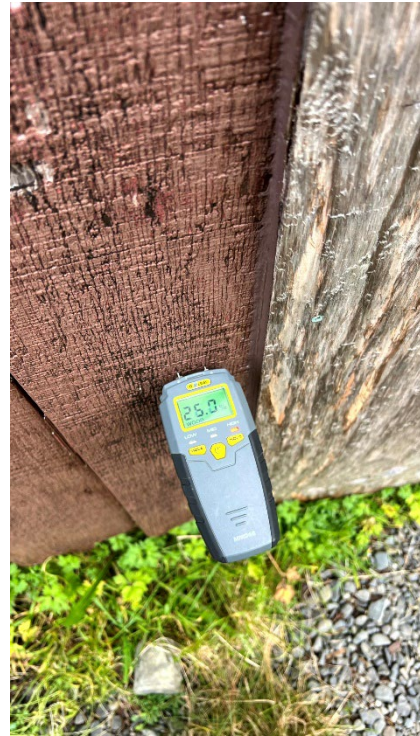
Fig. 7. Concession Stand Moisture Reading

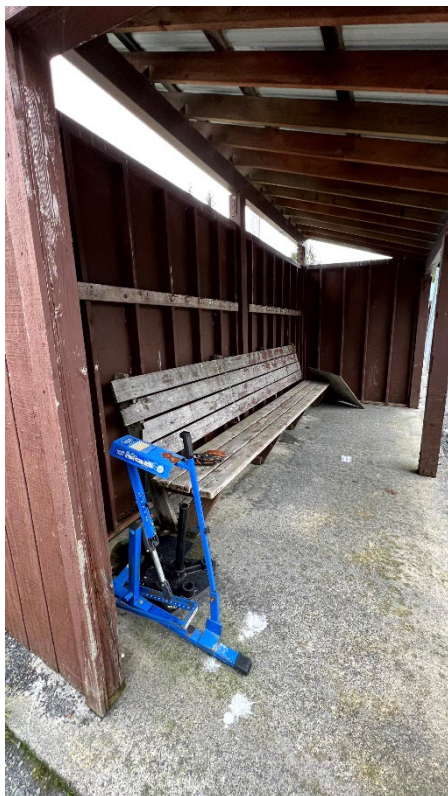
The dugouts are approximately 6-feet x 8-inches wide by 18 feet x 8-inches long with a post and beam shed roof and 2x6 stud wall on three sides. The metal roofing is connected to 2x4 flat furring at 24-inches on centers over 2x8 rafters at 16-inches on centers supported by 4x12 girders on 4x4 and 6x6 wood posts. The same recommendations for the concession building apply to the two dugouts, although the dugouts do not appear to have the same extent of dry rot damage and do not warrant replacement at this time.

Fig. 8. East Dugout.

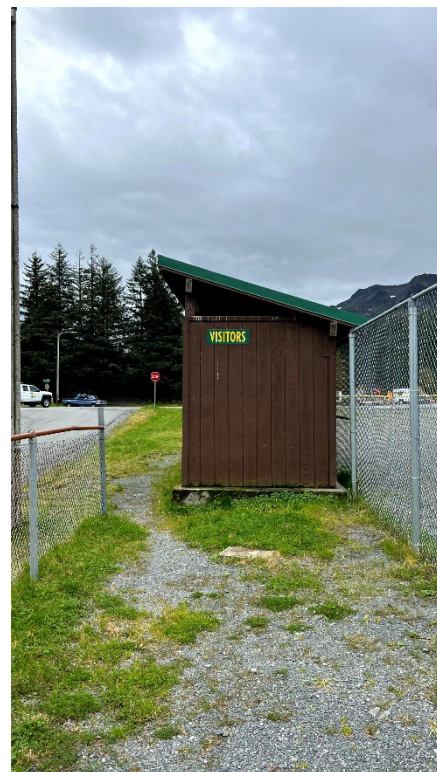
Fig. 9. West Dugout

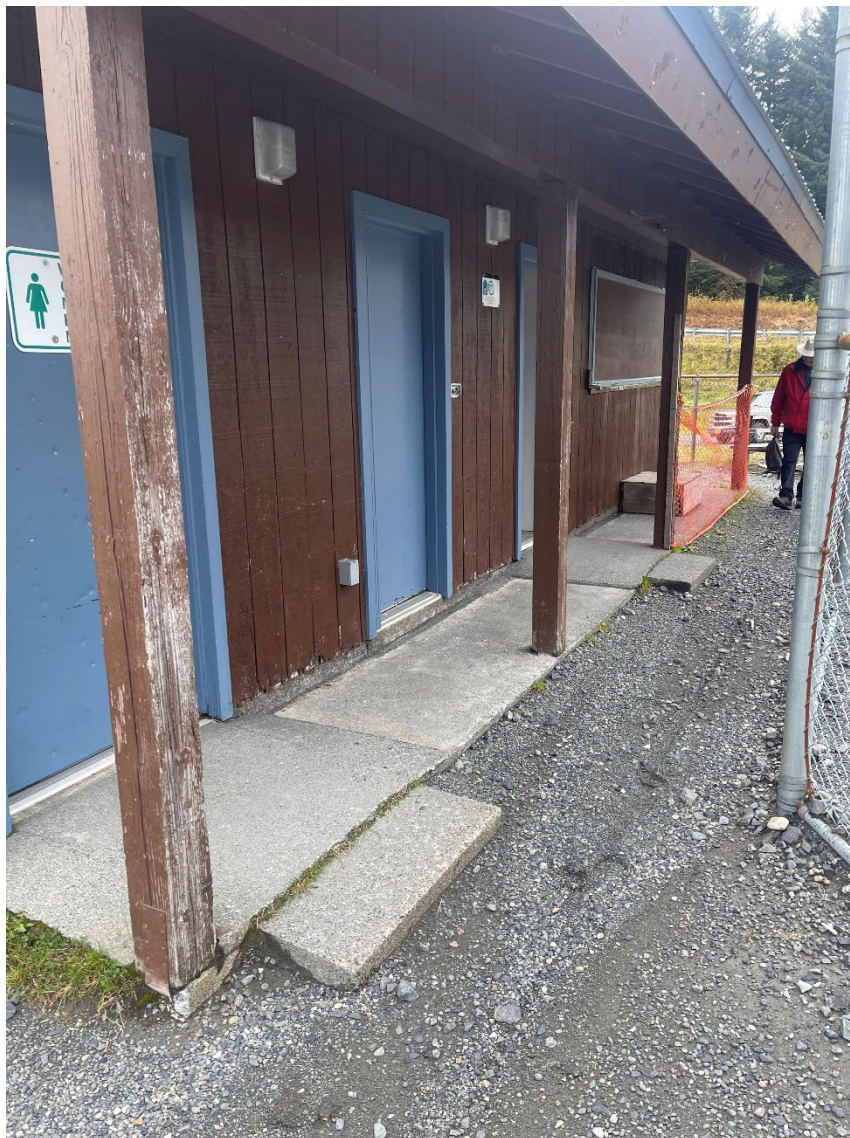
- ▶ *The concrete landing/sidewalk has damage that creates elevations changes in excess of ½-inch. While there has been some concrete work completed to ease the transitions at the doors, it is not in compliance.*
- ▶ *The width of this landing is not adequate: concrete is narrow, about 40-inches, and the existing columns encroach into this area. Target width would be 48-60 inches clear.*
- ▶ *None of the toilet rooms are ADA accessible. While it may be possible to configure one compliant stall, it would require removing an existing fixture.*

The restrooms and concession counter do not appear to be ADA accessible. The concrete access apron is uneven, deteriorating, and in overall poor condition.

Fig. 10. Concrete Apron.

3. **ADA Accessibility - Ramp.** The slope of the concrete walkway to the building qualifies it as a ramp. Ramps are to have handrail and guardrail protection on both sides. In this case the existing grade would only require handrails to be installed. A painted 1 ½-inch tube steel handrail at 34-inches would be the correction.

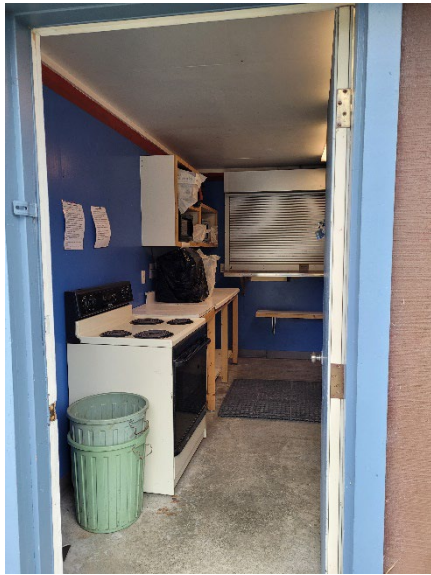
Fig. 11. Oven in kitchen

The current kitchen has an electric cooking appliance and does not currently have a hood installed. Per the *2021 International Mechanical Code*, the domestic cooking appliance is being used for commercial purposes and requires either a Type I or II hood.

For the current setup located in this kitchen, a Type I hood is required for cooking that can lead to grease or grease by-products. An automatic fire suppression system is required to be installed in any cooking appliances that have Type I hoods.

- ▶ *Install a Type I hood with an automatic fire suppression system.*

2. **Kitchen Hood.** Provide a packaged type 1 hood with integral fire suppression.

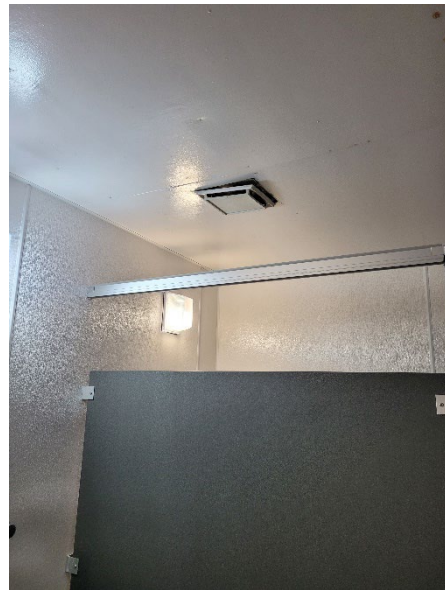
Fig. 12. Bathroom exhaust

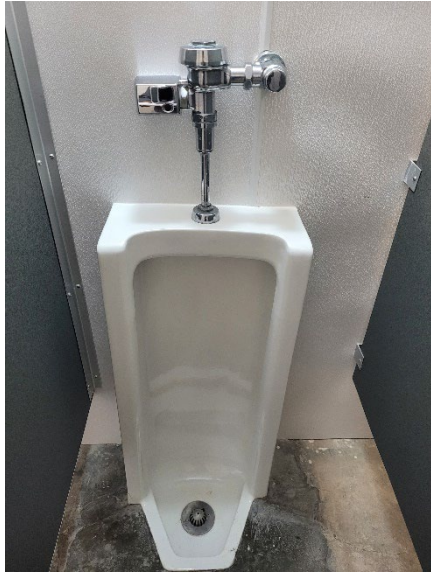
Fig. 13. Urinal

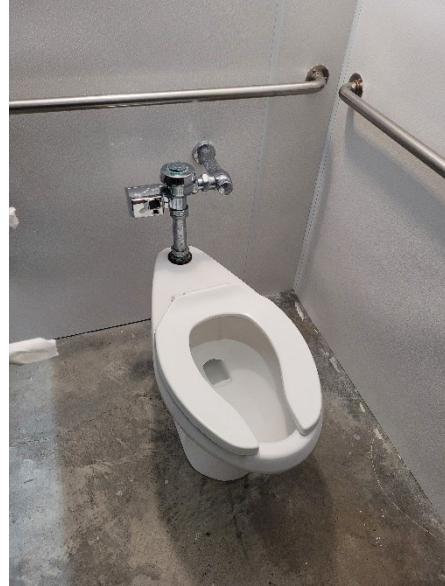
Fig. 14. Typical toilet

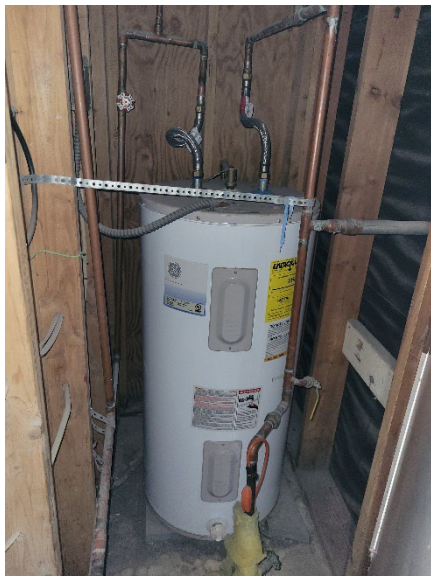
Fig. 15. Electric hot water heater

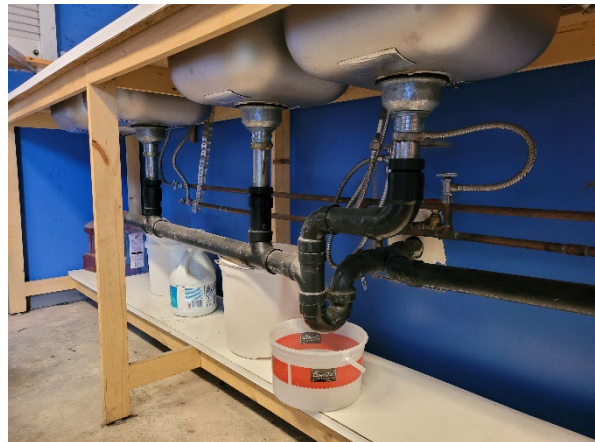
Fig. 16. Sink connections

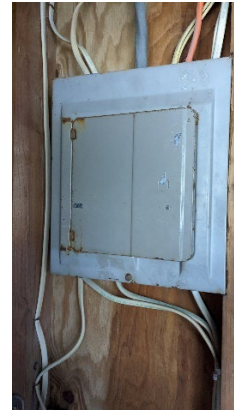
The branch circuit wiring is type NM cable and is exposed in the electrical/mechanical room. NEC 334.10 allows the use of type NM cable for this building type provided that the cable is concealed within walls, floors, or ceilings with a material with a minimum of 15-minute fire rating.

Fig. 18. Branch Circuit Panelboard exposed wiring

5. **Electrical Working Space and wiring.** Replace the electrical panel and locate within the mechanical/electrical room to allow for a 36-inch depth working space. Extend all circuits to new panel location. Conceal all wiring behind sheetrock.

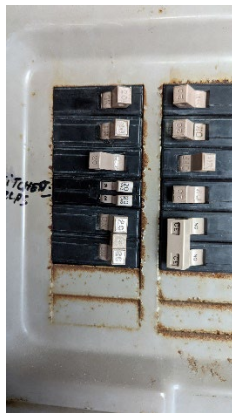
The facility is served by a 120/240V, single-phase, 3-wire, 100A electrical service provided by Cordova Electric Co-Op. The utility meter and service disconnect are located on the exterior of the building and show signs of weathering. The service transformer for the facility was not located. A 100A, 120/240V, single phase, 3-wire branch circuit panel is located within the electrical/mechanical room and provides distribution for the entire facility. The panelboard has a moderate amount of surface rust and has likely surpassed its anticipated life expectancy. Loads fed by the panel include lighting, receptacles, an electric water heater, and kitchen equipment. Kitchen loads include a refrigerator, a freezer, a microwave, and an electric range. The panel has a working clearance of 24-inches from structure which is in non-compliance with NEC article 110.26 which requires a minimum working clearance depth of 36-inches.

Fig. 19. Branch Circuit Panelboard Interior

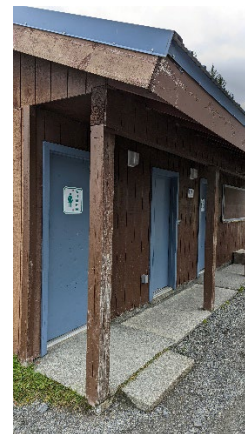
Lighting throughout the facility is a mixture of fluorescent fixtures. The kitchen area is illuminated by T8 fluorescent fixtures. The rest of the facility is illuminated by compact fluorescent bulbs. A photocell for daylight control of the exterior light fixtures was not located. Occupancy sensors are located in each bathroom for lighting control.

Fig. 20. Exterior Lighting

7. **Facility Lighting.** Replace all fluorescent fixtures with LED light fixtures. This includes two ceiling mounted T8 fixtures in the kitchen, three wall mounted fixtures in each bathroom, and three wall mounted exterior light fixtures. Install a photocell for daylight control of the exterior light fixtures.
