**City of Cordova  
Multi-Building  
Condition  
Assessment:  
Bob Korn Memorial  
Swimming Pool**

**Prepared For:  
The City of Cordova**

Due to the amount of information and quantity of sites, a separate report has been developed for each facility. This condition assessment report is for the Bob Korn Memorial Swimming Pool.

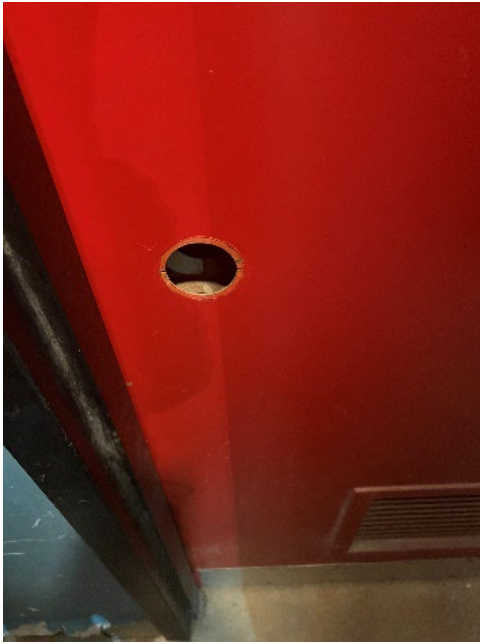
- ▶ *Exit Access Doors:* *The exit leading out of the northwest rear corner of the pool, while properly signed, is in poor condition and warrants replacement. This includes door, frame, and hardware.*
- ▶ *Electrical Room Door:* *At this same exit, there is a life safety concern that requires correction: The door leading into the electrical room has no hardware. Door hardware shall be installed at the owner's earliest convenience. Both this door and the adjacent Pool Pump Room doors shall be locked during normal business hours.*

Fig. 1. Missing Hardware at Electrical Room

no hardware. Door hardware shall be installed at owners' earliest convenience, and both this door and the pool pump room shall be locked during normal business hours. Exterior door is in poor condition and warrants replacement; this includes door, frame and hardware.

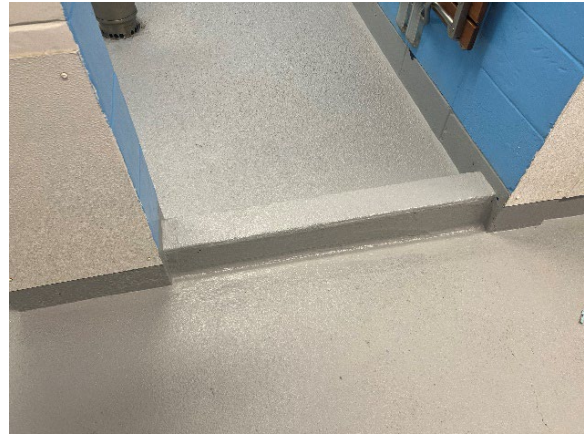
Fig. 2. Typical Curb at Entrance to Showers

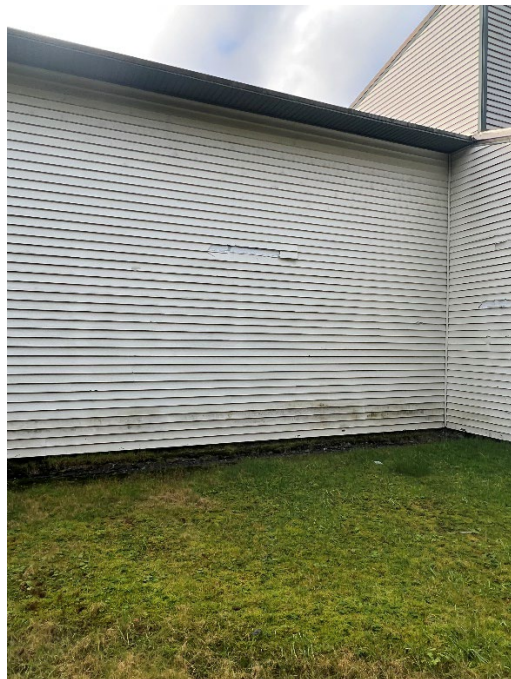
- ▶ Siding appears to be in serviceable condition. There was some flashing that was damaged, but only minor corrections would be needed. Siding replacement was not included in the cost estimate, but when discussing repurposing the facility for the next 20-30 years, siding replacement would be advisable.

Fig. 4. Siding Damage

8. **Siding repairs.** Siding appears to be in serviceable condition. There was some flashing that was damaged, but only minor corrections would be needed. In context of a larger project, siding replacement would be advisable.

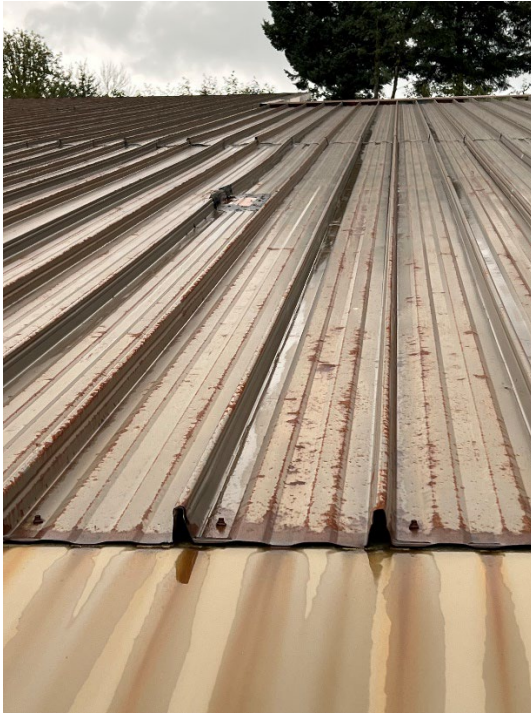
The roofing is in poor condition and requires replacement. While some portions of the roofing were replaced, onsite staff reported there were still roof leaks. The existing roofing is a standing seam metal roof with concealed fasteners. There have been numerous patches and corrections over the years. There were signs of major leaks in the northern mechanical rooms where Gypsum Wall Board (GWB) was removed on the interior. The roofing itself is starting to show deterioration in the form of surface rusting. Over time, this corrosion will start to develop pinhole leaks which could be the cause of the current water infiltration.

Fig. 5. Typical Roof Conditions

- ▶ Replace the existing metal roof with a similar, standing seam metal roof with concealed fasteners.

7. **Roofing replacement.** Replace the existing metal roofing with a similar, standing seam metal roof with concealed fasteners. While replacing roofing, inspect roof sheathing / decking for water damage and replace in kind if deteriorated. Verify and improve roof eave cantilever members along east and west walls and remove post and beam shoring on east eave along mechanical / chemical storage rooms.

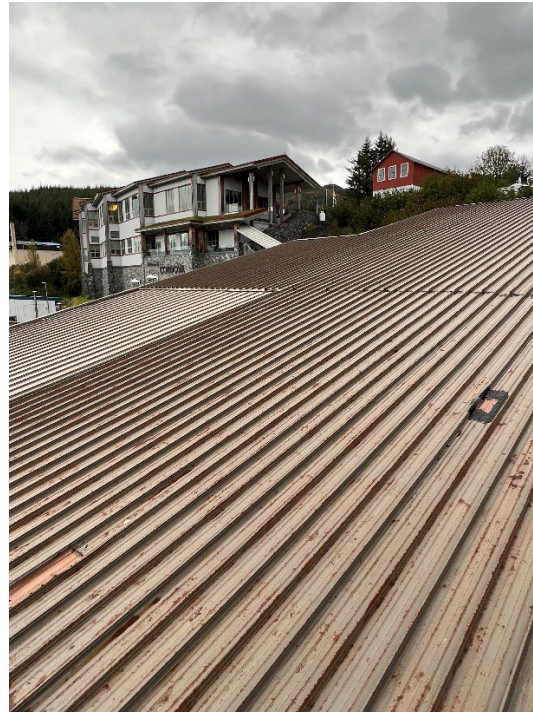
Fig. 6. Roof Overall

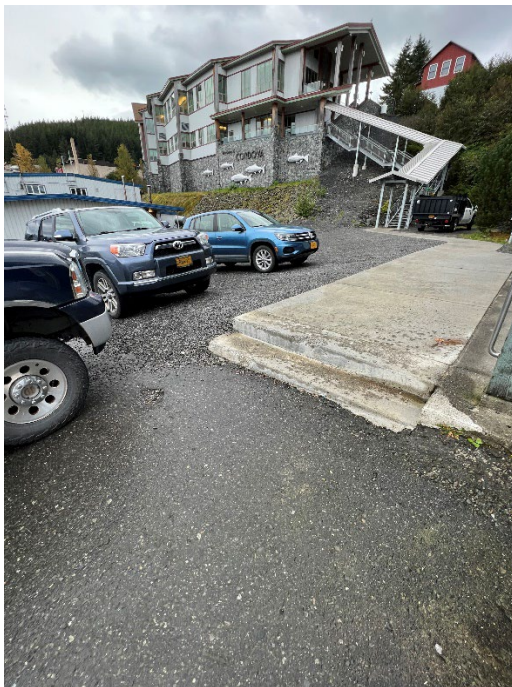
Fig. 7. Possible ADA Ramp Location

immediately adjacent to the existing stairs to accomplish this. Ramp would be approximately 12-feet long and 4-feet wide and would be equipped with handrails on both sides. While the strategy above is fairly easy to accommodate, Civil has identified the parking lot grading exceeds maximum allowable slopes in the Grading correction deficiency.

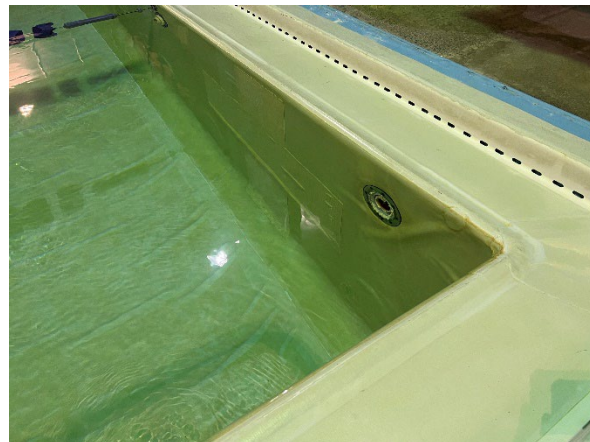
Pool staff did not report any water loss at time of inspection. That said, water level is automatically corrected so some water loss could be occurring but not noted by staff. Documented water loss is a deficiency that speaks to the subsurface piping condition, and overall condition of the pool shell. While no water loss was reported it was noted that the existing liner has exceeded its service life and warrants replacement. There are areas with liner adhesion loss, and air pockets and bubbles. Liner service life is approximately 10-15 years, and operator could not remember last time the liner was replaced.

Fig. 8. Pool Liner – Note Delamination

- ▶ *Replace the existing pool liner. While this work is being done, all inlets and outlets should be inspected and/or replaced as well as ensuring there is a compliant VGB cover over the existing main drain.*

5. **Pool liner replacement.** Replace the existing pool liner. While this work is being done, all inlets and outlets should be inspected and/or replaced as well as ensuring there is a compliant VGB cover over the existing main drain.

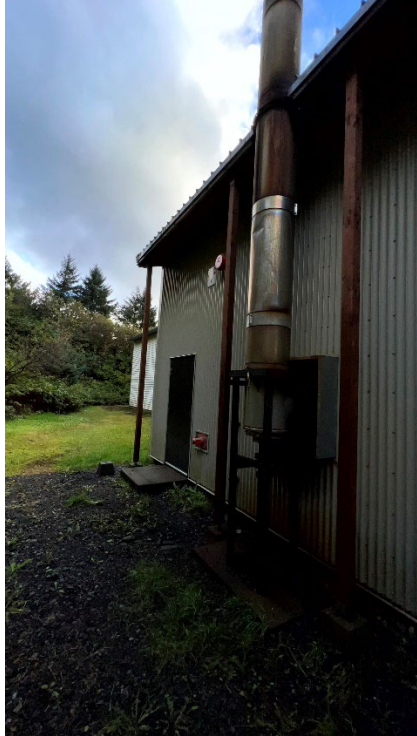
The original roof structure had no eave extensions past the outside face of exterior walls. During a previous roofing replacement approximately 2-foot-wide eave extensions were added to the low roof eaves along the east and west walls. The eave extension along the west wall of the mechanical and chemical storage rooms has been reinforced with exposed 4x beams and 4x4 treated wood posts bearing on concrete pier blocks at grade. We recommend all roof eave extensions be inspected and replaced as needed during roofing replacement. The exposed beams, posts and pier blocks should be eliminated after installation of properly designed outriggers, with back-spans sistered to the existing rafters.

Fig. 9. Propped East Eave

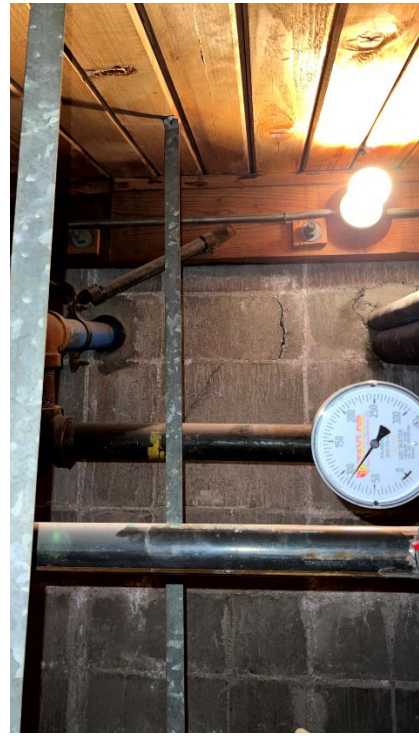
The CMU walls are also in good condition. However, there appear to be mortar joint and block cracks in the 16-inch square pilasters supporting the glue-laminated roof girders. The cracks are predominately within the upper third of the pilaster height and near the beam seat. The cracks should be repaired by epoxy injection and fiber-reinforced polymer (FRP) wrap. The concrete masonry unit pilaster repairs should be assigned a high priority in the list of repairs.

Fig. 10. CMU Cracked Block in Attic Mech Room

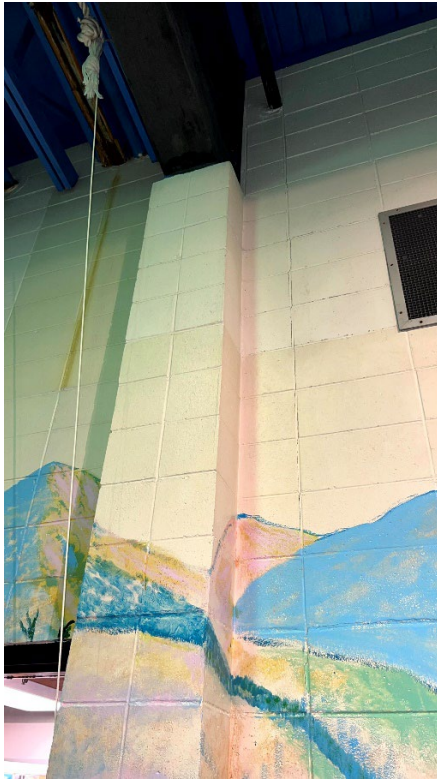
Fig. 11. CMU Wall Joint Crack Near Pilaster

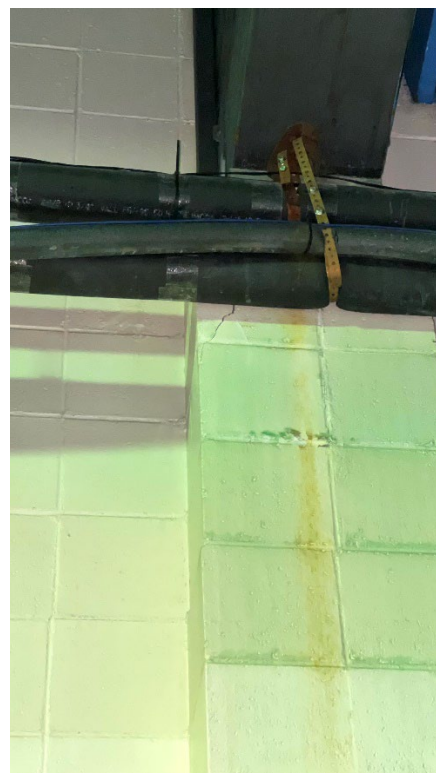
Fig. 12. Pilaster Crack at GL Girder Bearing

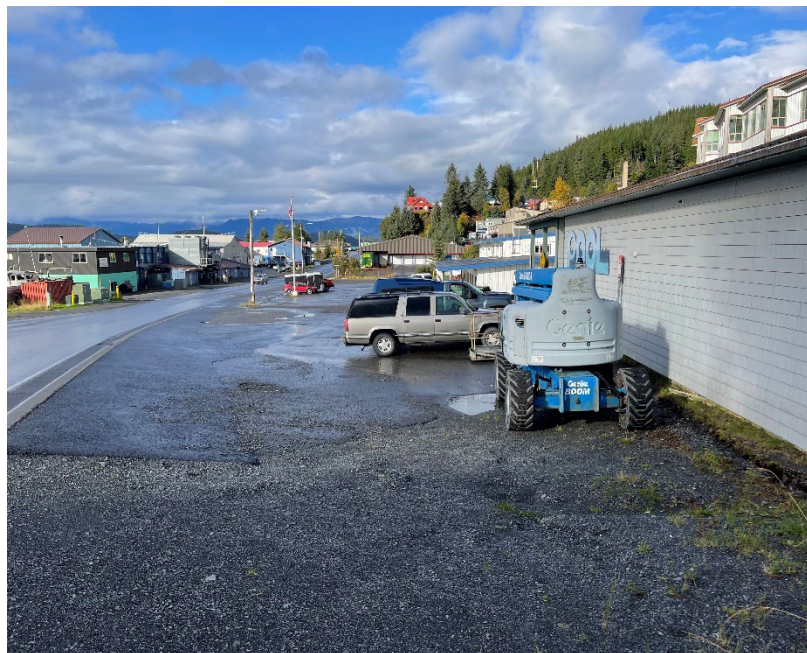
Pavement adjacent to the pool area is in fair condition, with minor cracking and deterioration near Railway Ave. Gravel parking to the north looks to be newer and in good condition. See Figure 13.

Fig. 13. Asphalt parking adjacent to pool building.

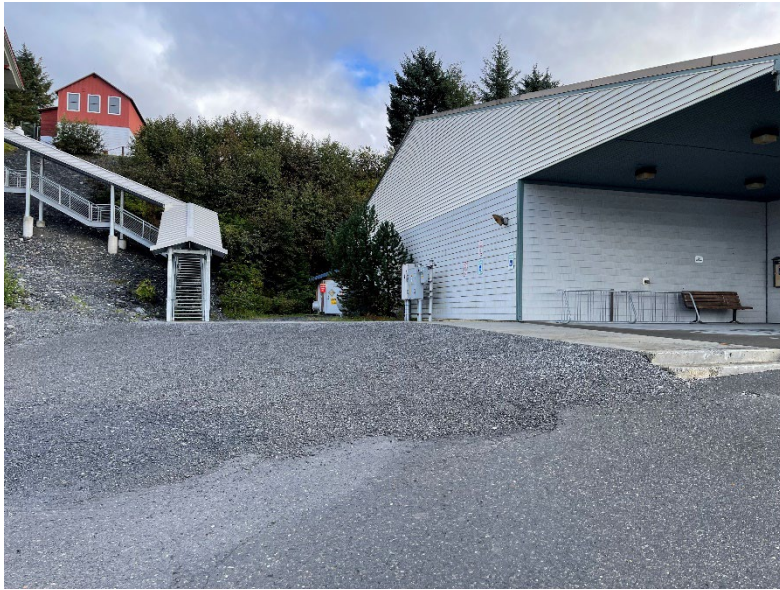
Two ADA accessible parking stalls are present near the main entrance to the pool, however there is no striping, accessible aisles, or routes to the main entrance. No ramps exist at the concrete apron entrance. Grades in this area are greater than ten percent, which is a code violation. The owner reported this area to be dangerous in the winter months when icy, and users have been hurt while walking here. See Figure 14.

Fig. 14. Gravel parking with steep slopes.

To correct the parking area on the north side of the building, it is recommended that a 100-foot long eco block style retaining wall, approximately 10-feet high be installed between the pool building and emergency services building. The area will be backfilled with approximately 2,500 cubic yards of ADOT Selected Material Type A and finished with an E1 type material surface wearing course for durability (approximately 325-square feet). ADA accessible parking will be present in this area next to the building, in conjunction with the new ramp described in the ADA Accessibility recommendation below.

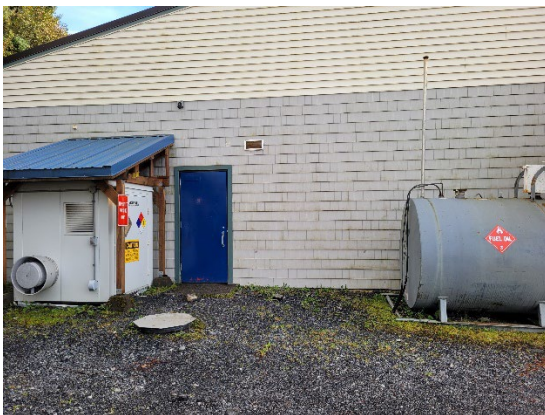
The fuel oil tank is located approximately a foot from the building, and is required by NFPA 30 to be at least 5 feet from the building. The tank is near a parking lot and a door into the building, a new location for the tank will require coordination to ensure code compliance, as well as minimal disruption to parking and fueling operations. This tank has buried fuel lines, depending on tank location new lines may be run above or below grade.

Fig. 17. 1,000 gallon fuel oil storage tank located outside the building.

1. **Fuel Tank Location.** The fuel tank is currently located directly adjacent to the building wall. Move the fuel tank a minimum of 5-feet from building to get the required NFPA 30 setback from the structure. Evaluate new locations to minimize disruption to parking or fueling operations. Provide new fuel oil piping as needed.  
Estimated Cost: \$40,629
2. **CMU joint cracks.** Repoint CMU joint cracks and epoxy inject block cracks in walls and pilasters. Estimate 100 linear feet of joint repointing and 20 liner feet of epoxy injection.  
Estimated Cost: \$13,830
3. **Electrical room door lock.** The exit leading out of the rear corner of the pool, while properly signed, has a life safety concern: The door leading into the electrical room has

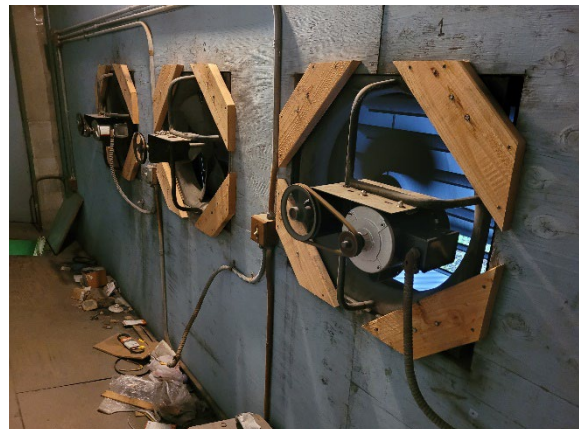
Fig. 18. The three exhaust fans located with AHU-1.

2. **Ventilation remodel.** Demolish and replace the primary ventilation systems. Demolish AHU-1, AHU-2, the hydronic coils and dedicated coil pumps and valves, the three exhaust fans in the clearstory, the exhaust fans in the attic area, and all associated ductwork and controls. Design and install a Heat Recovery Ventilation (HRV) unit to provide ventilation to the natatorium, locker/restroom, and admin areas. The HRV should contain a hydronic heating and preheating coil for outside air (along with any recirculation pumps needed), and a return air connection and mixing box. This allows the natatorium to achieve the recommended 4-8 air changes per hour (ACH) of ventilation air for circulation and humidity control, and provide the recommended outside air volume, which is less than the 6 ACH, approximately 0.5 CFM/SF depending on pool activities. The new system and ductwork should be designed to current natatorium design standards such as those provided by the American Society of Heating, Refrigeration, and Ventilation Engineers (ASHRAE). Evaluate the pressure relationships of the building airflows and balance so the natatorium is negative, the locker/restrooms are neutral, and the admin and support spaces are positively pressurized in relation to ambient outdoor air. This will help protect the building envelope from moisture intrusion and improve air quality within the administrative spaces and restrooms.

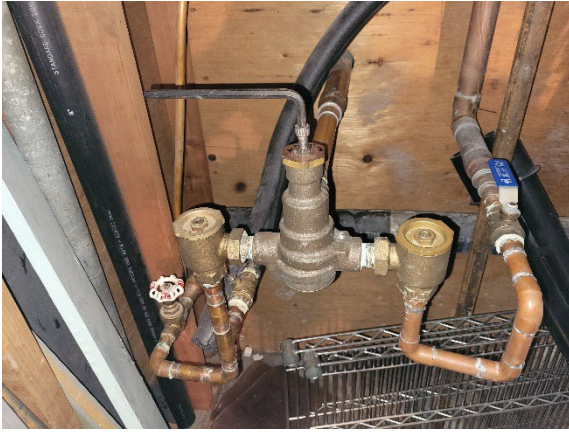
The domestic hot water is heated via three stacked indirect water heaters, heated from the boiler loop. It was reported onsite that the tempering valve for the locker rooms and restroom does not hold the temperature setting and must be manually adjusted on a regular basis; it is in the attic space and requires a ladder to access.

Fig. 19. Domestic hot water tempering valve located in the attic.

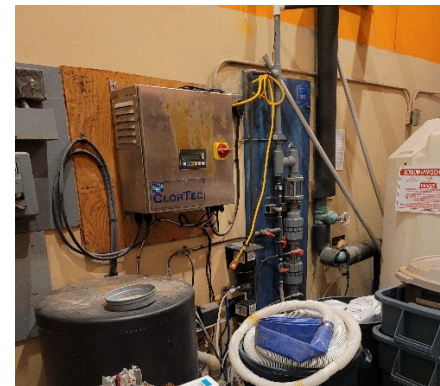
Fig. 22. Abandoned pool filtration and treatment system in the sprinkler room.

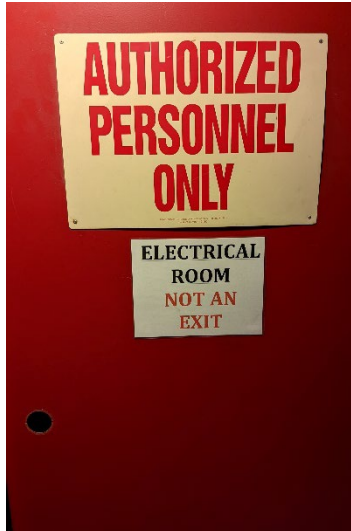
Fig. 27. Electrical room door opens inward posing an egress hazard.

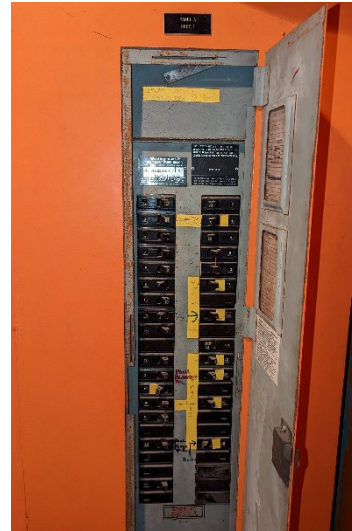
Fig. 28. Panel schedules for panel A section 1 do not match panel circuiting.

3. **Replace electrical distribution system.** This includes replacement of a 600A switchboard, (3) 225A panelboards, and associated feeders. Provide accurate as-built drawings and panel schedules for the electrical system. This includes reconfiguring the electrical room to remediate current NEC working clearance issues. Recommend an Arc Flash Risk Assessment is performed on power systems for employee safety and compliance with OSHA regulations. Install arc flash hazard labels to all panels and equipment per NEC 110.16.

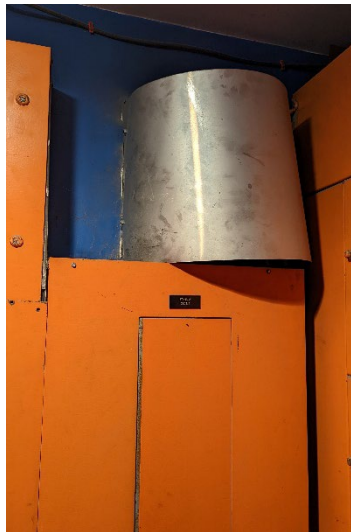
Fig. 29. Exhaust fan located within NEC required panel clearance

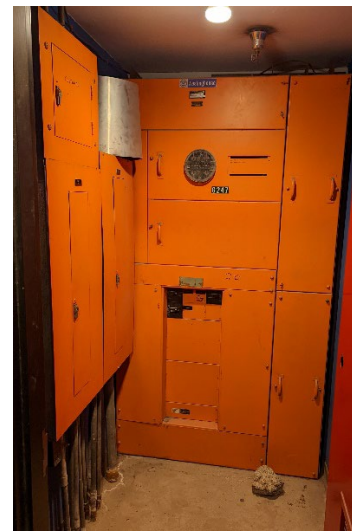
Fig. 30. Panelboards located within NEC required working clearance of facility switchboard

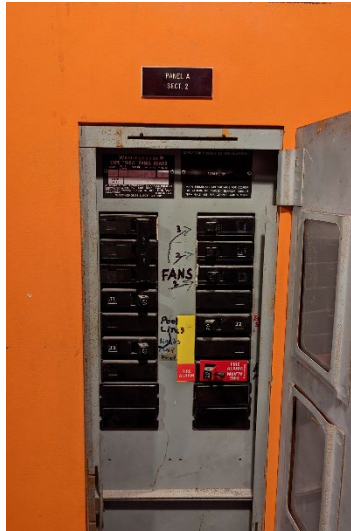
Fig. 31. Panel A Section 2 does not have a panel schedule

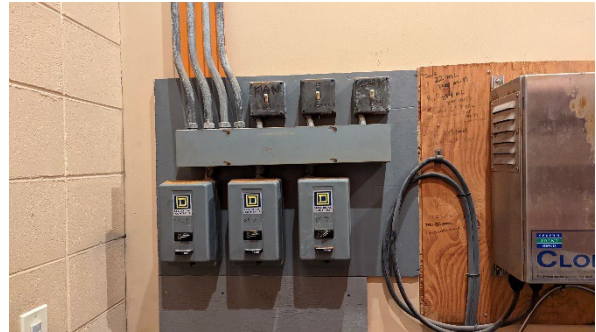
Facility maintenance indicated there haven't been significant issues with the electrical system except for the starter for the supply fans of the pools which appear to trip the breakers feeding the circuits.

Fig. 32. Pool exhaust fan starters are causing the breakers to trip

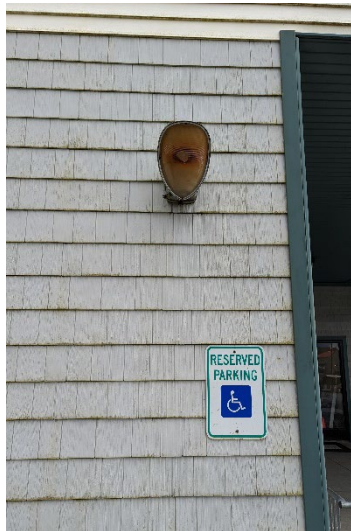
Exterior lighting is provided at the entry area canopy only. These fixtures have been retrofit with LED lamps but are in poor condition with yellowed lenses. Exterior lighting is controlled via a photocell located on the northwest corner of the building. The site visit took place during the daytime so functionality of the exterior lighting was not verified; however, all lighting covers appeared to be burned due to age and heat produced by the lamps used in the fixtures.

Fig. 33. Exterior lighting fixture with burned cover

1. **Replace all exterior light fixtures.** Replace all exterior light fixtures with LED fixtures. Provide additional fixtures on the exterior of the building for parking areas. Replace exterior lighting photocell.  
Estimated Cost: \$13,042

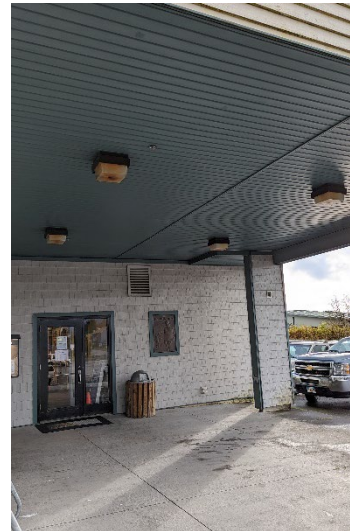
Fig. 34. Canopy lighting with damaged covers

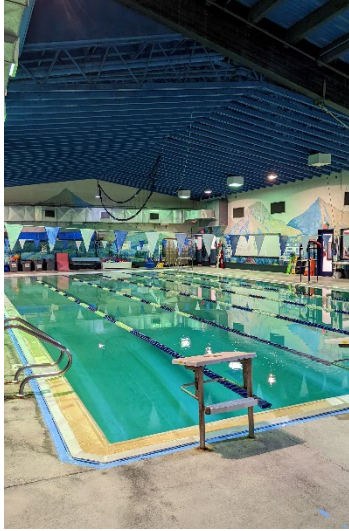
Fig. 35. Pool lighting – with mix of metal halide and LED fixtures

2. **Replace all interior light fixtures.** Replace all interior light fixtures with LED fixtures. Provide occupancy sensor control for non-pool areas.  
Estimated Cost: \$189,553

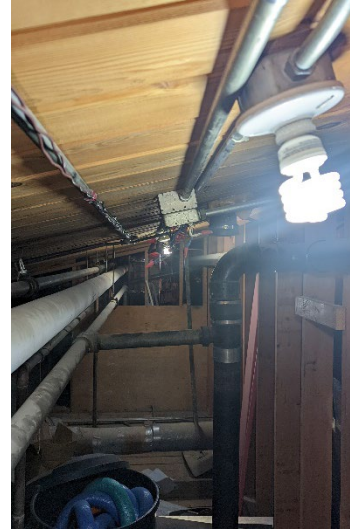
Fig. 36. Uncovered junction boxes in attic area
