City of Cordova

Multi-Building Condition Assessment: City Maintenance Shop

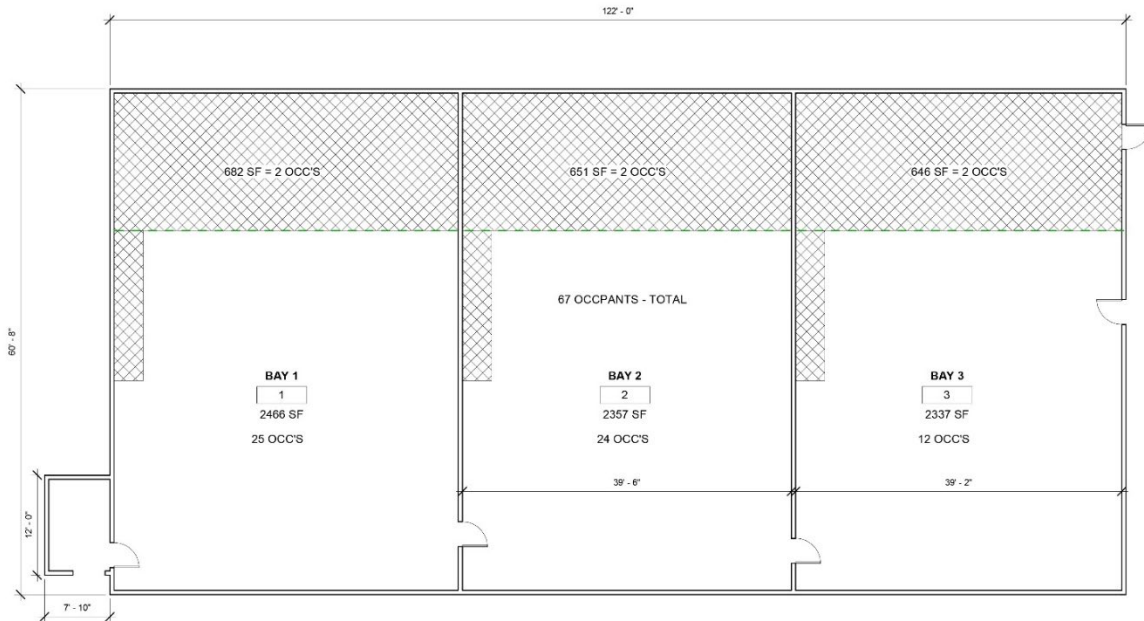
Fig. 1. Floor Plan

There is a significant deficiency with the existing exit path of the facility. See floor plan above. Code dictates maximum travel distances until the occupant is presented with two means of egress or is at an exterior exit. For this type of construction, without a fire suppression system that distance is 75-feet. In almost all areas of the building, the length is exceeded. What is required is an additional exiting study to design a new compliant exiting path. Most likely 3-4 additional exit doors will be required. Their location is critical as well with more than likely 2 being located under the mezzanines. Overhead doors do not qualify as exiting doors per the code. For cost estimating we are assuming the following:

7. **Exiting Deficiency.** Provide 4 additional steel exit doors. All equipped with standard hardware, no panic devices are required. Doors are to be insulated hollow metal, with hollow metal frames. Exit signage will be provided at all locations. Doors will be installed in walls where no doors existed, provide headers as required.

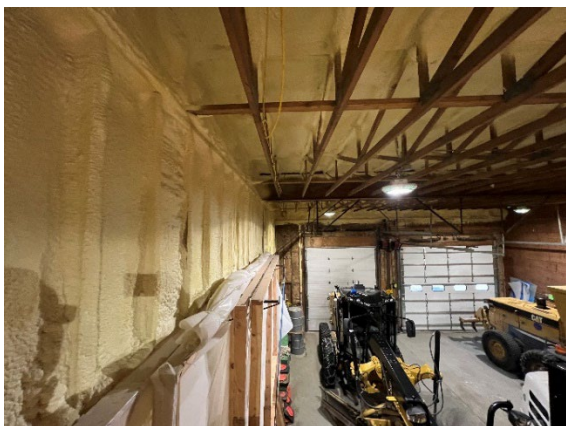
Fig. 8. Exposed Foam

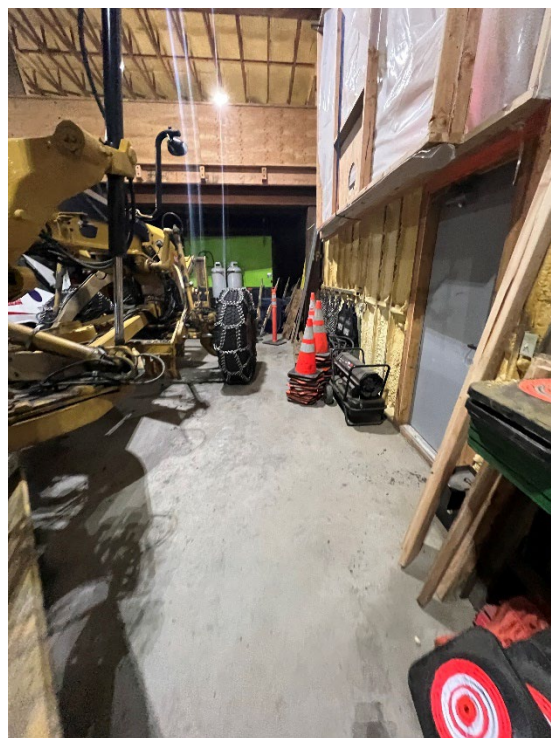
Fig. 9. Exit door requires signage

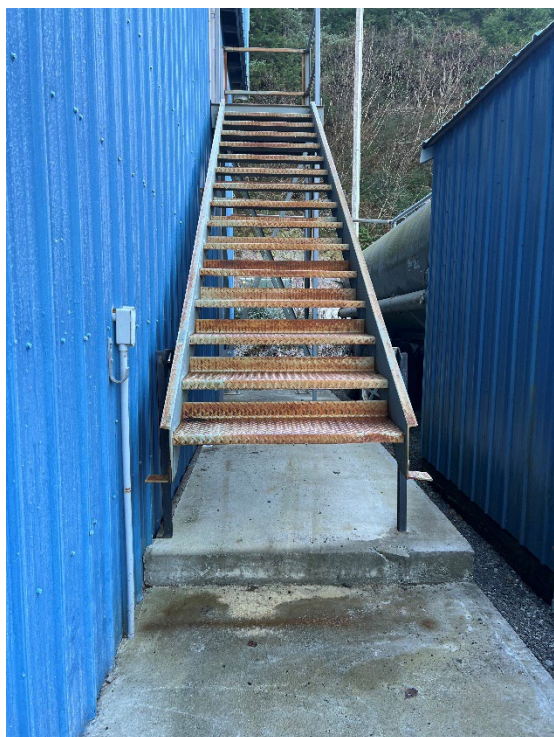
Fig. 10. Exit out of Bays 3 Mezzanine

9. **Mezzanine Exit Repair.** Complete construction of the stair exiting out of the upper mezzanine in Bay 3. Work includes 42-inch-tall guard on one side, 34-inch handrails on both sides, and the stair construction to be extend to grade. Follow all current stair dimension requirements for grasp ability and extension and openness.

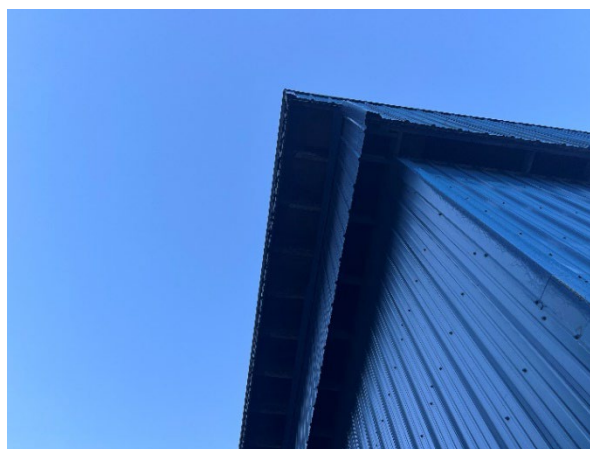
Fig. 11. Open soffits

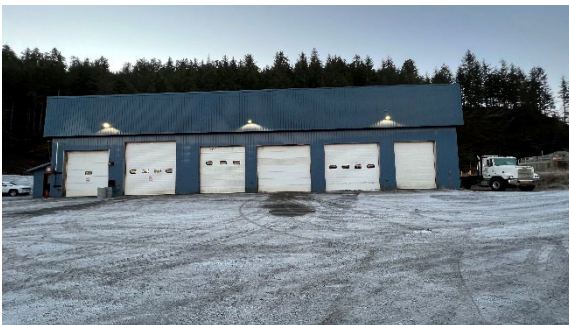
1. The height of exterior walls is too tall for 2x6 wood studs.
2. The lateral load resistance of the north wall is suspect. The north wall, with six overhead doors, leaves only seven narrow shear walls with high height to width aspect ratios and no hold down anchors to resist the over-turning forces.

Fig. 12. Public Workd Shop North Elevation

1. **Structural Assessment.** Perform a full structural assessment of the building. This assessment would be significantly more involved than the structural component of this condition assessment and would investigate all structural members of the building and loading, and provide a report of the building construction, condition, and needs.

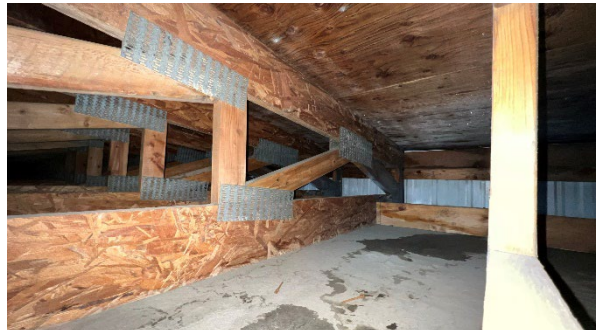
The roof is a low slope metal roof. It was reported by the user that the roof leaks and should be replaced. There is a large cavity created by over framed wooden trusses where evidence of water damage is visible. While low slope metal roof systems are available, a more economical solution would be a membrane roof system.

Fig. 17. Overframed Roof Truss Eave End

- ▶ *Replace the existing metal roofing with a membrane system. Assume a 65-millimeter scrim reinforced EPDM over a new coverboard.*

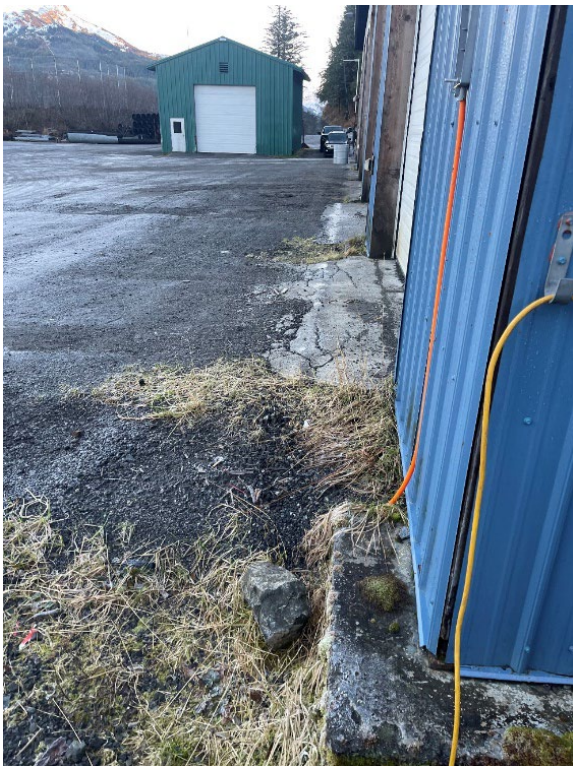
Concrete aprons extending from the bay access doors were observed to be deteriorated and damaged. Large cracks and chunks of concrete were seen during the inspection. See Figure 19.

Fig. 19. Concrete apron at bay entrances

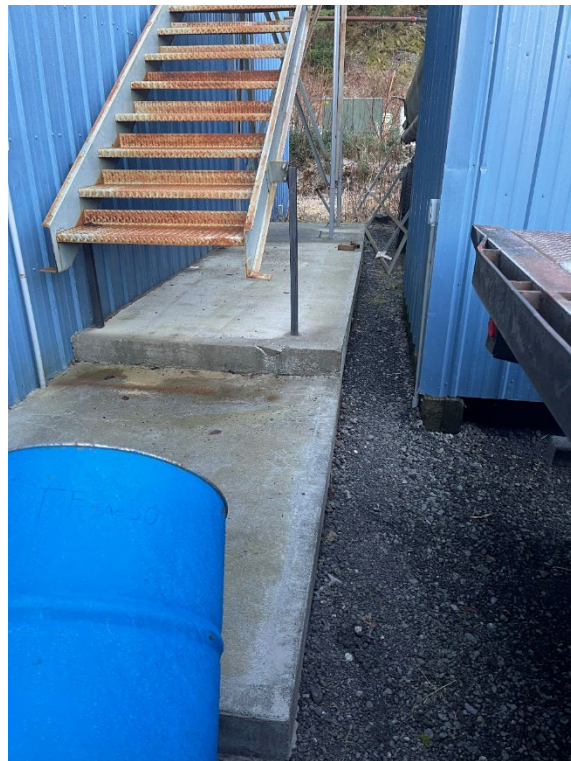
The exterior exit stairs on the west side from Bay 3 appear to be damaged and removed, and do not connect to the concrete apron. See Figure 20. See architectural for more information.

Fig. 20. Stairs on west side

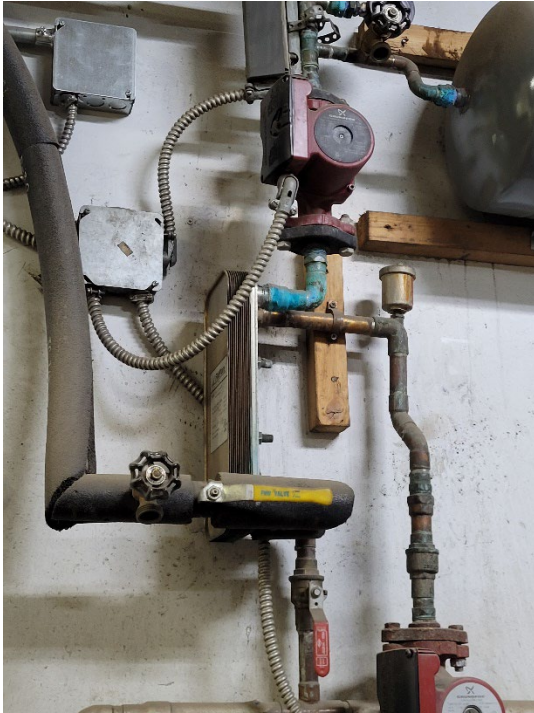
The sand storage building piping is buried but goes above grade and routes through the sand storage building. It was noted onsite that the system is run on water with no glycol. The piping would be subject to freezing if the system goes down during the winter, especially where the piping is uninsulated at the entrance to the building where it leaves the ground. This piping should be insulated, and it is recommended that glycol be added to this system as it is separated from the building by a heat exchanger.

Fig. 21. Heat exchanger and pump for sand storage building

14. **Add glycol to sand storage heating loop.** This is not a deficiency or code requirement, but is it recommended to add glycol to the sand storage system heating loop to protect the unit heater and piping against freezing if the door is left open or the system goes offline.

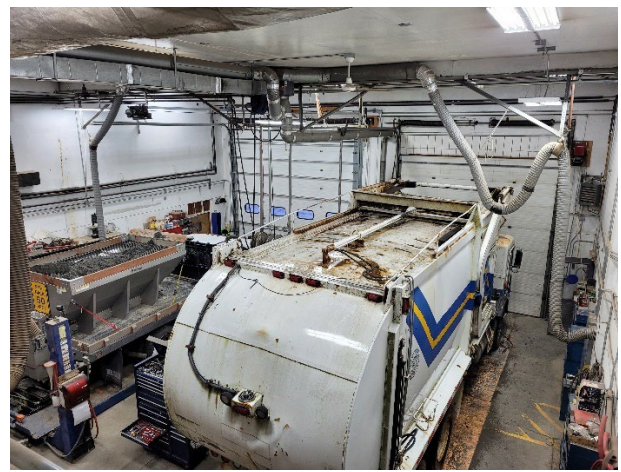
There is a vehicle exhaust system in the main two bays of the shop. It was discussed onsite that it was designed and installed by the shop workers and it works well. Generally, vehicle exhaust systems are a specialty item made of purpose-built components that are rated for certain vehicles and usage. This system did not appear to be designed and constructed to that level. The International Mechanical Code (IMC) requires vehicle exhaust systems to be engineered by a registered design professional or be factory-built equipment designed and sized for the purpose. While this custom system is an impressive example of local ingenuity and handiness, it would have to be replaced with a Carmon, Nederman, or similar vehicle exhaust system sized for the needs of the shop if the city wants the building to be code compliant. Alternatively, if the vehicles are only running to pull into and out of the shop, vehicle exhaust is not required.

Fig. 24. Main two bays (east end), note vehicle exhaust system

6. **Vehicle exhaust.** Demolish the existing vehicle exhaust system, design and replace with equipment rated for vehicle exhaust and sized for the equipment and usage that is needed.

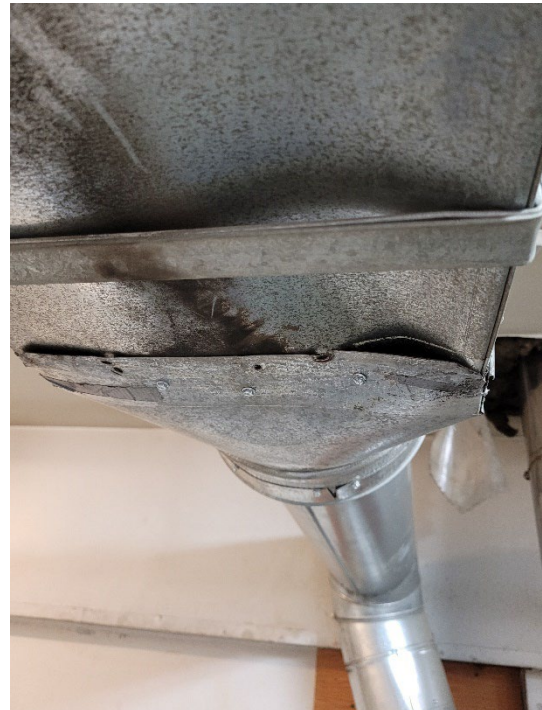
Fig. 28. Damage to vehicle exhasut ductwork

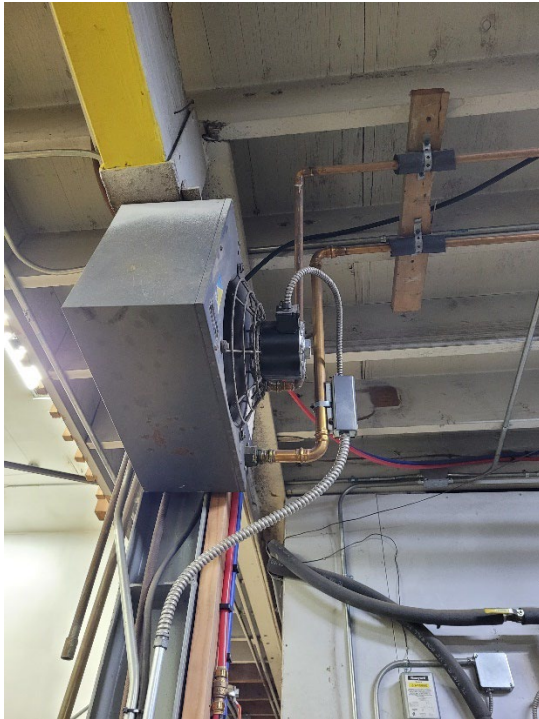
It was noted onsite that the shop area takes 1-2 hours to reach 60 degrees after an overhead door is opened on a 20-degree day, and that the unit heaters in the shop are not adequate. There are two- or three-unit heaters per bay, depending on the bay, each is rated at 43,000 BTH/hr. This is in line with other successful hangar and shop designs in colder parts of the state. It was noted onsite that the supply temperature from the boiler felt cooler than the 180-degree water that the unit heaters are commonly designed for. A thermometer on the main supply piping was not located during the site visit, however, by touch the piping felt a similar temperature to the piping serving the sand storage building, which does have a thermometer and read 100 degrees. The boiler seems to be producing water in the 120-degree range, which is appropriate for radiant piping, but not unit heaters. Furthermore, the nameplate of the boiler indicates the design outlet water temperature is rated at 160–220-degree water. A heat exchanger for the shop radiant floor piping was not observed; one should be added, and controls set up so the boiler produces 180-190 degree water to the unit heaters and 120 degree water to the radiant piping and the heat exchanger to the sand storage building. The radiant slabs can be damaged by running high temperature water through the slab. It was also noted that some of the heating piping did not have insulation. Insulation should be added to ensure the water temperature is maintained to the unit heaters.

Fig. 29. Unit heater with uninsulated piping

5. **Heating System.** Design and install a heat exchanger to separate the radiant floor (120-degree system) from the unit heater loop (180-degree system). Adjust the boiler to provide a 180–190-degree output water temperature. Adjust the boiler to operate per the manufacturer's recommendations to minimize cycling. Install heating pipe insulation (assume 300 feet of 1-1/2" piping) where missing.

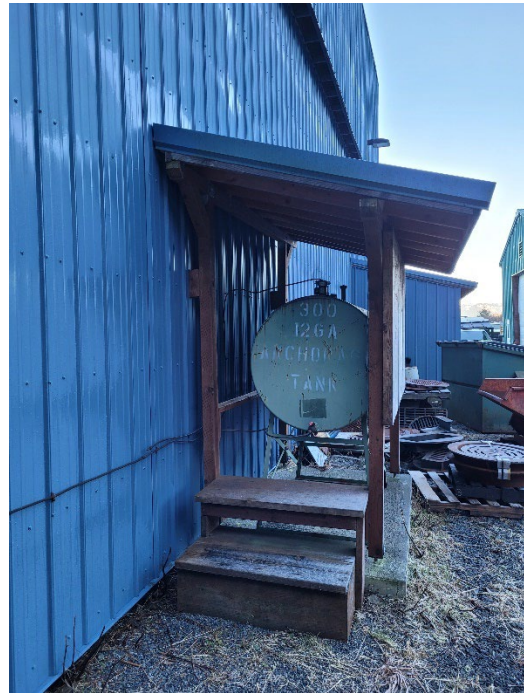
Fig. 30. 300 gallon fuel oil tank

The 300-gallon located on the exterior part of the building is not protected by an approved method, is within 5 feet of the building, and is not provided with secondary containment. The 3,500-gallon oil tank is 5 feet away from the building but does not have any secondary containment.

- ▶ *Provide code-compliant tanks for secondary containment of Class IIIB liquids.*
- ▶ *Provide code-compliant distances between above-grade outdoor storage tanks and fuel dispensers, buildings, lot lines, public way, and other tanks.*

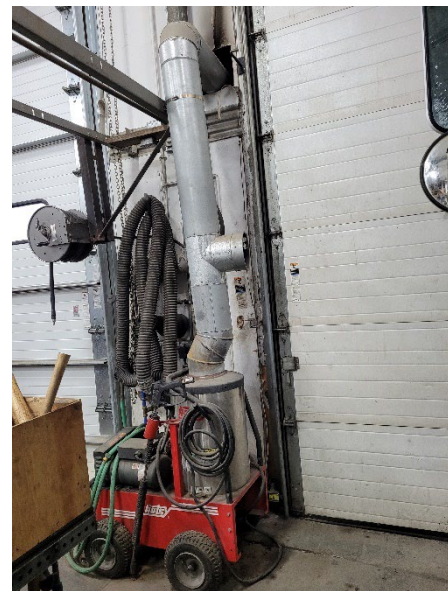
Fig. 38. Fuel fired pressure washer

12. **Fuel fired pressure washer.** Verify with the Fire Marshal that wall penetration meets the required clearance to combustibles. If required, replace the exhaust penetration through the wall with double wall ductwork rated for the application, or a wall thimble assembly to maintain clearance to combustibles.

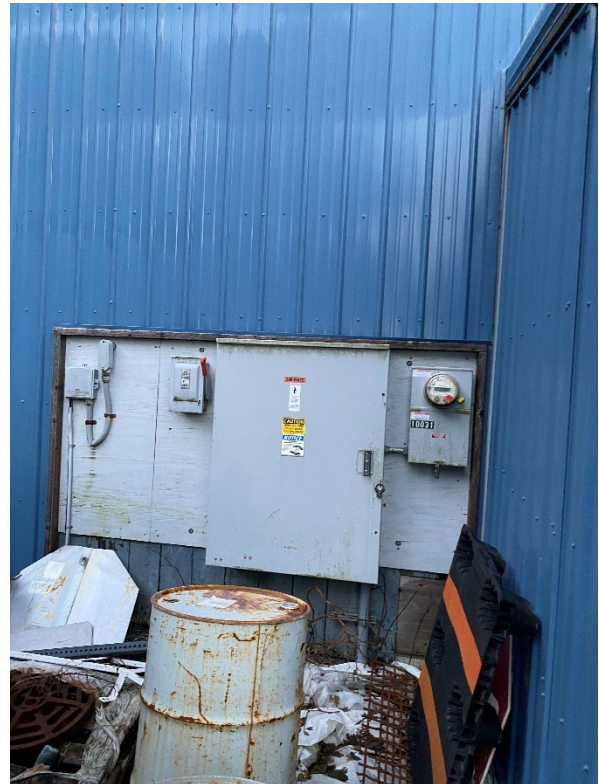
Fig. 42. Electrical service equipment, remove stuff in front of electrical equipment

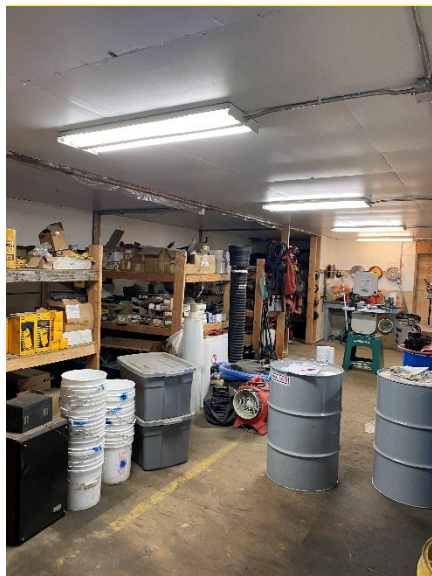
Fig. 45. Fluorescent lights below mezzanine missing lens

18. **Interior lighting upgrade** Replace the high bay fluorescent lights in Shop Bays 1 and 2 and add new lights in Bay 3, with surface mounted, wet location listed lensed high bay LED light fixtures. Maintain connection to existing ceiling mounted occupancy sensors for lighting control. Replace all fluorescent strip lights with 1-foot x 4-foot surface mounted vaporlume style (dust light) LED light fixtures. Shops should be illuminated to a minimum of 50fc average. The lighting upgrade would improve lighting levels, reduce maintenance, and reduce energy consumption. It would also improve safety for the staff using tools.

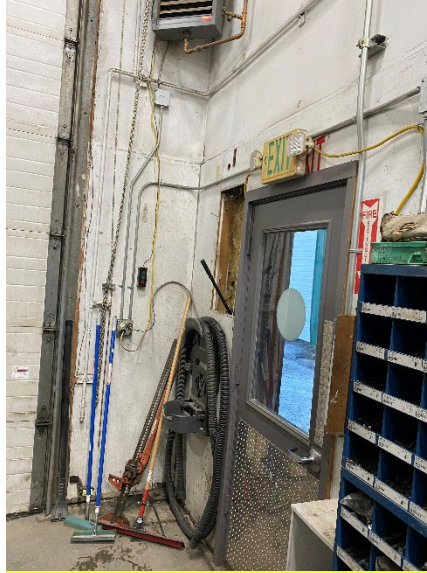
There are combination emergency light/exit signs located above the egress doors. The combination emergency light/exit sign located in Shop Bay 3 is covered up by a wall panel hanging from the wall and obstructs the view of the sign. A combination emergency light/exit sign is required for the mezzanine door leading to the exterior stairs. There is no emergency lighting at the exterior of the main egress doors, or on the exterior stairs. A couple of the combination emergency light/exit signs were damaged and had dead batteries. General condition of the combination emergency light/exit signs is poor, and they should be replaced if a lighting upgrade is done. Four new exit doors (refer to architectural) will require exit and emergency lights.

Fig. 33 Combo emergency/exit sign in poor condition

13. **Emergency lighting upgrade.** Replace all combo emergency light/exit signs and add one in the mezzanine above Shop Bay 3. Add exit signs and emergency lights to the four new exit doors referenced in architectural. Extend emergency lighting to the exterior path of egress by adding remote emergency heads at exterior doors and the exterior stairs, powered from the combo battery unit. Relocate the wall panel blocking the view of the exit sign in Shop Bay 3.
