City of Cordova

Multi-Building Condition Assessment:

Eyak Skaters Cabin

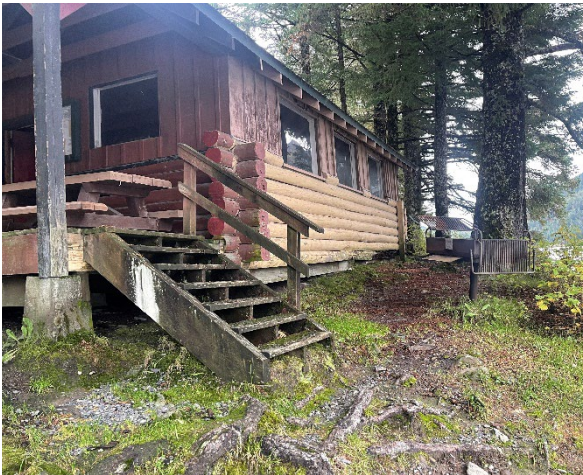
Fig. 1. South Wall and Stairs

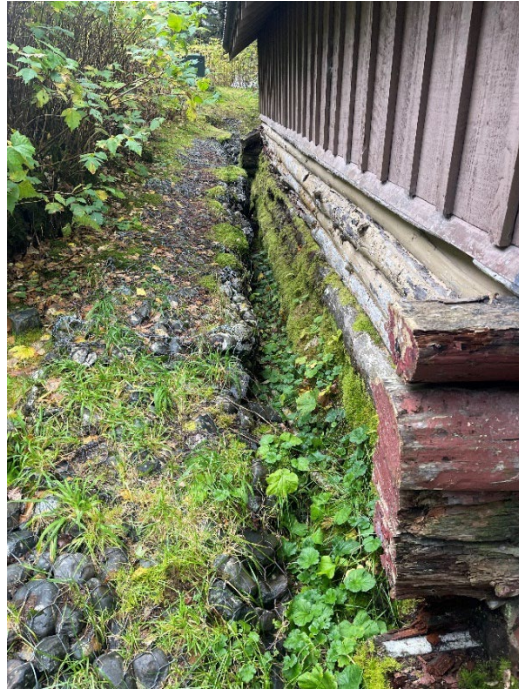
Fig. 2. North wall

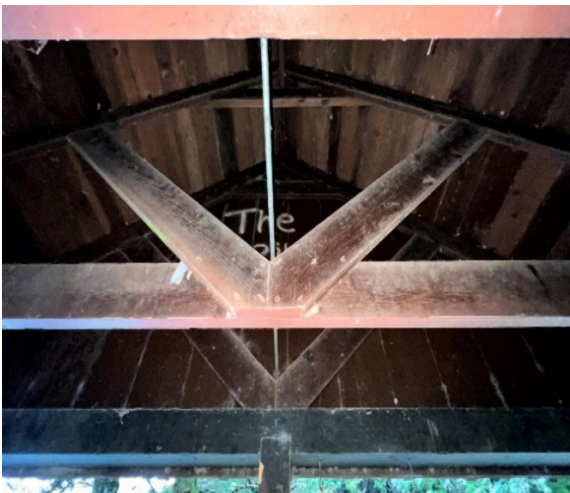
The structural condition of Skaters Cabin is poor. The nailed roof truss connections are inadequate to support the local code level snow load. Alterations to the roof trusses has occurred to accommodate the original fire pit chimney and later its removal. The lower lake side timber logs have extensive deterioration from dry rot. The foundation piers have settled unevenly, evident by the floor sloping approximately 2-inches downward towards the lake.

Fig. 7. Typical Roof Truss

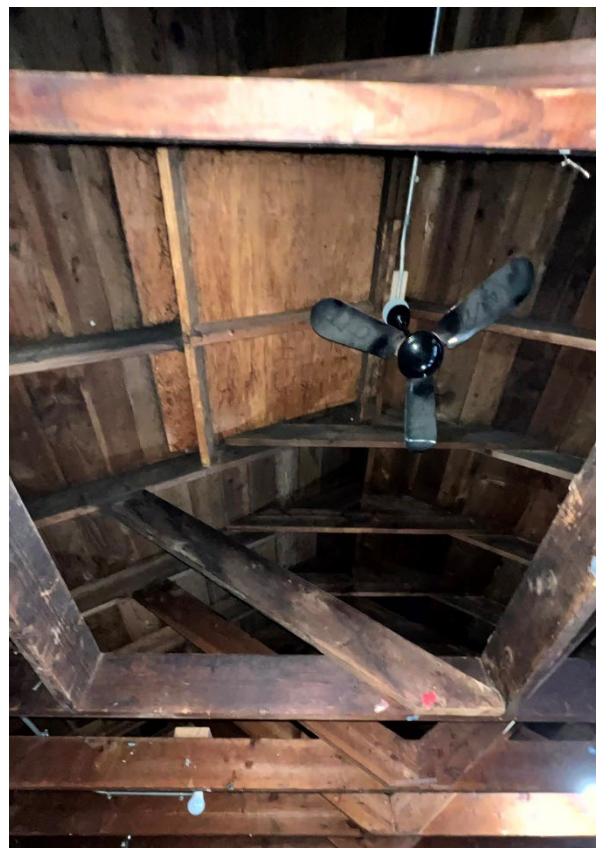
Fig. 8. Altered Roof Trusses

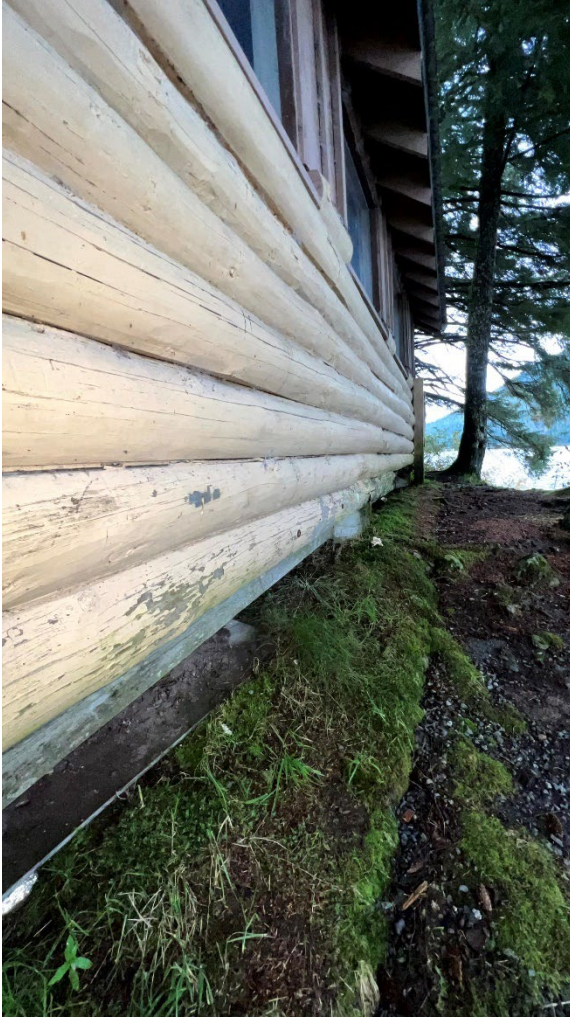
Fig. 9. Lakeside Deteriorated Logs.

Demolish and Replace. Replace the cabin with a similar building that meets the future projected needs. The estimate below assumes a 2x6 stud wall construction and metal roof, and would include electrical connection and a new wood stove. The existing site drainage should be evaluated and corrected if needed depending on the new building foundation.

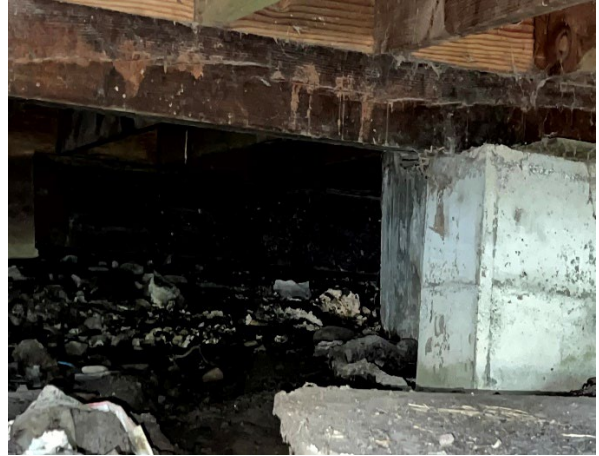
Fig. 10. Differential Settlement of Concrete Piers

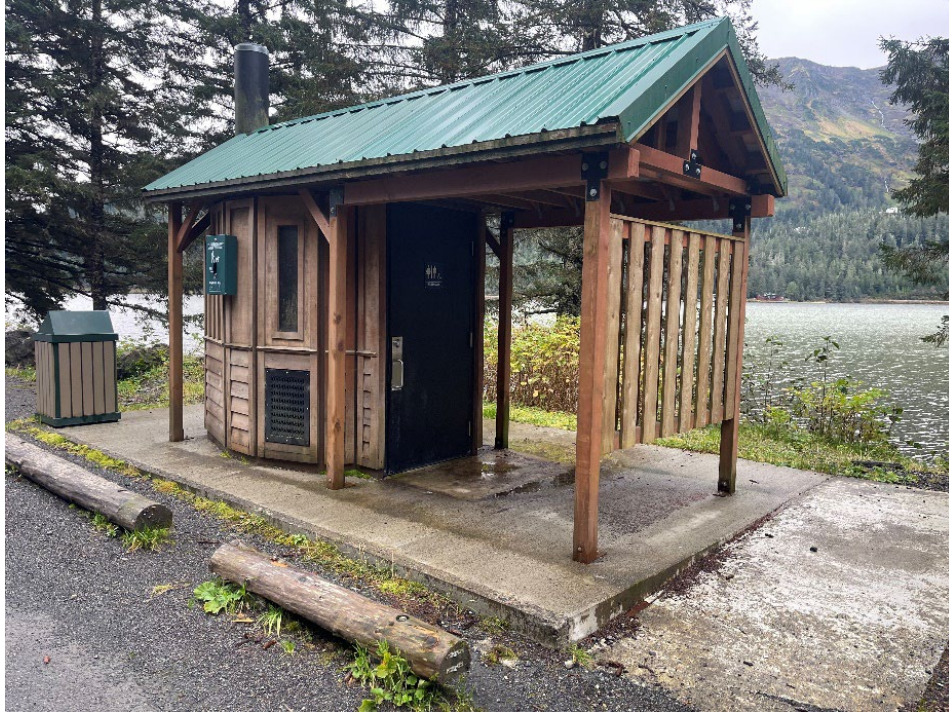
The Eyak Skaters Cabin is located on Eyak Lake, directly off Lake Avenue. The cabin does not have any domestic water or sewage utilities, but there is an outhouse located directly east that shares a parking area. The outhouse is newer and in good condition, and will remain at its current location. The cabin sits below the road and parking area, utilizing gabion baskets with rock as a retaining wall to the north.

Fig. 11. Outhouse Next to Skaters Cabin

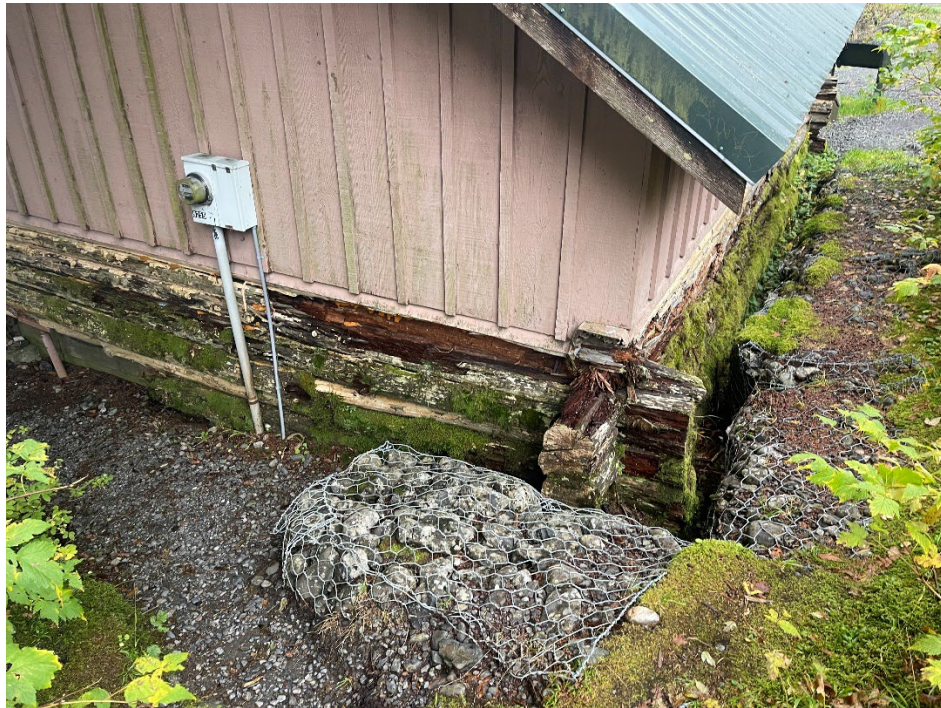
Drainage at the cabin site consists of overland flow from the road and parking area to the lake. The runoff goes directly under the cabin and is affecting the structure and foundation. Wood rot and other issues were identified at the super structure and foundation. Runoff from the cabin roof is also degrading the surrounding ground creating erosion and sediment runoff.

Fig. 12. Skaters Cabin Site and Drainage

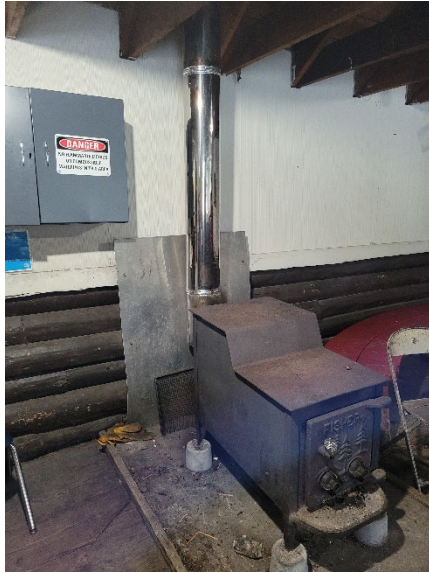
Fig. 13. Wood Stove

There is no fire protection in this facility. The wood stove flue appears to be in fair condition but should be inspected and cleaned. The wood stove is raised on concrete blocks and placed over a noncombustible pad. The stove clearance to combustibles should be reviewed against the stove manufacturer recommendations.

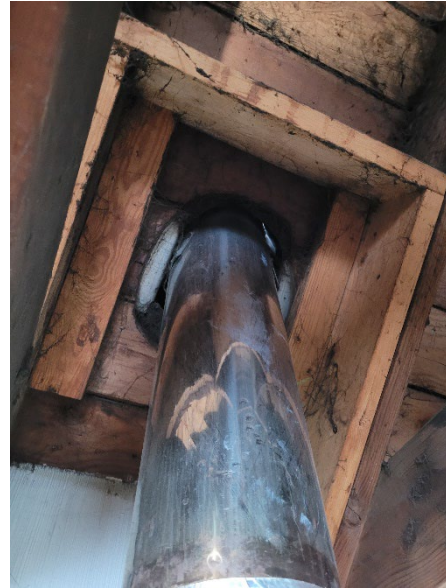
The mechanical systems at the Skater's Cabin consist of a wood fired stove and stainless steel double wall flue. The assembly appeared in fair condition.

Fig. 14. Stove Flue

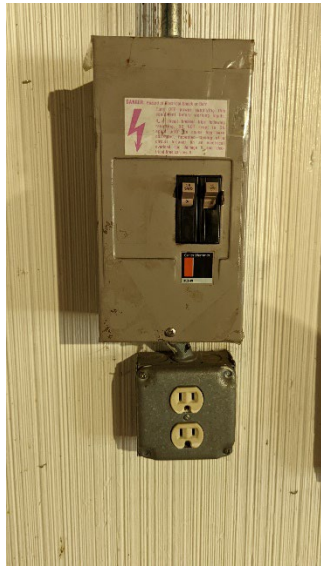
The breaker box is an older Cutler Hammer panel manufactured in the 70s-80s era. It is recommended to replace breakers and/or associated panels older than 30-40 years because they can stop functioning or function unpredictably, especially when exposed to changing climate conditions.

Fig. 15. Electrical Breaker Box in Cabin

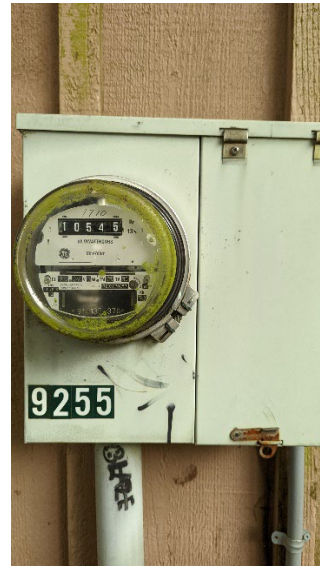
The facility is served by a 120/240V, single phase, 3-wire electrical service provided by Cordova Electric Co-op. A combination disconnect meter main with two integral 20A breakers is mounted to the exterior of the cabin. The meter is fed by a nearby 25kVA pad mount utility transformer. It is assumed that the transformer also feeds nearby street lighting.

Fig. 16. Electrical Service Combination Meter Main

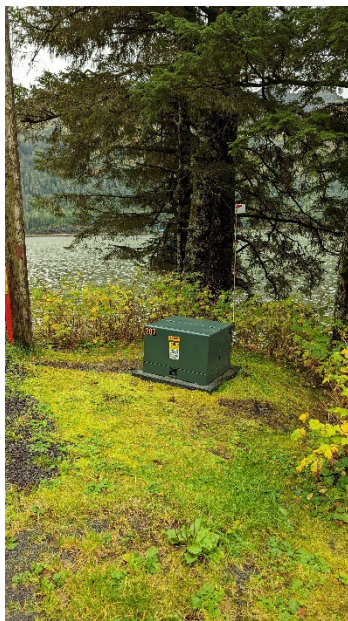
Fig. 17. Service transformer

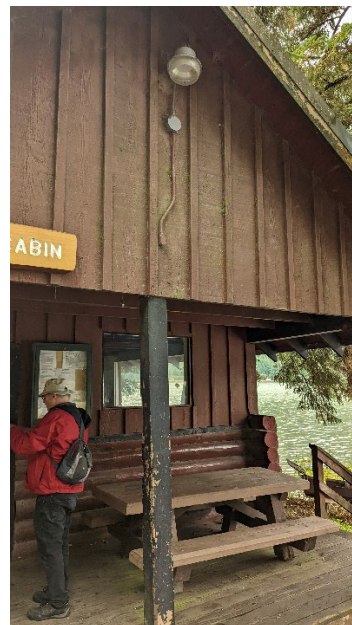
Fig. 18. Cabin Exterior Light Fixture
