City of Cordova

Multi-Building Condition Assessment: Fire Department Sub Station Building

The Fire Department Sub Station Building is a pre-engineered metal building from 2001. It serves as Sub Station for fire trucks and firefighting equipment.

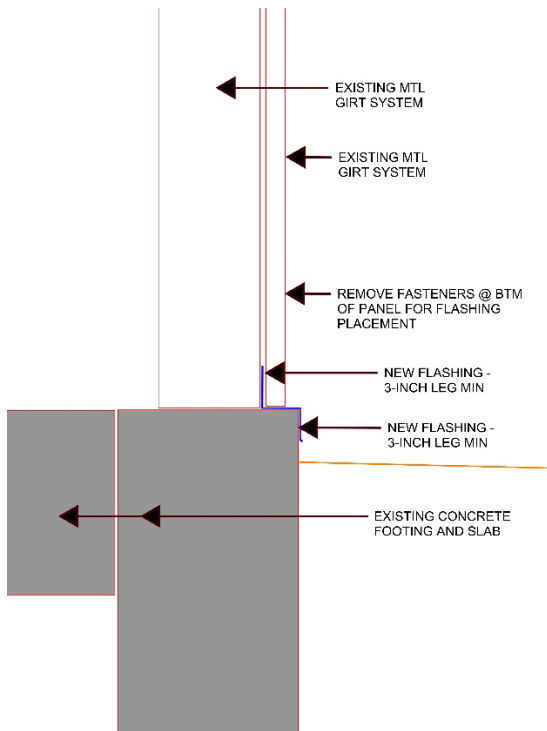
- ▶ *It appears that the footing and concrete slab work is oversized for the building. This does not allow for a proper drip edge or closure. The user stated that they get large amounts of water coming in from the wall base. Correction is new metal flashing. It appears that the fasteners at the bottom could be removed, and new metal flashing added. A small area should be selected to serve as a test area. If this is not feasible, the bottom 12-inches should be removed from the perimeter of the building. See Options 1&2.*

Fig. 1. *Flashing Option 1*

1. **Facility Maintenance – Base Flashing.** It appears that the footing and concrete slab work is oversized for the building. This does not allow for a proper drip edge, or closure. The user stated that they get large amounts of water coming in from the wall base. Correction is new metal flashing. It appears that the fasteners at the bottom could be removed, and new metal flashing added. A small area should be selected to serve as a test area. If this is not feasible, the bottom 12-inches should be removed from the perimeter of the building. See Options 1&2.

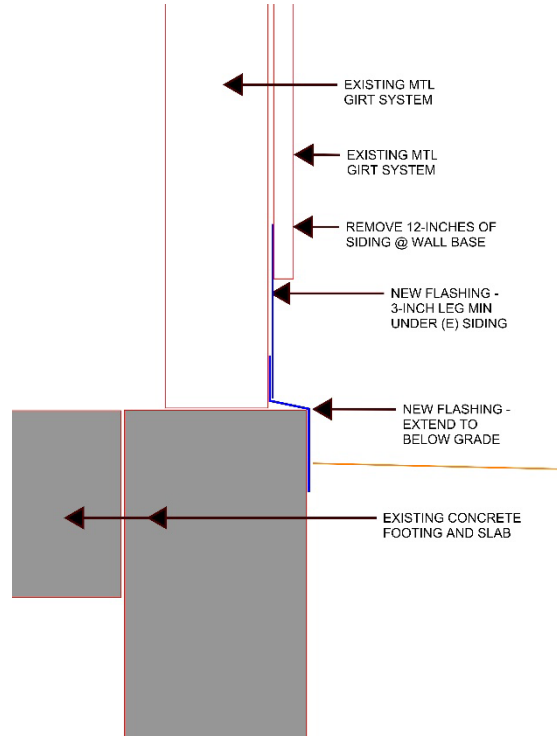
Fig. 2. *Flashing Option 2*

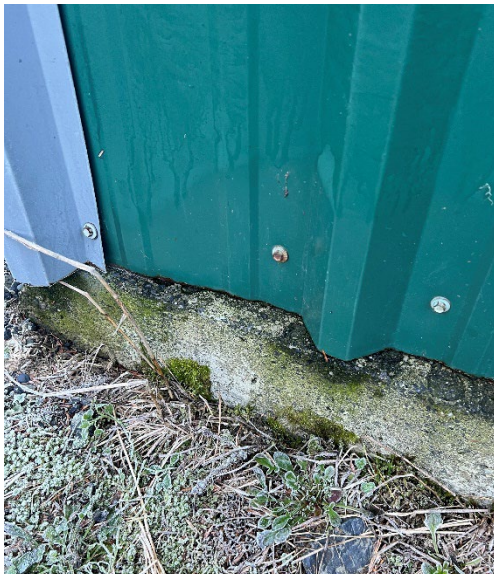
Fig. 3. *Metal Wall Panel Typical Condition*

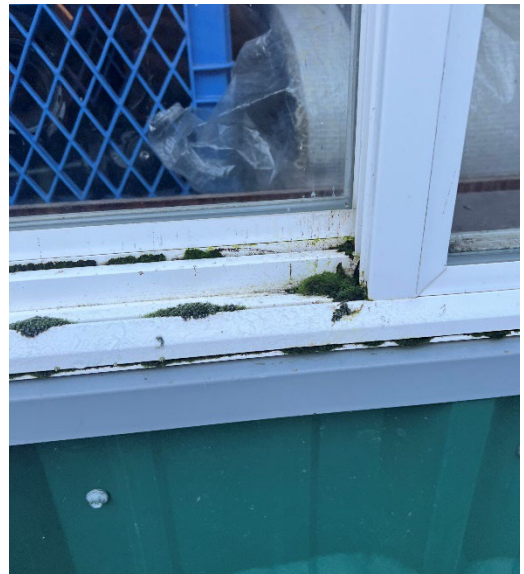
- ▶ *Windows are all vinyl, no hardware deficiencies were noted, but moss should be washed out of the perimeter tracks.*
- ▶ *The wall deflector for the heater was not present, it's caused decay and damage to the siding. The siding should be prepped and painted to stop future deterioration. A stainless deflector should be added.*

Fig. 4. *Existing Windows*

2. **Facility Maintenance.** Windows are all vinyl, no hardware deficiencies were noted, but moss should be washed out of the perimeter tracks.

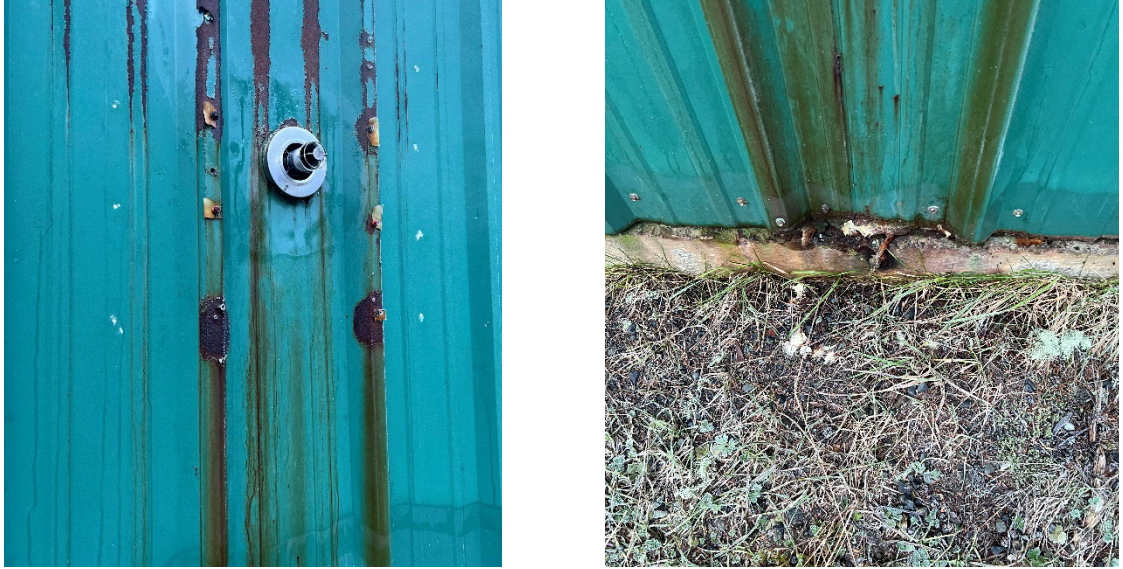
Fig. 5. Missing Heat Deflector and Damage

3. **Facility Maintenance.** The wall deflector for the heater was not present, it's caused decay and damage to the siding. The siding should be prepped and painted to stop future deterioration. A stainless deflector should be added.

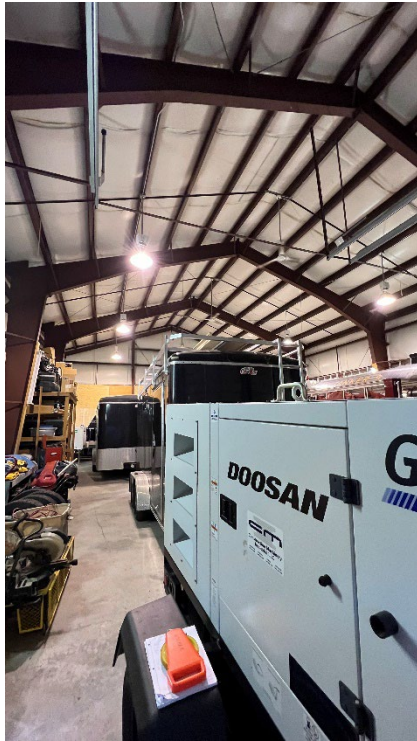
The fire department was in the process of adding wall sheathing to the inside face of the walls when it was discovered that the floor slab has settled in the northeast corner, approximately 12-inches compared to the rest of the building. The slab slope is essentially uniform from the center of the building to the lowered northeast corner. The department has since stopped the wall sheathing installation and is awaiting foundation repairs before proceeding and adjusting the building tension-only bracing. The fire department indicated there is a 6" standpipe in the northeast corner of the building, which should be filled in.

Fig. 6. Interior View Along North Half

We have contacted a general contractor experienced in raising slabs and foundations such as this for a construction estimate to include in our repair estimates. We recommend the soil around the thickened slab edge foundation be injected with polyurethane to a depth of 5 to 6-feet to stabilize the pad and then mechanically raise the slab edges back to level using hydraulic jacks. Once level, the voids between the bottom of slab/footings and gravel pad should also be injected with polyurethane for support. Port holes drilled through the slab will enable the polyurethane to be installed below the interior slab. The plywood panels installed on the walls should be removed prior to the foundation leveling and should be replaced after leveling is

completed. The building diagonal rod wall and roof bracing will also need to be retightened after the floor leveling is complete.

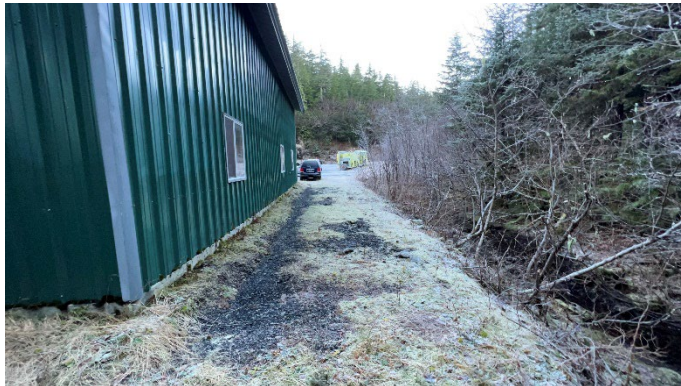
Fig. 11. Drainage Ditch Along North Side

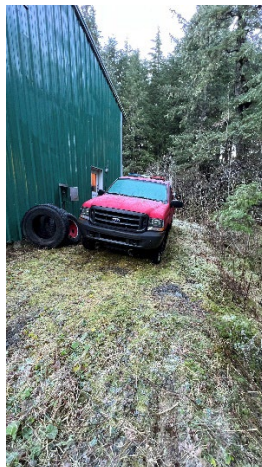
Fig. 12. East Edge of Building and Pad

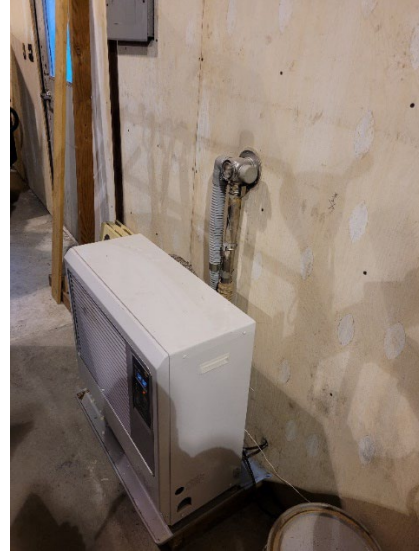
This building is heated by two Tototomi oil fired heaters, which are fed by an above ground fuel oil tank that is located on a stand along the backside of the building. The equipment appears in good condition. The exhaust discharge from each heater terminates almost flush with the exterior metal siding and is causing staining and corrosion. The heater along the back wall of the building showed evidence of an exhaust leak on the flue pipe. It may or may not have been corrected, but should be checked and repaired if needed.

Fig. 16. Evidence of exhasut leak on flue

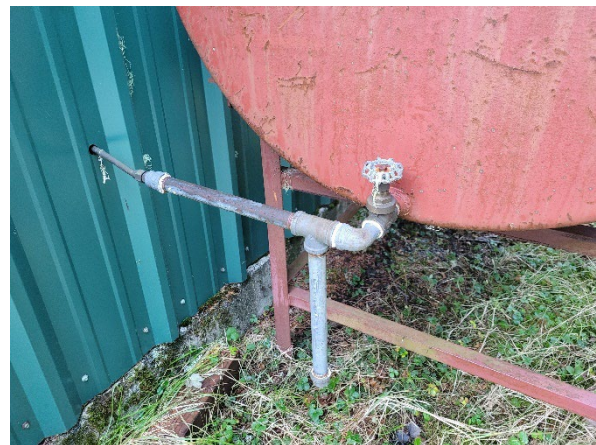
The fuel piping from the tank to the building has a filter in the South East corner of the building. There did not appear to be a fuel shutoff valve at each heater connection, a ball valve shutoff should be installed at each heater.

Fig. 18. Fuel piping

2. **Fuel Piping.** Provide a fuel filter between the tank and heaters. There also did not appear to be a fuel shutoff valve at each heater connection, one should be installed at each heater.

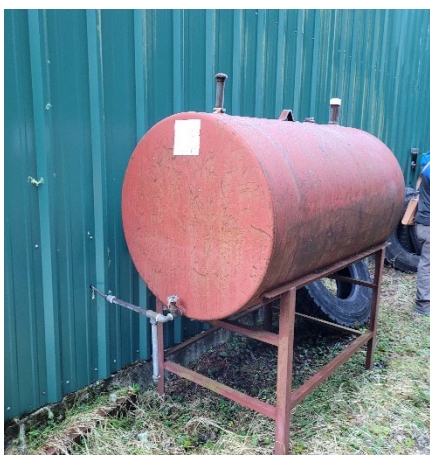
The 300-gallon tank located on the exterior part of the building is not protected by an approved method, is within 5 feet of the building, and is not provided with secondary containment.

Fig. 19. 300 gallon waste oil tank.

- *Provide code-compliant distances between above-grade outdoor storage tank and lot lines, public way, and other tanks.*

1. **Fuel Tank Location.** Move the fuel oil tank away from build to provide 5-feet of clearance required by code.

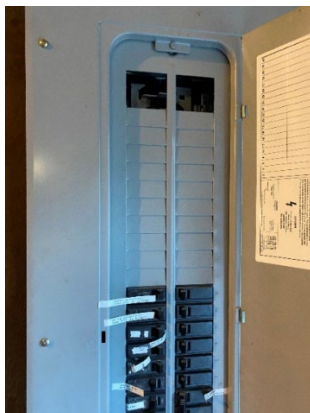
Distribution for the building is provided via a 100A, 240/120V, single phase, 3-wire panelboard located on the wall adjacent to the front door. The main panelboard sub feeds a 100A panel located on the back wall. The main panelboard is missing circuit breaker cover plates which exposes a portion of the main electrical bus. The electrical distribution system is generally in good condition.

Fig. 23. Main panel with missing circuit breaker covers

4. **Main Panel repair.** Install circuit breaker blank space covers to panel. This is a minor repair to fix a safety issue. Also provide typed panel schedules for each panelboard showing current circuiting.

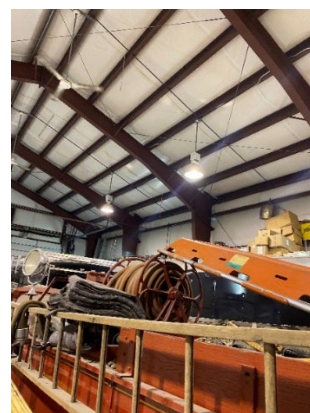
Lighting within the building is from high bay suspended HID lights which is inefficient and has a long start up time.

Fig. 24. Interior HID lighting

4. **Interior lighting upgrade** Replace the high bay HID lights with suspended high bay LED lights. The LED lighting will improve the quality of lighting, will turn on instantly (no warm up time like HID) and reduce energy and improve maintenance.
