City of Cordova

Multi-Building Condition Assessment:

Fleming Spit Restroom

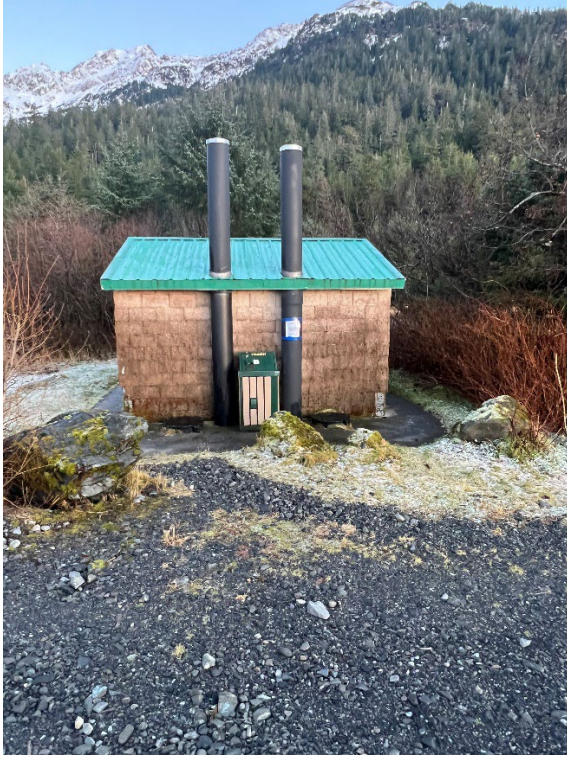
Fig. 1. Front Elevation

The building is constructed out of CMU and is in fair condition. The roof is wood framed with an exposed fastener metal roofing system. Given the overall condition of the building, no corrections are recommended, but the deficiencies and corrections are as follows:

- ▶ *There are a couple CMU faces that are broken away, install new facing.*
- ▶ *Power wash and remove all organics from the block. Provide new exterior paint to the facility to clean up the appearance.*
- ▶ *Door frames are beginning to rust, replacement is recommended.*

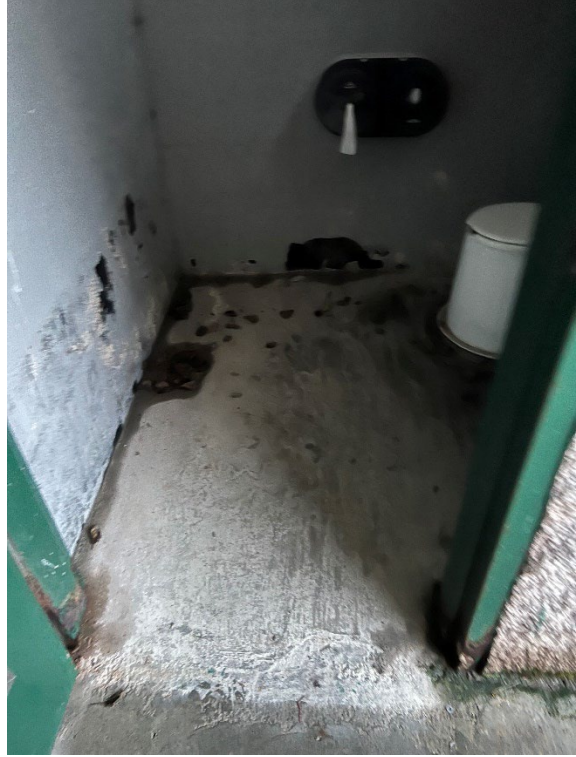
Fig. 2. Typical Toilet Room

The building interior is in fair condition overall. While winterized, the facility appears fully operational. The following deficiencies were noted:

- ▶ *There is heavy spalling and blistering of the existing paint. Power wash, scrape, and prep the interiors for a new epoxy paint finish throughout.*

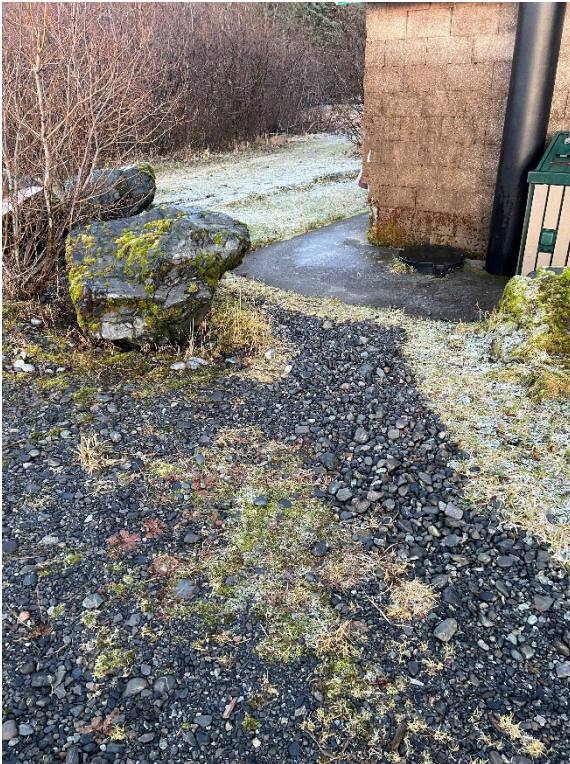
Fig. 3. Front Approach

The building currently has no accommodations for accessibility. The parking area is roughly graded, then the toilet facility is accessed by a narrow gravel trail. The biggest issue is grade. The facility sits approximately 24-inches below the parking lot elevation. There is a small concrete sidewalk around the facility, but it does not provide the required accessibility. However, the toilet rooms themselves are generally sized to the correct proportions.

- ▶ *If the City elects to keep this facility in operation, and provide it as an accessible facility, the existing building should be demolished, and the existing grade brought up. Asphalt grading should be provided for a portion of the parking lot to create a ADA accessible stall. A new facility would be constructed or set. These types of facilities are commonplace, and there are a few manufactures of packaged units exist. These units are constructed out of resilient materials, concrete, and plastic that could be erected in the current building's footprint.*

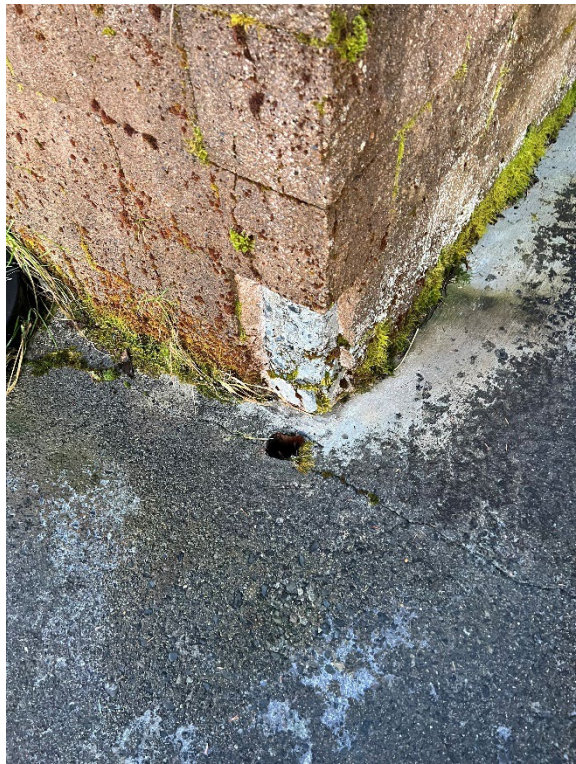
Fig. 4. CMU Damage

The concrete masonry is in poor condition, especially the lower 24 inches where the exterior face of walls have a buildup of moss and where face shells have broken off revealing the grouted cells.

Recommend the concrete masonry be repaired or totally replaced above the floor slab or the be building demolished in its entirety if it is no longer used.

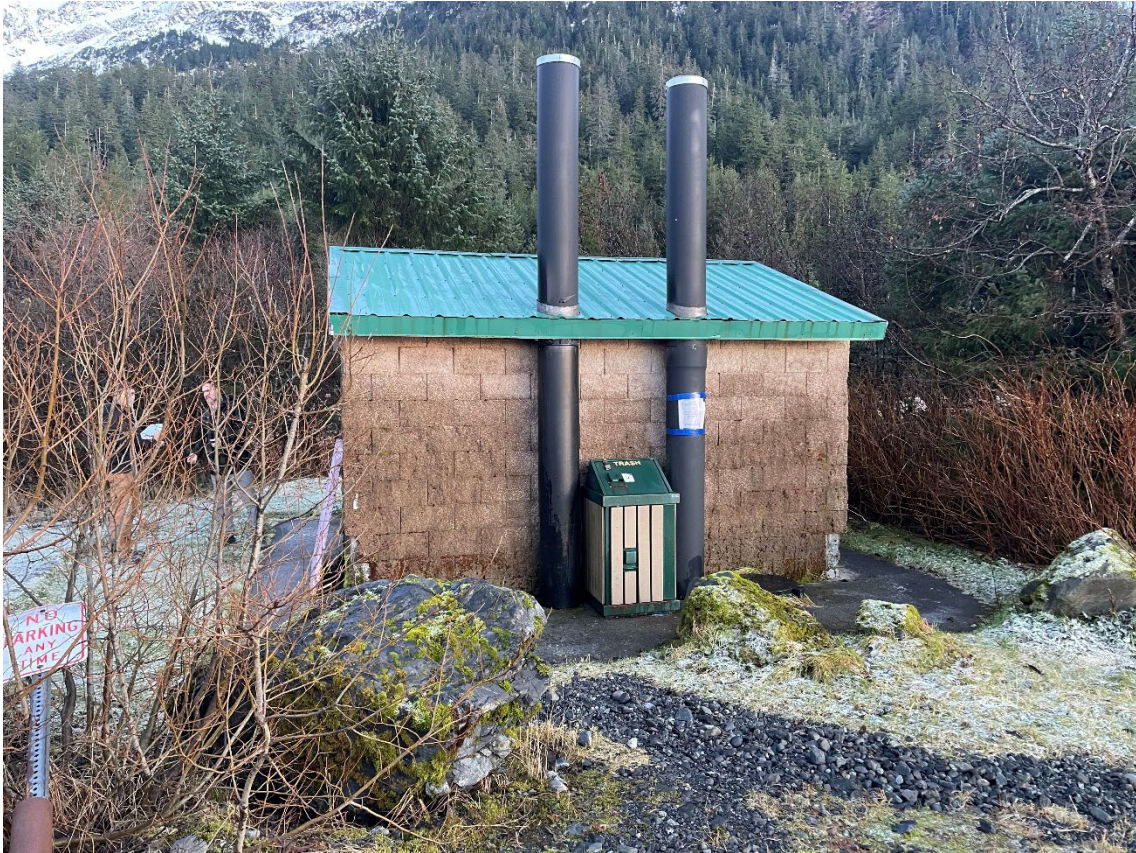
Fig. 9. Outhouse View from Road

The Flemming Spit Restroom is located at 650 New England Cannery Road. The restroom access is directly off the road corridor via a gravel trail. No City utilities are present at this location as this is a dry and unheated restroom. The restroom is not ADA accessible.

Drainage around the facility appears to be adequate with no indication of ponding. Lower areas of the exterior CMU wall show signs of moisture and plant growth, indicating the areas may not dry out.
