City of Cordova

Multi-Building Condition Assessment:

Hollis Heinrichs Park Restroom

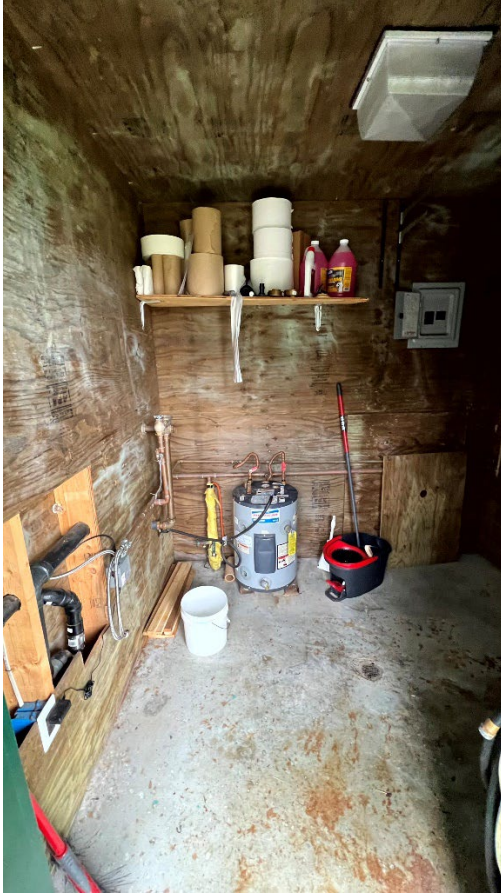
Fig. 3. Mechanical / Electrical Room

The mechanical/electrical building is sheathing with plywood. The plywood itself appears to have heavy water damage. No active water leaks were observed. At this time the assumption is being made that the roof did indeed leak at one point, possibly the same cedar shake was installed at the roof at some point. After the roofing was replaced, the roof leaks were corrected, and the leaks were stopped. This is just an assumption based on our inspection. If facility staff still has issues with water infiltration, some sheathing should be removed at this location to inspect the condition of the wood studs.

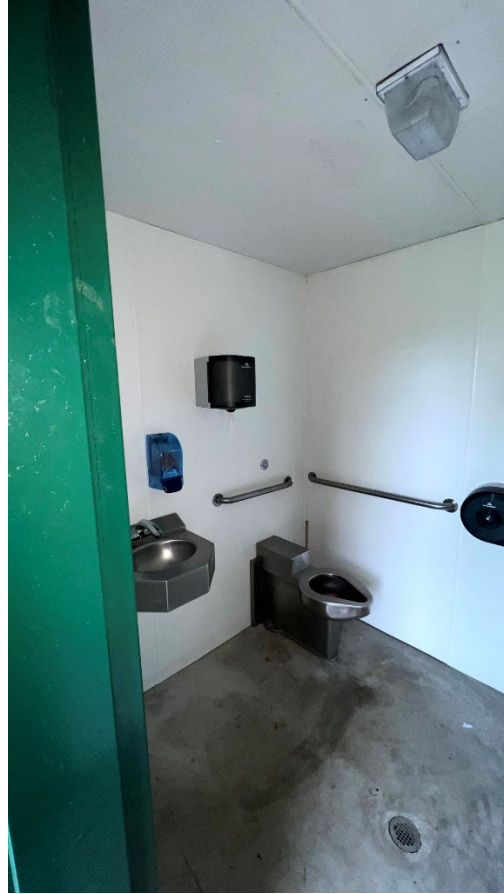
Fig. 4. Typical Toilet Room

The building has made reasonable accommodations for accessibility. There are small discrepancies in some of the toilet accessories mounting dimensions, but none requiring correction. The approach to the facility is reasonable and the concrete sidewalk is compliant. A vertical grab bar was not installed (a relatively new required of ADA) and one is recommended to be installed.

- *Install new vertical, 18 inch, grab bar.*

1. **ADA Accessibility.** Install a new vertical 18-inch grab bar and relocate toilet dispenser in both stalls.

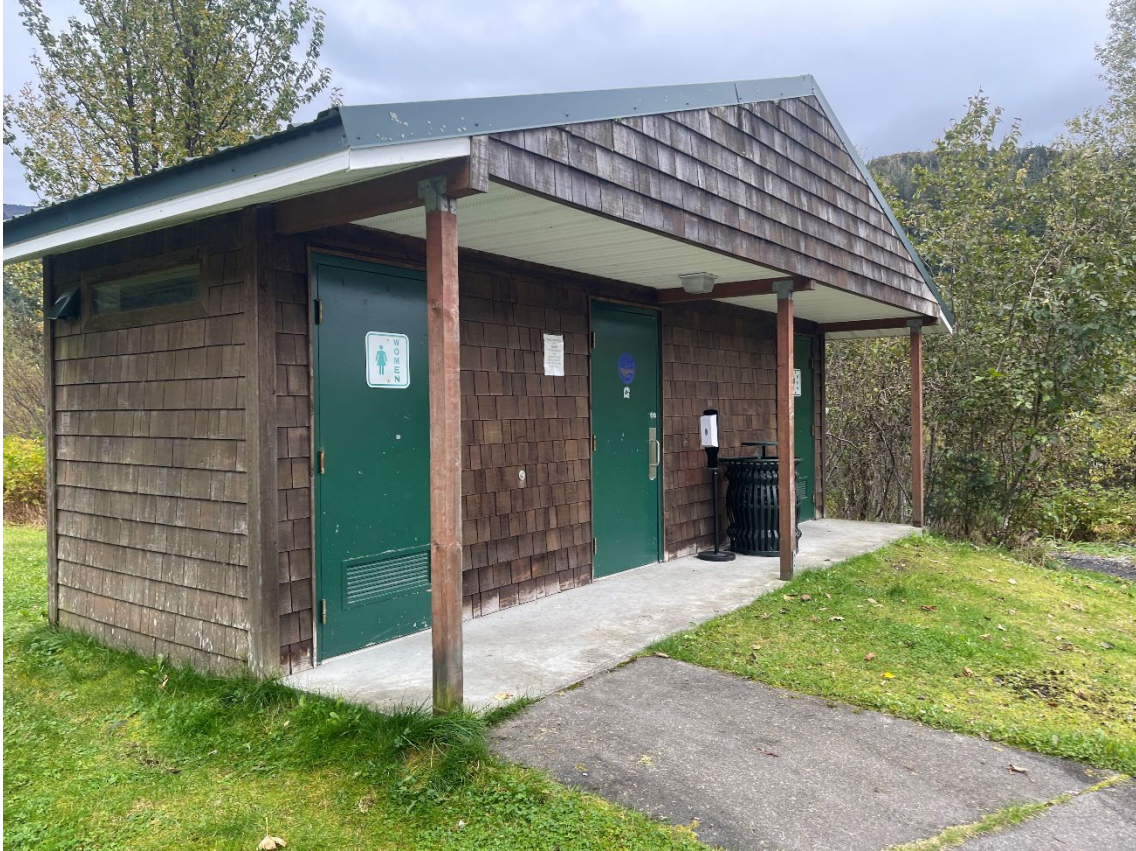
Fig. 10. Concrete apron

The concrete apron at the entrance to the facility is in adequate condition. The restroom entrances and path are not ADA accessible. See architectural for more information on interior accessibility. See Figure 10.

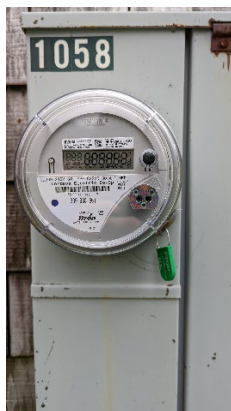
Fig. 11. Electrical Service Disconnect/Meter

The facility is served by a 120/240V, single phase, 3-wire electrical service provided by Cordova Electric Co-op. A combination disconnect meter main with two integral disconnect breakers is mounted to the exterior of the restrooms. One breaker is 100A rated, 2-pole and feeds the main panelboard for the facility. The other breaker is 20A rated, single pole. It is unknown what the single pole breaker feeds. It is assumed it feeds the water heater located in the electrical/mechanical room.

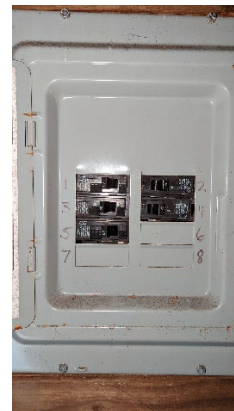
Fig. 12. Branch Circuit Panelboard for Facility

There are no arc flash labels on the electrical panels and equipment. It is recommended that an Arc Flash Risk Assessment be performed on power systems for employee safety and compliance with The Occupational Safety and Health Administration (OSHA) regulations. OSHA requires that employers provide a place of employment which is free from recognized hazards that are likely to cause death or serious physical harm to employees. OSHA also requires that employers employ safety-related work practices to prevent electrical shock or other injuries resulting from direct or indirect electrical contact.

The branch circuit panelboard for the facility is located within the electrical/mechanical room. The panel is 125A, 120/240V, single phase, 3-wire rated and appears to be in good condition. Loads for the facility include lighting, receptacles, and the hot water heater.

3. **Arc Flash Risk Assessment.** Recommend an Arc Flash Risk Assessment is performed on power systems for employee safety and compliance with OSHA regulations. Install arc flash hazard labels to all panels and equipment per NEC 110.16.

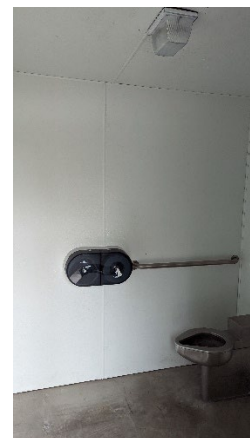
Fig. 14. Typical Bathroom Light Fixture

Lighting for the entire facility appears to be incandescent fixtures, all ceiling mounted. A photocell for control of the exterior lighting was not located.

2. **Lighting upgrade.** Replace all incandescent lights with ceiling mounted vandal resistant, wet location listed LED light fixtures. This includes replacement of three interior lights and one exterior light. Install a photocell for daylight control of the exterior light fixture.
