City of Cordova

Multi-Building Condition Assessment:

Odiak Pond Gazebo

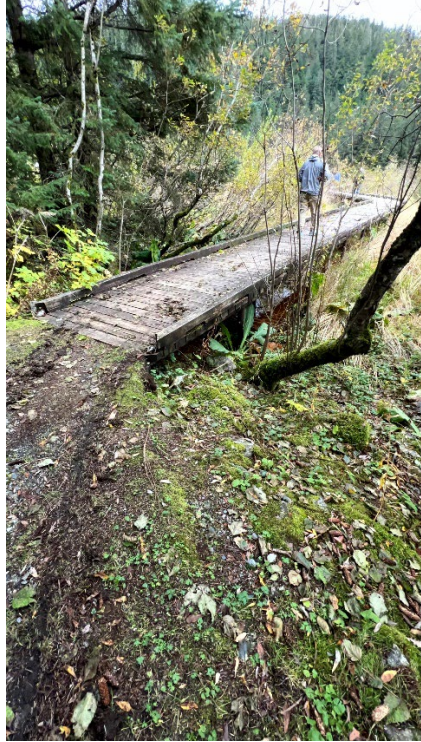
The approach to the boardwalk currently has no accommodations for ADA accessibility. The path is gravel and has some damage that prevents wheelchair access. If the City of Cordova wants to provide ADA accessibility to this amenity, the following is required.

Fig. 1. Gravel and termination at boardwalk

- ▶ Provide a 48-inch-wide asphalt walkway to the boardwalk; any height transition to the boardwalk shall be less than 1/2-inch. Any areas where slope exceeds 1:12 inches, with 1:8 maximum, handrails shall be provided on both sides of the path. Gravel path is approximately 300-feet.

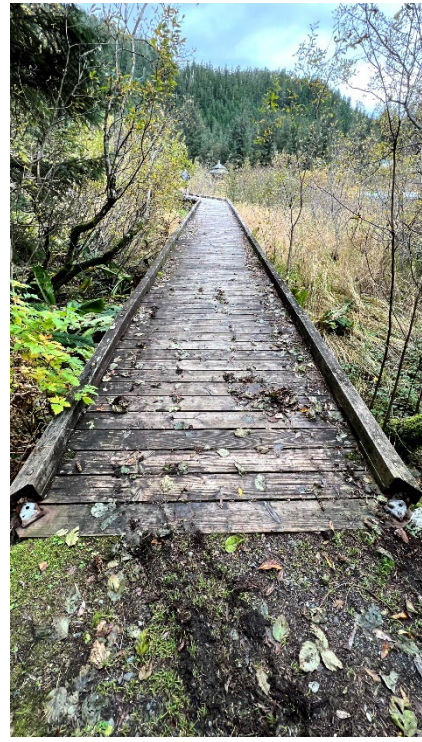
Fig. 2. Gravel and termination at boardwalk
