**City Council Work Session
April 25, 2024 @ 6:00 pm
Cordova Center Community Rooms
Agenda**

RE: Eyak Lake Weir Ownership Assessment

TO: Eyak Weir Stakeholders
THROUGH: Kate Morse, Program Director, Copper River Watershed Project (CRWP)
FROM: Euan-Angus MacLeod, PE, CFM
DATE: 03/11/2024
SUBJECT: Eyak Weir Replacement

APPENDIX A: EYAK WEIR: CURRENT CONDITION PHOTO LOG

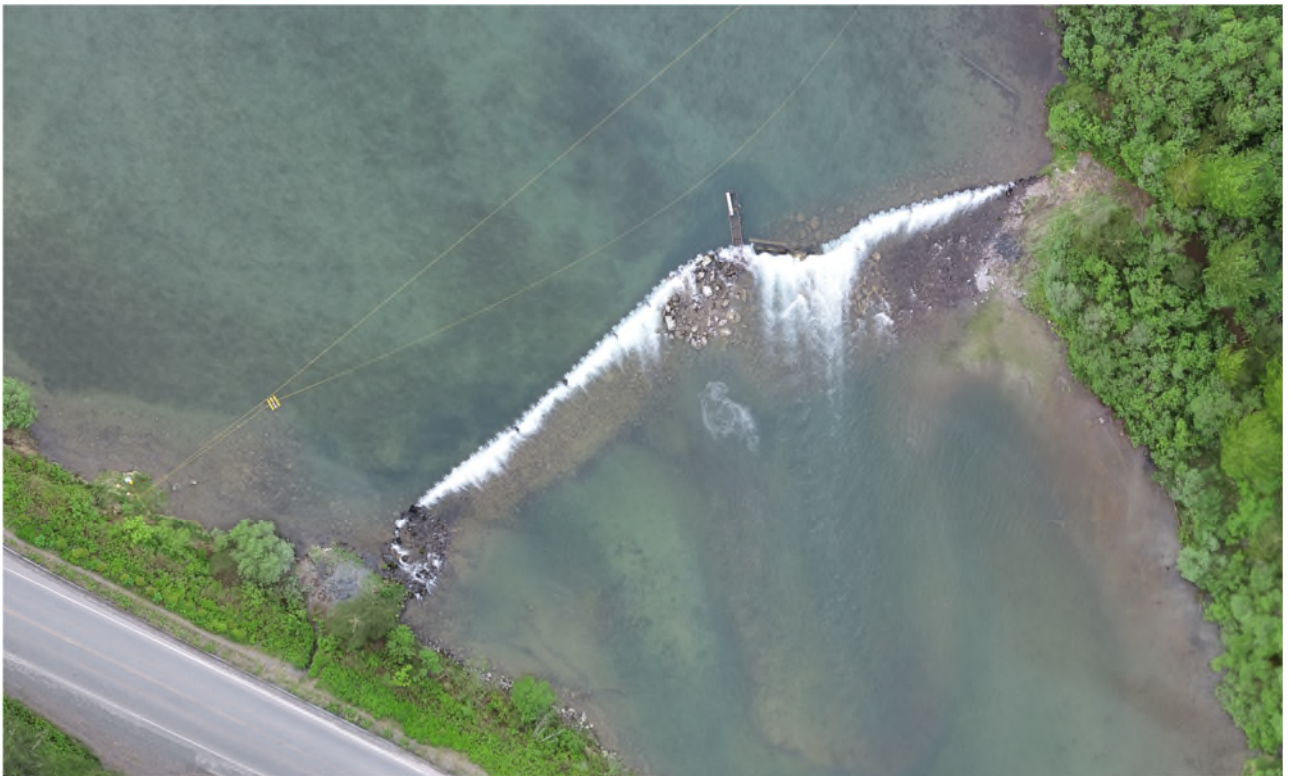
FIGURE: Aerial Image of the Existing Eyak Weir

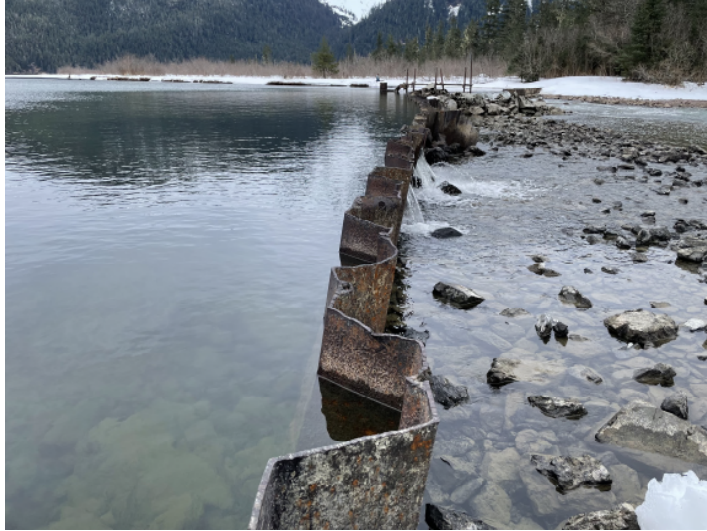
FIGURE: Crest of Eyak Weir

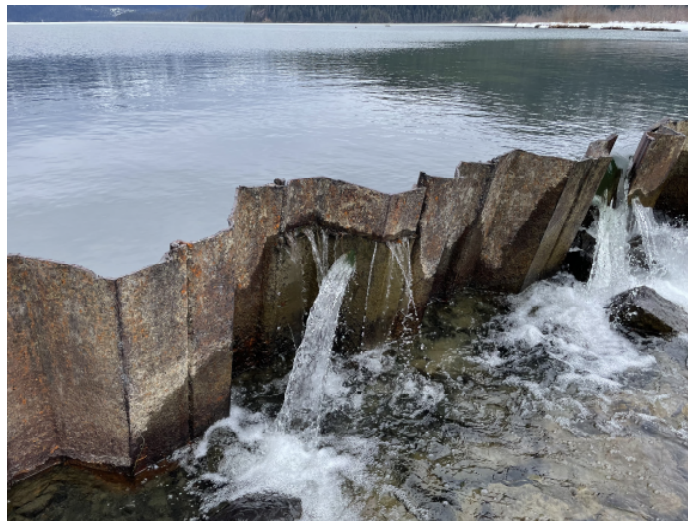
FIGURE: Material Degradation and Leaking

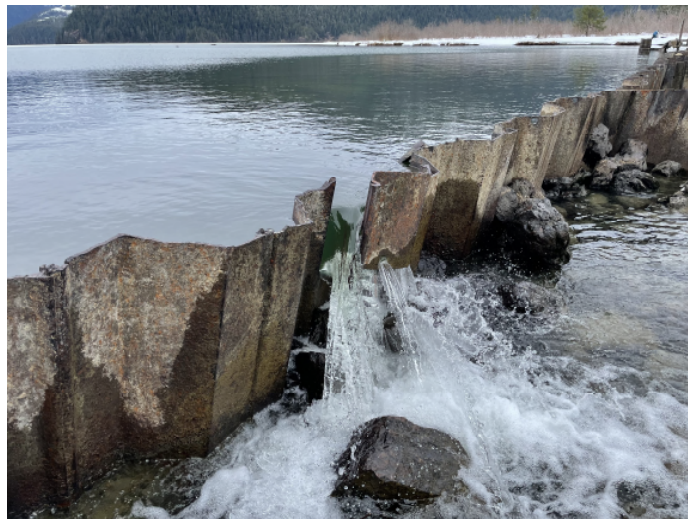
FIGURE: Sheet Pile Joint Burst

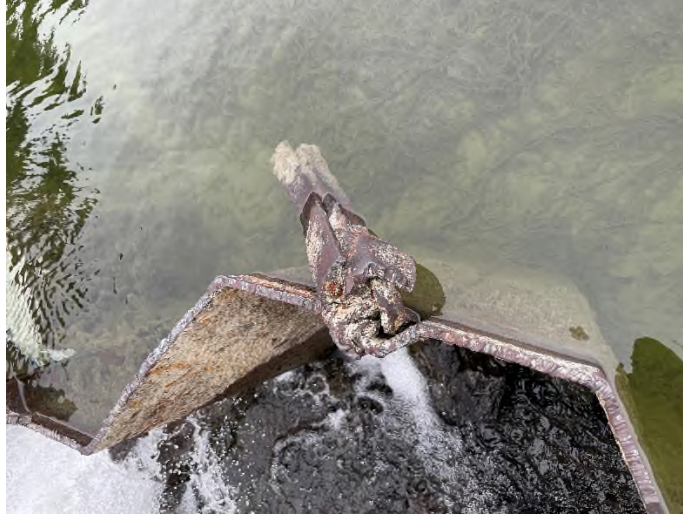
FIGURE: Leaking of Sheet Pile Joints

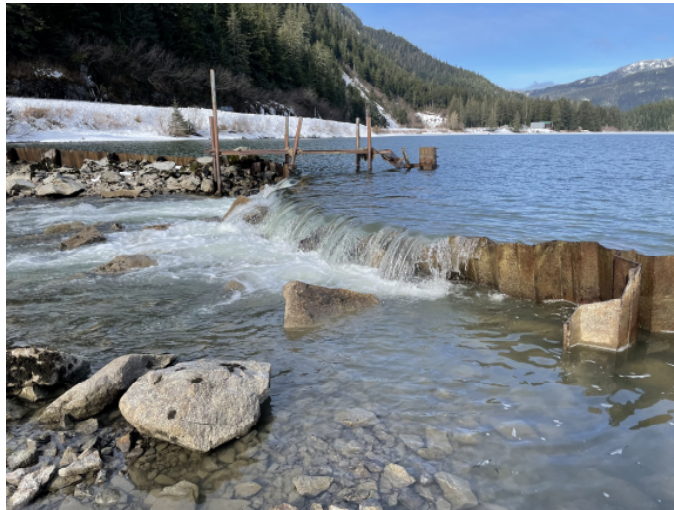
FIGURE: Sheet Pile Failure Lowering Crest of Weir

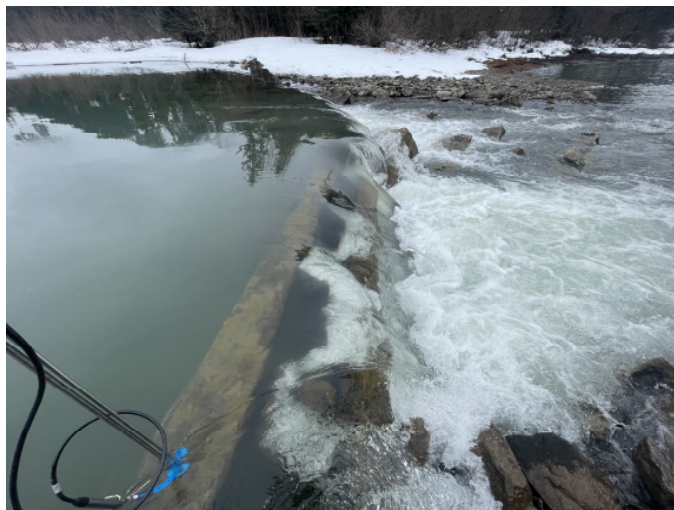
FIGURE: Failed Section of Crest
