# City of Cordova Multi-Building Condition Assessment: Bidarki Recreation Center

Due to the amount of information and quantity of sites, a separate report has been developed for each facility. This condition assessment report is for the Bidarki Recreation Center.

The Bidarki Recreation Center was evaluated by the team on November 17, 2022. This report provides:

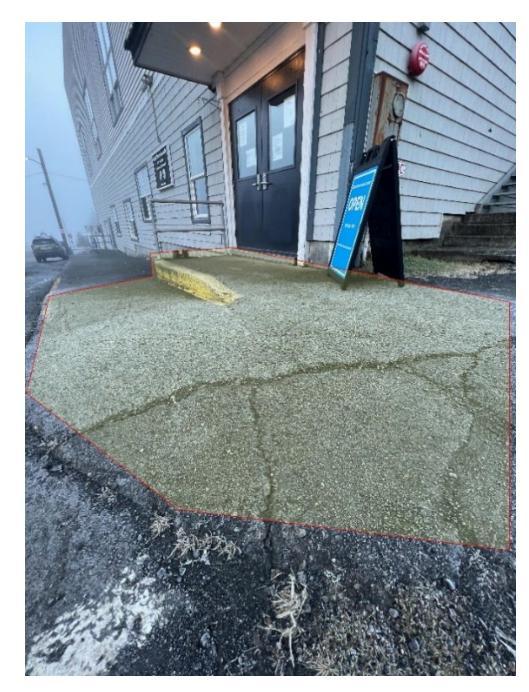
- The existing concrete landing and a portion of the sidewalk would be removed and replaced; this would provide the correction needed to the main level.

Fig. 1. Shaded area indicates replacement entry

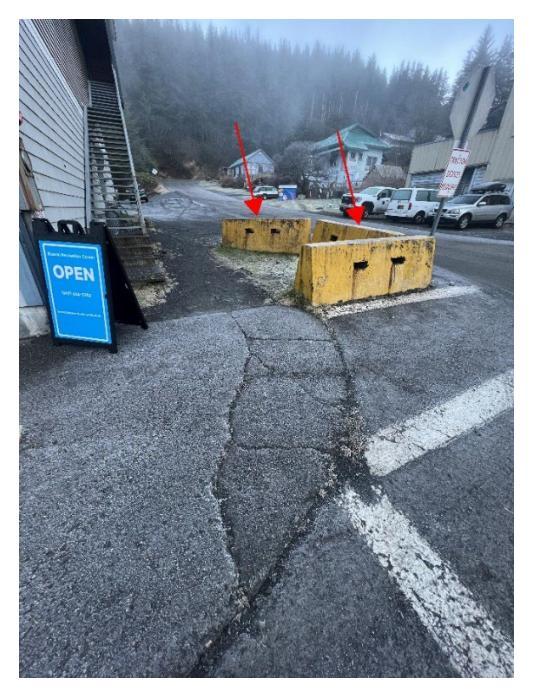
Fig. 2. Remove barricades for ADA parking

There is no ADA accessible parking at the entrance to the facility and no ADA accessible route to the facility entrance from the back parking area (See Figure 24). Surrounding grades follow the grade of the natural hillside, sloping east to west across the building. General parking for the facility is located to the north of the building and is uncontrolled. The Owner indicated an interest in enhancing this parking area to be similar to the adjacent parking to the north, however, it may be cost prohibitive. Snow typically gets piled in this area as well and takes up a substantial amount of parking according to the Owner.

**3. ADA Parking**. Construct an accessible parking stall and accessible entrance to the building. Demolish and replace concrete landing and approximately 20 square feet of sidewalk and curb. Add approximately 300 square feet of asphalt paving for parking stall. Demolish built-up curb and replace front door. Replace stomp grate with ADA compliant version.

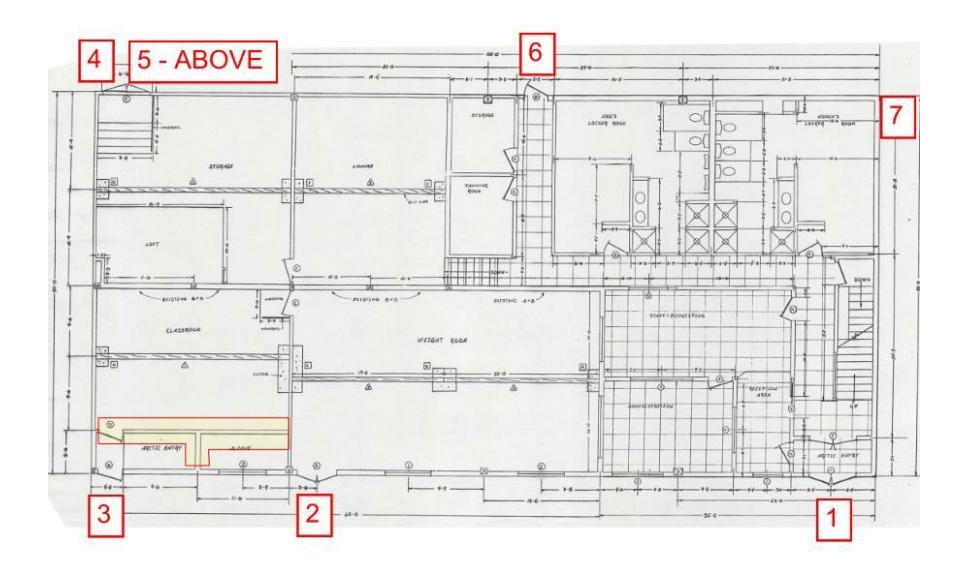
- At the front entry there is an approximate 4-inch step-up. The existing doors would be removed, the built-up curb removed, and the doors replaced. While there is a very functional gravel catch in the main entry, the grating installed is larger than ADA allows and should be replaced.

Fig. 3. Entry floor plan

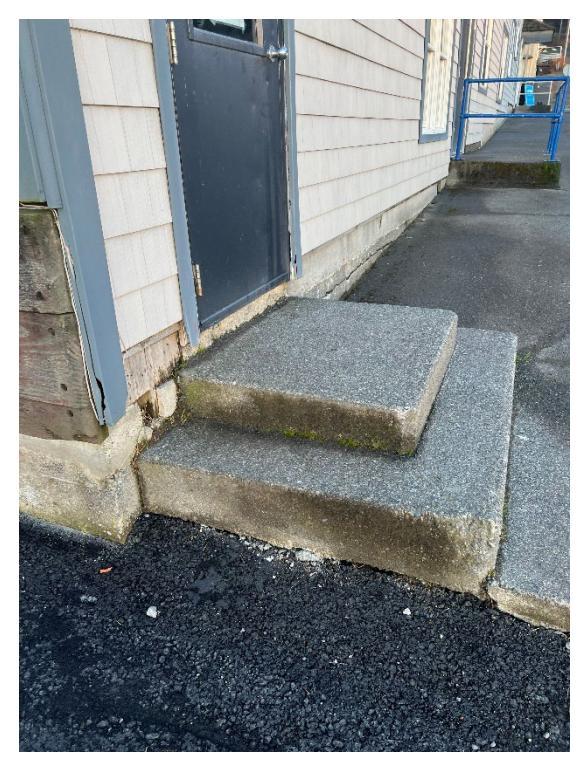
Fig. 6. Exit 3

- There is another exit door at this elevation, it connects to a concrete landing. No required hand or guardrails are present. Recommendation would be to remove this exit in its entirety, the alcove and arctic entry walls could be removed to allow more area for weights or aerobic activity. (Exit 3) Note the interior arctic entry door walls are original construction and may be load bearing, requiring replacement by a new girder beam and posts. Finish removal will be required to determine status.

5. Eliminate Exit Door. Exit 3 is located at lower corner of building, it connects to a concrete landing. No required hand or guardrails are present. Recommendation would be to remove this exit in its entirety, the alcove and arctic entry walls could be removed to allow more area for weights or aerobic activity. (Exit 3)

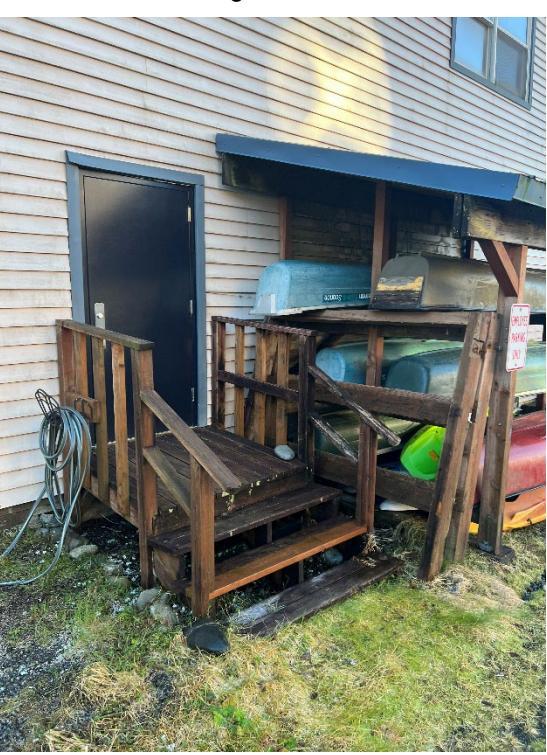
Fig. 9. Exit 6

- The exit doors off the first floor are compliant, however, the wood landing is deficient dimensionally and warrants replacement. A new landing should be constructed out of durable materials such as concrete and steel. (Exit 6)

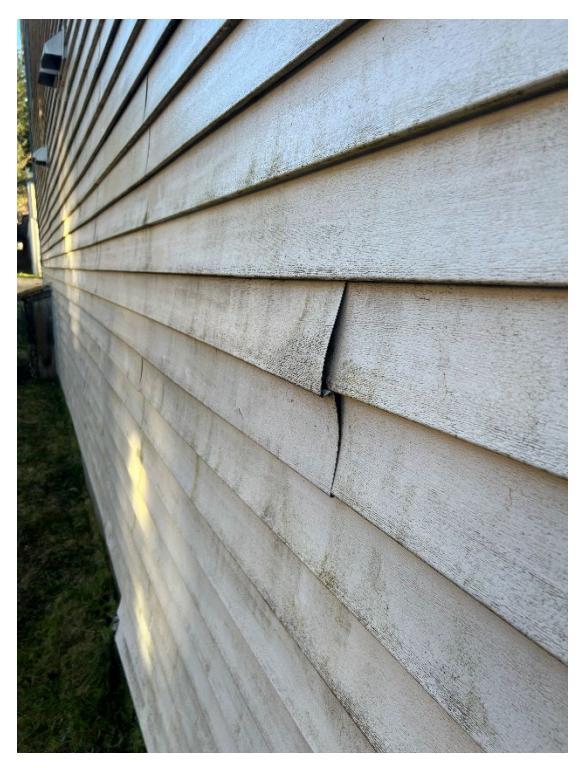
Fig. 11. Typical Siding Condition

The building is clad with vinyl siding throughout. We do not know when, but this was added after the original construction, the siding is similar to what was installed at the Bob Korn Memorial Pool. There are areas of damage. Rather than repair the existing siding, it should be replaced with metal siding. This also makes sense with the recommended door and window replacement discussed below.

Replace the existing vinyl siding with a concealed fastener metal siding. Color and orientation could be selected that matches the general feel of the City of Cordova as well as the general age and historic value of the building.

14. **Siding Replacement.** Replace the existing vinyl siding with a concealed fastener metal siding, color and orientation could be selected that matches the general feel of the City of Cordova, and the general age and historic value of the building.

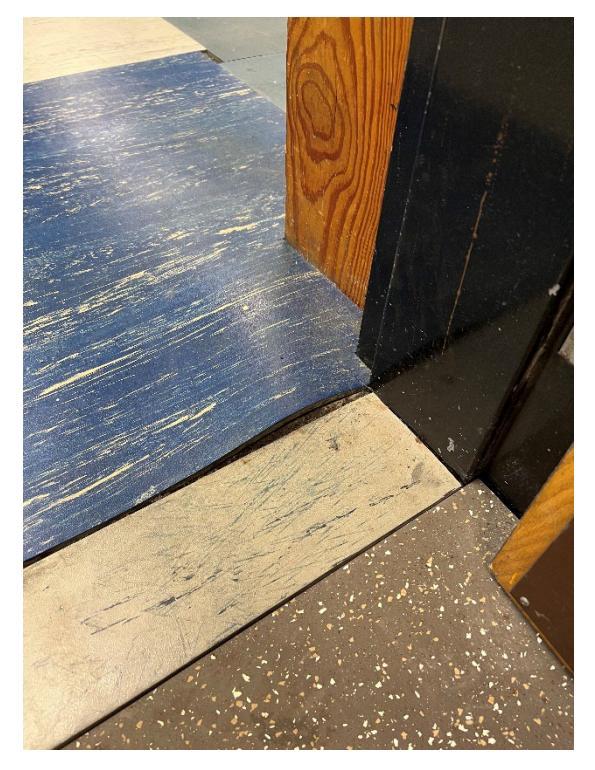
In the lower weight room areas, there is flooring that is showing wear and deficiencies. Throughout all areas there is wall and flooring damage. There is also a mixture of interior finish treatments. The goal would be to give all areas a cohesive and fit for purpose new appearance:

Fig. 16. Weight Room Flooring Damage

- All floor and wall finishes would be replaced. Flooring would be evaluated for use. In the weight room flooring, would be a drop zone or similar floor. In aerobic areas there are options to weigh, but the focus would be easier to clean and maintain surfaces.

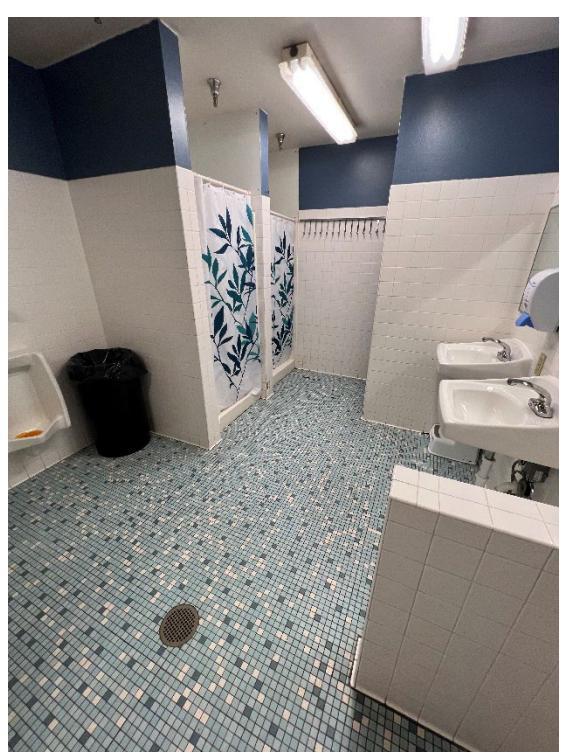
All toilet and locker rooms are in fair to poor condition. This is largely due to the age of the facility. There is no record of the project, but the existing locker room was renovated approximately 15-20 years ago just from our observation. While there are ADA accessible stalls, as noted above, the showers are not accessible. Renovation of the locker rooms not only allows for fixture and finish improvements, it allows the overall layout to be reevaluated. Work is as follows:

Fig. 19. Typical Locker Room

- Work with the City of Cordova to redesign the layout of the existing locker rooms, evaluate items such as need for lockers, etc. The locker rooms are flanked by additional rooms; locker room expansion can be looked at, or adding other amenities such as family changing rooms.
- All toilet fixtures would be replaced. This would extend to all toilet accessories.
- All wall and floor finishes would be replaced. Floors to be welded type flooring, wall protection could be a sheet good in lieu of the existing ceramic tiling.
- Lighting would be replaced. And any mechanical systems.

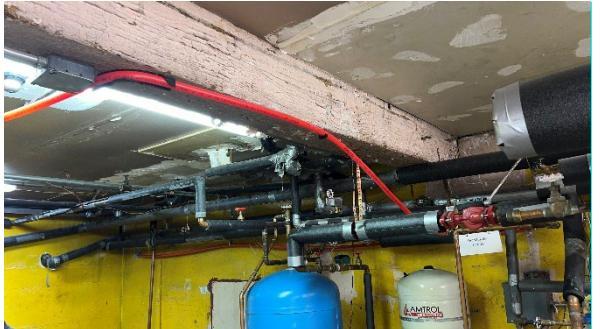
Fig. 21. Boiler Room 8x10 Girder Check Cracks

1. **Epoxy Injection.** Repair mid-depth check cracks in the crawlspace 8x10 floor girders by epoxy injection (approximately 500 linear feet). This repair recommendation is made to prevent the cracks from becoming a life safety issue in the future.

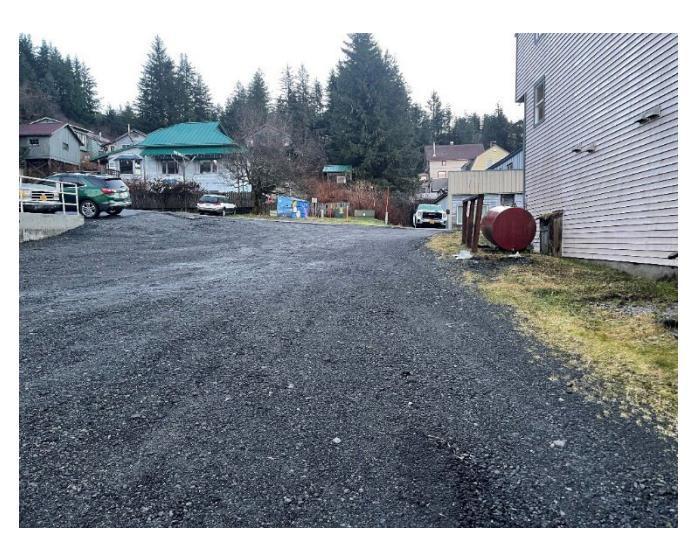
Fig. 24. Gravel parking area north of Rec Center.

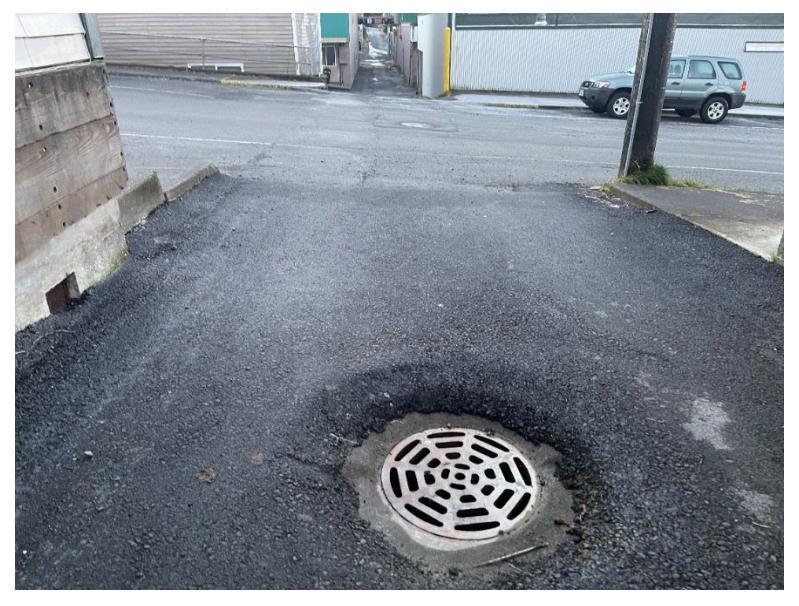
Drainage directly around the building is adequate. A storm drain inlet is present north of the building on the northwest corner of the gravel parking area. Snow from the parking area is typically piled near the inlet. An inlet is also present to the west of the building centered in the driveway. Pavement appears to have been placed recently, without the rim elevation of the inlet being adjusted (See Figure 26).

Fig. 26. Rec Center driveway with recessed inlet.

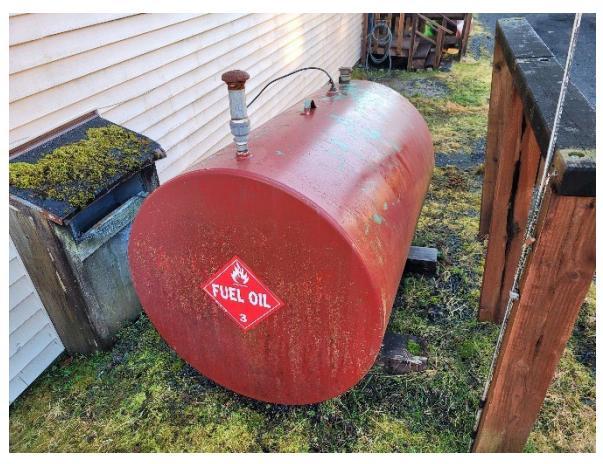
The Owner stated the Rec Center is on City water and sewer service and reported no issues with these services. Exterior utilities were not observed as part of this inspection. The fuel tank to the north of the building is protected by a wooden railing but does not appear to be secured to the skids or ground.

The fuel oil tank has multiple code deficiencies. It is located less than 5 feet from the building, does not have protection, and an anti-suction valve was not observed. The tank appears to be less than 660 gallons, so does not fall into a requirement for secondary containment.

Fig. 36. Fuel oil tank and conbustion air intake to left of tank

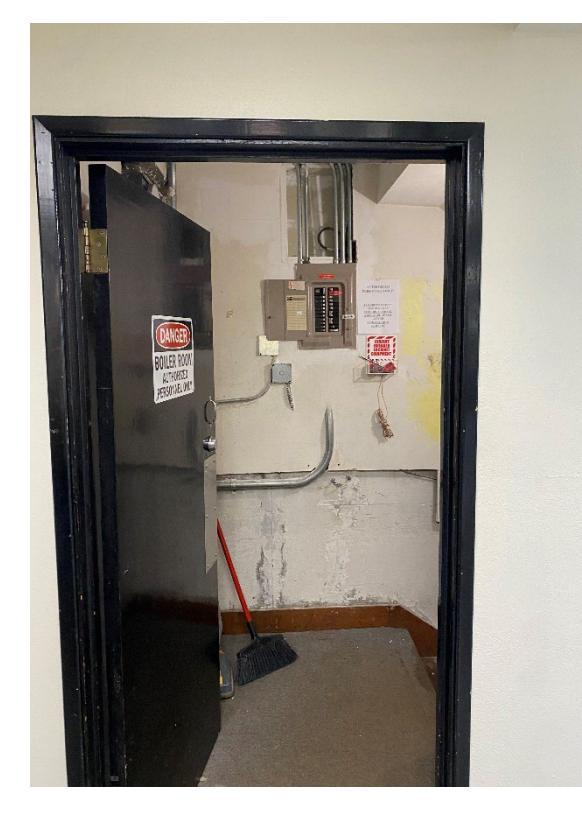
Fig. 45. Electrical room door opens inward posing an egress hazard.

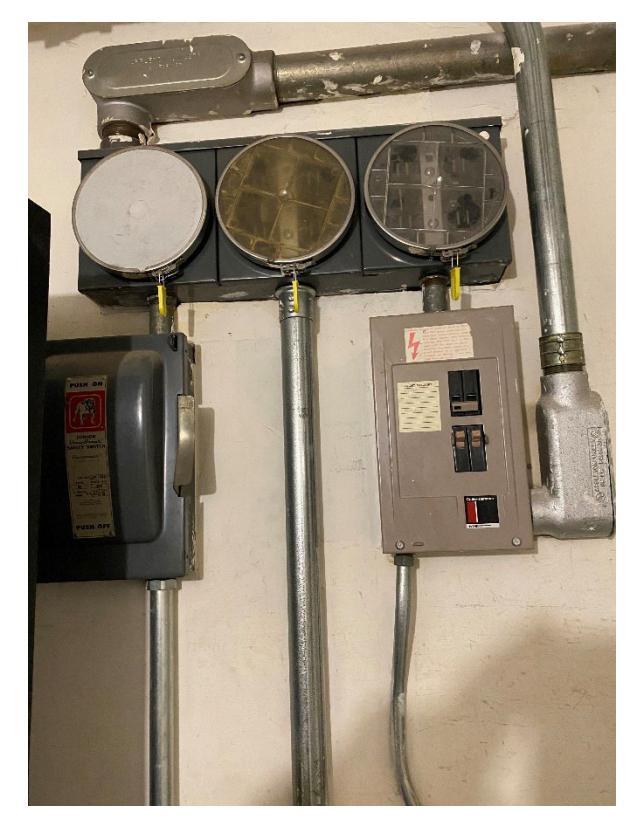
The facility is served by a 240V/120V, single-phase, 3-wire, 200A electrical service provided by Cordova Electric Co-op. The incoming utility service equipment, including CT cabinet, disconnect switch, generator inlet and meter are wall mounted on the east street side of the building. The service equipment appears to have been replaced recently and is in good condition. The exterior service has a 200A generator inlet plug protected by a mechanically interlocked 200A circuit breaker which allows for connection of a roll up generator. The service feeds a bank of three old blanked off meter sockets located in the boiler room stairwell landing. The disconnect switches are served out of the blanked off meter sockets which then serve three 100A branch circuit panels. The panels are located in the lower floor weight room, the boiler room stairwell, and upper-level gym. The electrical distribution system is about 50 years old and has had numerous modifications. The location of the electrical distribution equipment in the stairwell landing is poor. The electrical visual distribution equipment in the stairwell landing is poor. The electrical visual visual

Fig. 46. Old distribution equipment located in stairwell.

13. **Replace electrical distribution system.** Design and replace complete electrical distribution system. This includes a new 200A switchboard serving (3) 100A panelboards and associated feeders. Provide accurate as-built drawings and panel schedules for the electrical system. This includes relocating the electrical room to remediate current NEC working clearance issues. The electrical distribution equipment could possibly be moved to the basement boiler room. Recommend an Arc Flash Risk Assessment is performed on power systems for employee safety and compliance with OSHA regulations. Install arc flash hazard labels to all panels and equipment per NEC 110.16.

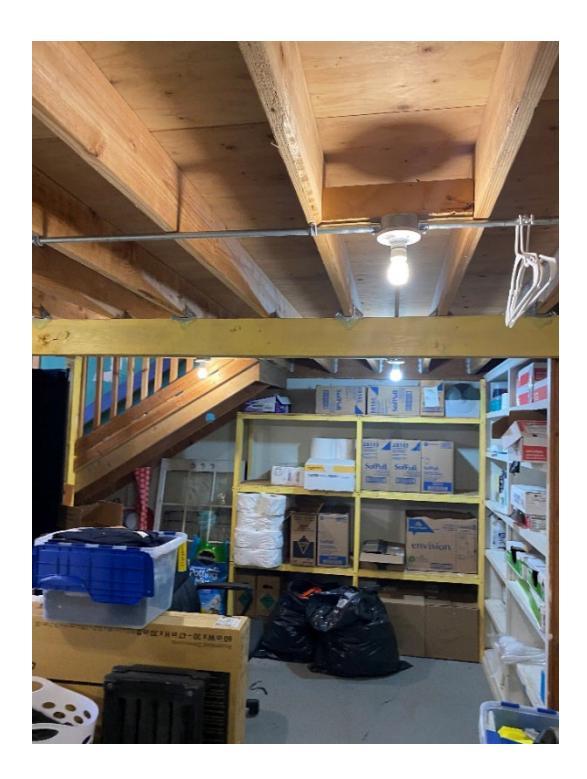
Fig. 47. Replace storage room lights or provide protective wire guards for fixtures.

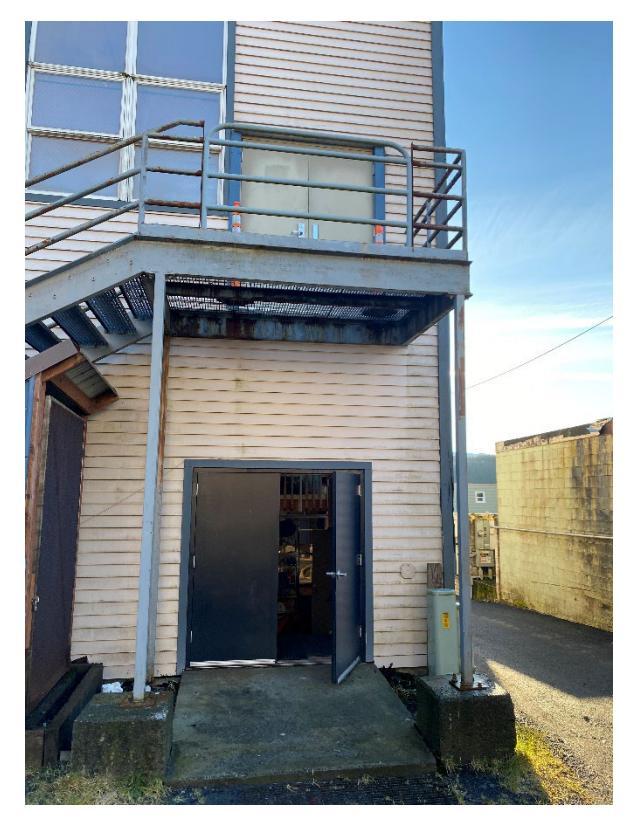
Exterior lighting was limited to LED can lights at the main exterior entrance canopy only. There is street lighting that contributes to the sidewalk lighting. There is no exterior lighting or emergency lighting at the three exterior egress doors or at the exterior stairs. It is recommended exterior lighting be added at the exterior doors and stairs.

Fig. 48. Provide exterior lighting at exterior doors and stairs.

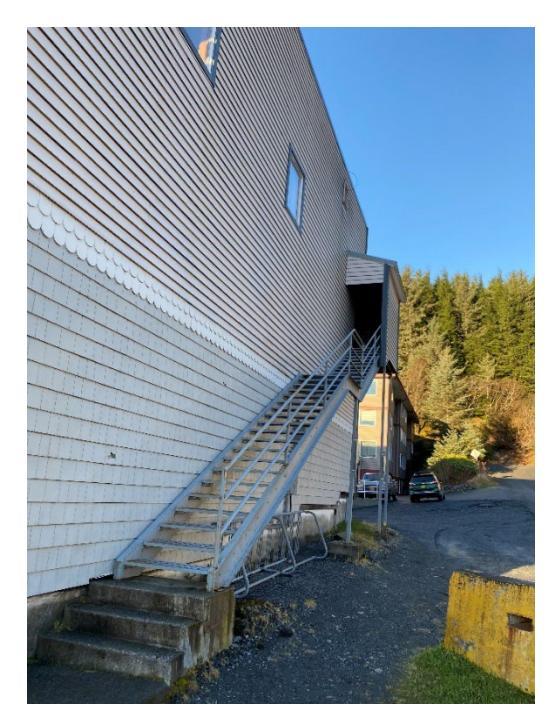
Fig. 49. Provide exterior lighting at exterior doors and stairs.

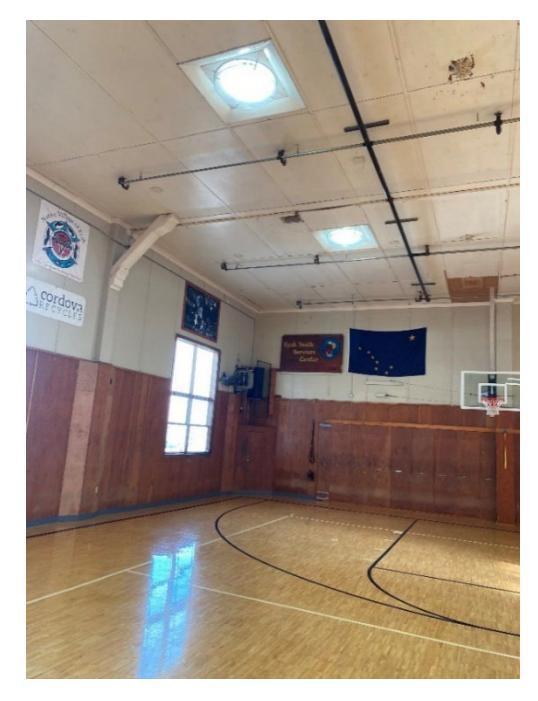
Lighting throughout the facility is a mix of fluorescent and retrofit LED. Most interior lighting fixtures are T8 fluorescent fixtures converted to LED with retrofit lamps. The gym lights are old HID fixtures in poor condition with retrofit LED lamps. The old gym fixtures also make a constant buzzing sound from the legacy ballasts. A majority of the interior lighting in occupied spaces, including the

gym, offices, workout areas, restrooms, and hallways are occupancy sensor controlled. Lighting levels were appropriate for the function of the spaces, except for the gym where the lighting levels were low. It is recommended all gym lighting be replaced. It is also recommended the lighting be replaced in other areas if architectural renovations occur.

Fig. 50. Replace Gym lights with high bay LED lights.

12. **Replace interior Gym light fixtures.** Replace the Gym light fixtures with LED high bay fixtures. Maintain the existing occupancy sensor control.

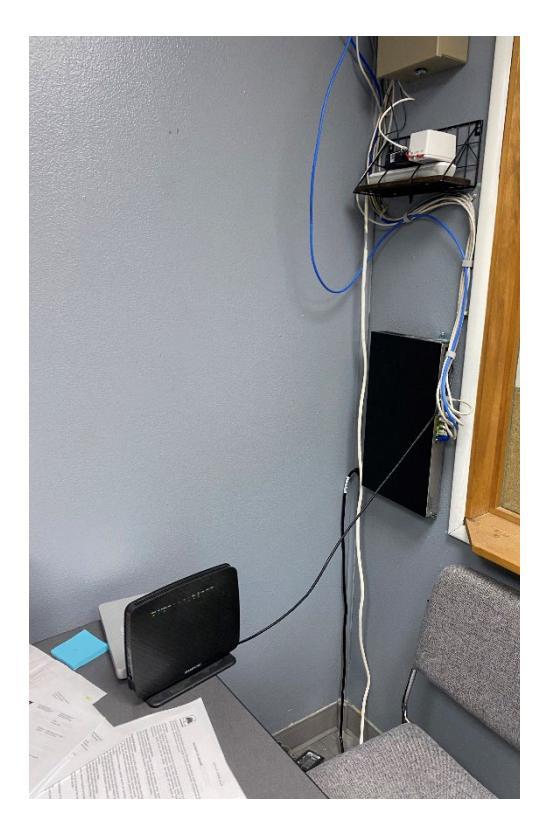
The telecom system is limited to a network switch located in the office area with wiring run from the switch to devices within the office. The current configuration limits usage and does not allow for a secure system. It is recommended the telecom system be replaced.

Fig. 51. Telecom Equipment

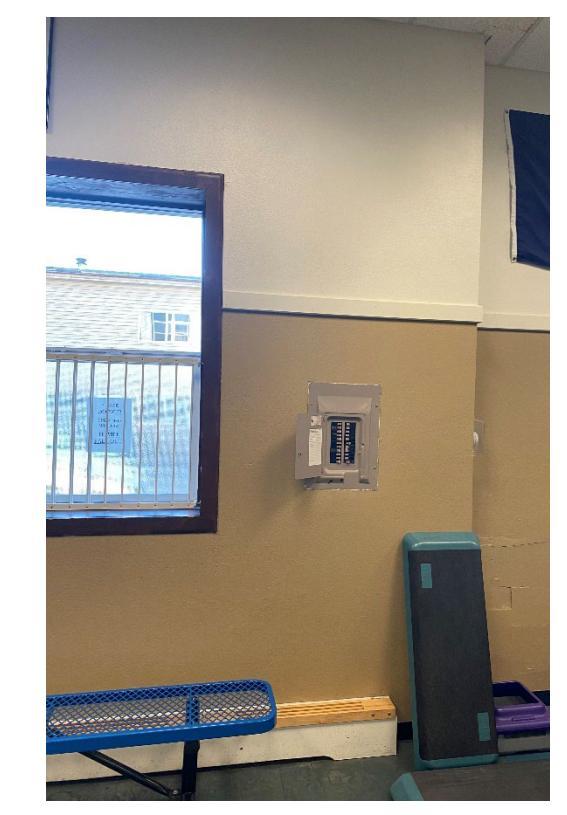
Fig. 52. Old panelboard in workout room
