City of Cordova Multi-Building Condition Assessment: Chamber of Commerce

Due to the amount of information and quantity of sites, a separate report has been developed for each facility. This condition assessment report is for the Cordova Chamber of Commerce.

The Chamber of Commerce building was evaluated by the team on November 18, 2022. This report provides:

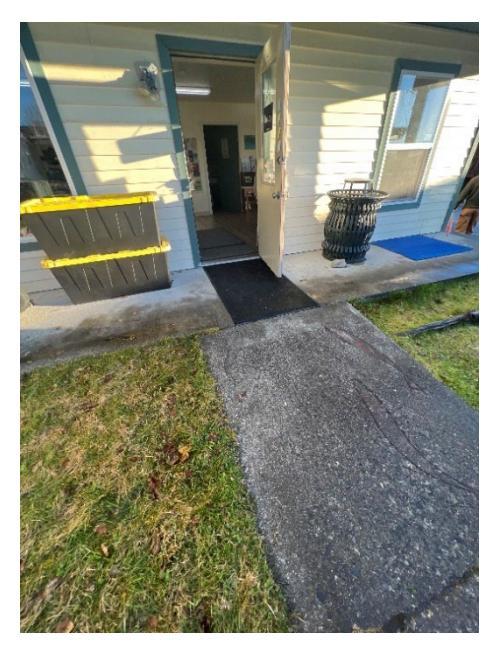
- The slope of the concrete walkway to the building qualifies it as a ramp. Ramps are to have handrail and guardrail protection on both sides. In this case the existing grade would only require handrails to be installed. A painted 1 ½-inch tube steel handrail at 34-inches would be the correction.
- The concrete stairs off the main porch had neither guardrails nor handrails installed. Both guardrails and handrails are required on both sides of the stairs. Guardrails are to be 42-inches from stair nosing, handrails are to be at 34-inches from stair nosing.

Fig. 1. Missing Handrail at Entry

2. **ADA Accessibility.** The slope of the concrete walkway to the building qualifies it as a ramp. Ramps are to have handrail and guardrail protection on both sides. In this case the existing grade would only require handrails to be installed. A painted 1 ½-inch tube steel handrail at 34-inches would be the correction.

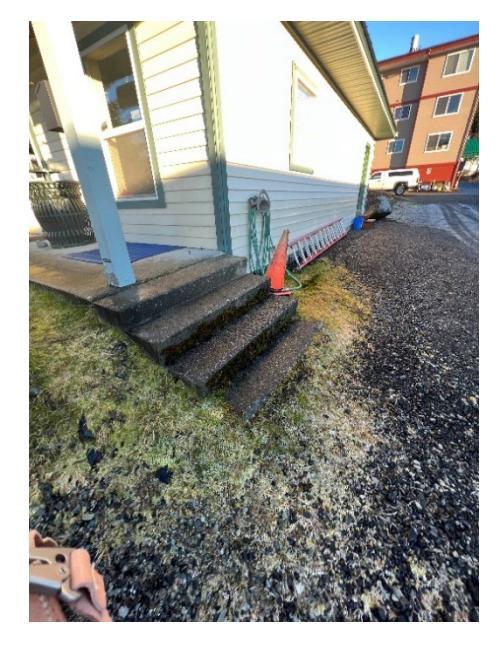
Fig. 2. Missing hand & Guardrails at Stair

3. **ADA Accessibility.** The concrete stairs off the main porch had neither guardrails nor handrails installed. Both handrails and guardrails are required on both sides of the stairs. Guardrails are to be 42-inches from the stair nosing, handrails are to be at 34-inches from the stair nosing.

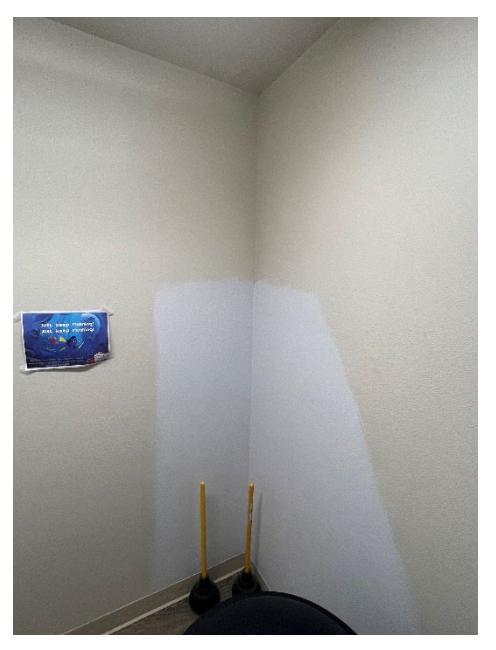
In the far corner of the restroom there is a newly painted section of wall. What was reported to the inspection team was there was some surface mold at this location. While this is not a current action item, redevelopment of mold in this area, or development is other areas is a sign of moisture in the wall assembly, or deficiencies in the vapor retarder. If it reoccurs in the same area, gypsum wall board removal is required in this area to inspect and repair any deficiencies is the plastic vapor barrier. If it appears in other locations of the facility, overall exterior waterproofing should be considered.

Fig. 3. Painted Area in Restroom

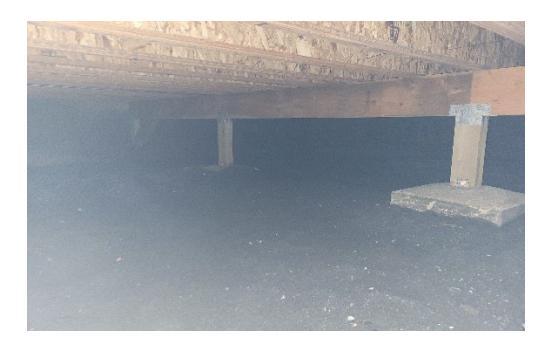
Fig. 5. Commerce Building Crawlspace

- Install a continuous 6-mil vapor barrier in the crawlspace.
- Install metal tie connections between I-joists and center beam.
- Install solid blocking between floor I-joists over center beam.

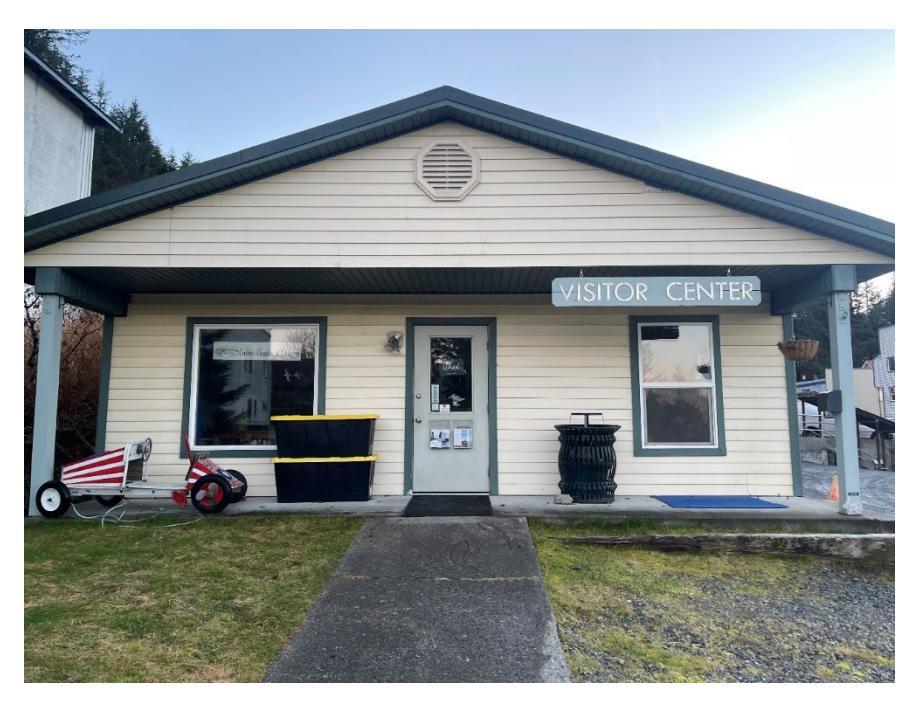
A sidewalk connects the front of the facility to the pedestrian sidewalk along First Street and appears to be ADA compliant, however there is no ADA accessible parking onsite. The sidewalk and front concrete apron appear to be in adequate condition. See Figure 7.

Fig. 7. Front from First Street.

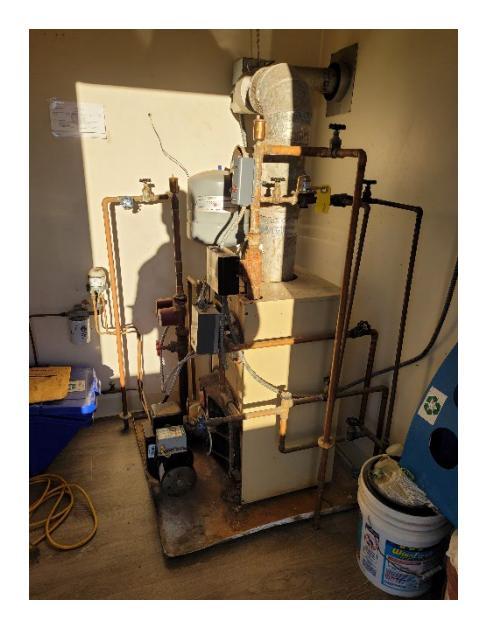
The boiler flue has a booster fan. It is unclear why this was needed as the boiler is located against an exterior wall on a single-story building and the flue's length is minimal. The boiler is in relatively poor condition and due for replacement.

Fig. 8. Boiler.

1. **Replace boiler.** Demolish and replace the existing residential oil-fired boiler and flue. Estimated Cost: \$31,596

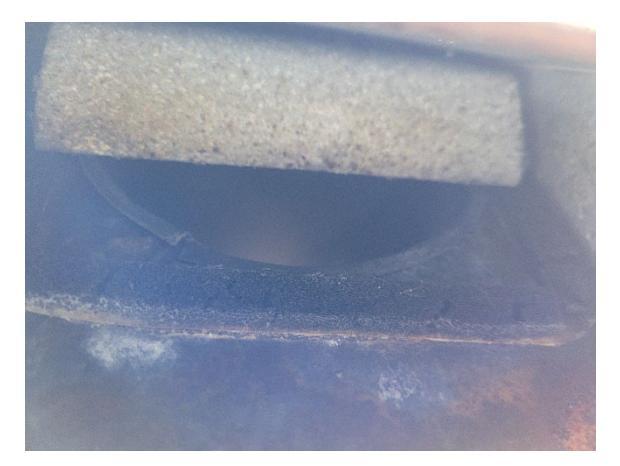
The combustion air opening for the boiler was partially blocked and should be inspected and kept clear. It was noted onsite that the boiler nearly caused a fire in the past and has been professionally maintained since. This was evident from the newer components on the system such as the expansion tank and fuel supply components.

Fig. 10. Partial blockage of combustion air opening

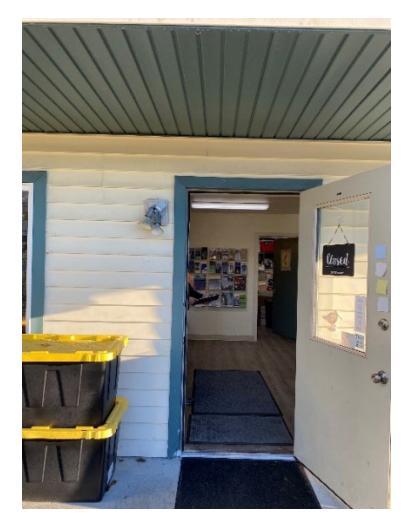
Exterior lighting is provided by twin head incandescent fixtures mounted adjacent the main entry door and adjacent to the boiler room door. The exterior lighting is functional but could be improved with replacement LED light fixtures.

Fig. 18. Exterior flood light at front door.

4. **Exterior lighting upgrade.** Replace two exterior rated lights adjacent to the exterior doors with an LED fixture with full cutoff optics and integrated photocells for automatic dusk to dawn operation. This would improve lighting by reducing the glare and reduce energy consumption and reduce maintenance.

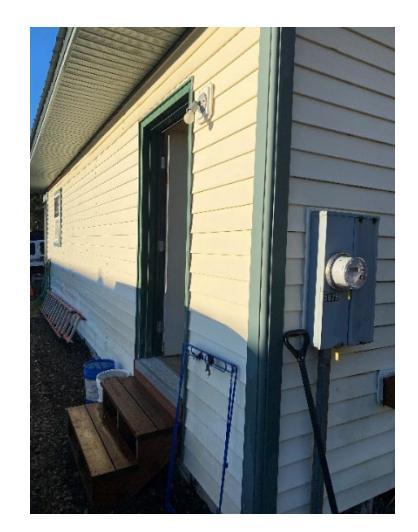
Fig. 19. Exterior flood light at Boiler room door.

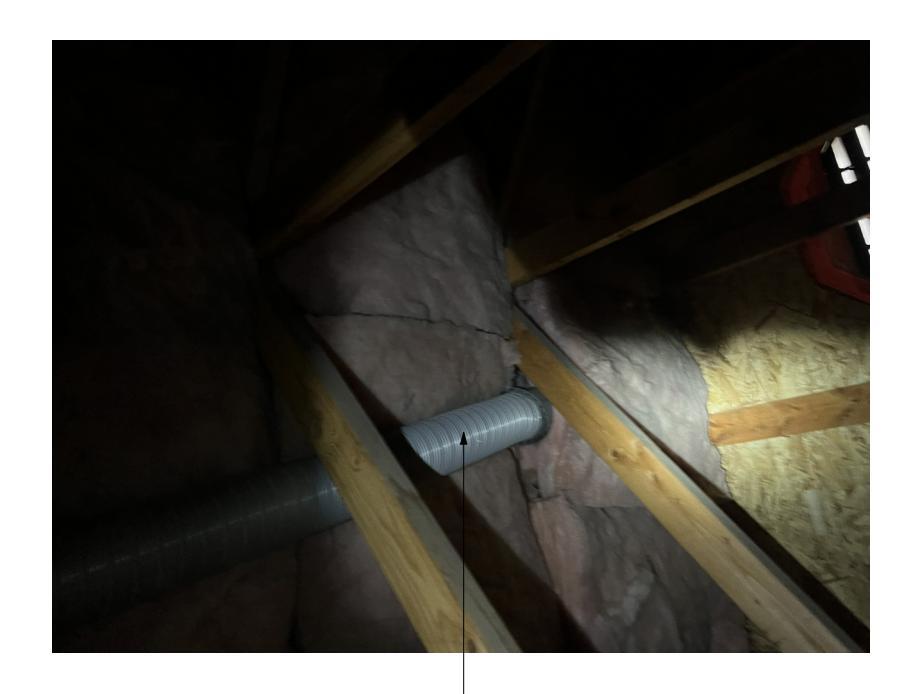
THIS EXPOSED VENT PIPING NEEDS TO BE INSULATED. EITHER REPLACE WITH INSULATED PIPING, OR COVER WITH ADDITIONAL BATT INSULATION
