City of Cordova Multi-Building Condition Assessment: Cordova Jr./Sr. High School

Due to the amount of information and quantity of sites, a separate report has been developed for each facility. This condition assessment report is for the Jr/Sr High School.

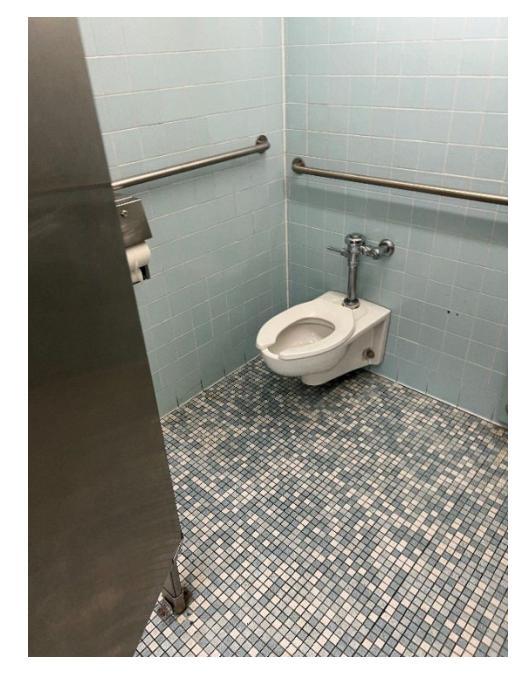
Issues noted were all toilet accessory mounting heights and omissions. If any work is conducted in these spaces, they should be adjusted, largely due to existing finishes. Relocating grab bars in tiled areas will create patching issues, etc., they are as follows:

Fig. 2. Existing ADA Stall

- Add vertical, 18-inch grab bars to all accessible toilets. This includes the single stalls in the main restroom, combined restrooms, and the single use restroom labeled as "Staff" toilets.
- Grab bars are mounted at differing heights in the accessible stalls.
- Provide piping protection at exposed piping in group toilet facilities.

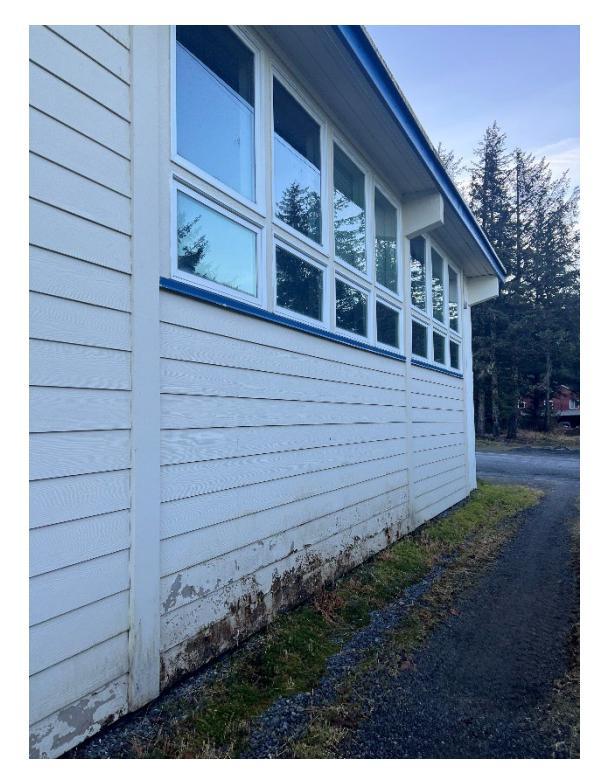
Fig. 4. Exit 1

Areas close to grade where paint is damaged and/or removed. Repaint as required.

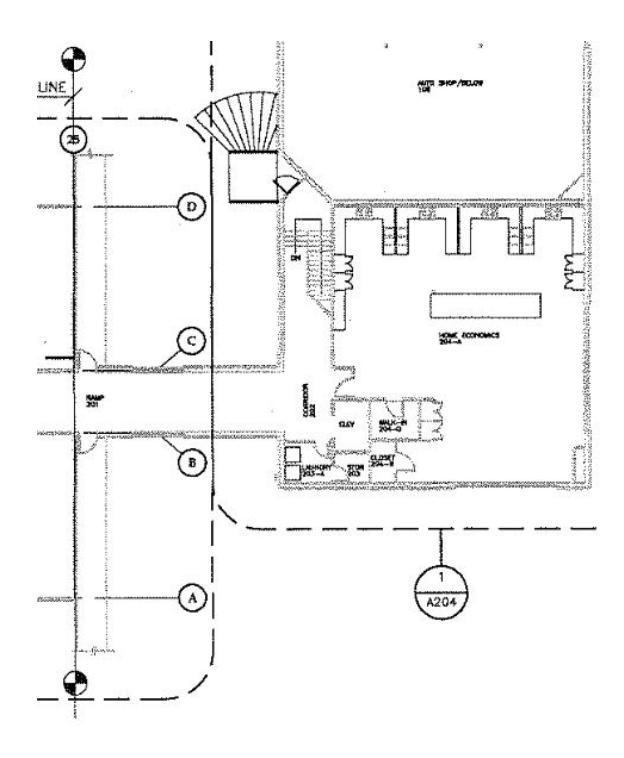
Fig. 7. Window Area 1

- Replace the windows noted in Figure 7 below, located in the hallway to the Voc Ed area. The glazing seal in these windows have failed, and there is also evidence of water infiltration around the frame. Prep CMU walls below, repaint.
- Replace the windows in the Home Economics classroom and Voc Ed. The seals have failed, and units show signs of sealant failure.
- Replace exterior double door out of the existing kitchen.
- Replace single exterior door from the mechanical room.
- Other exterior doors should be inspected for operation when any door replacement project is executed.

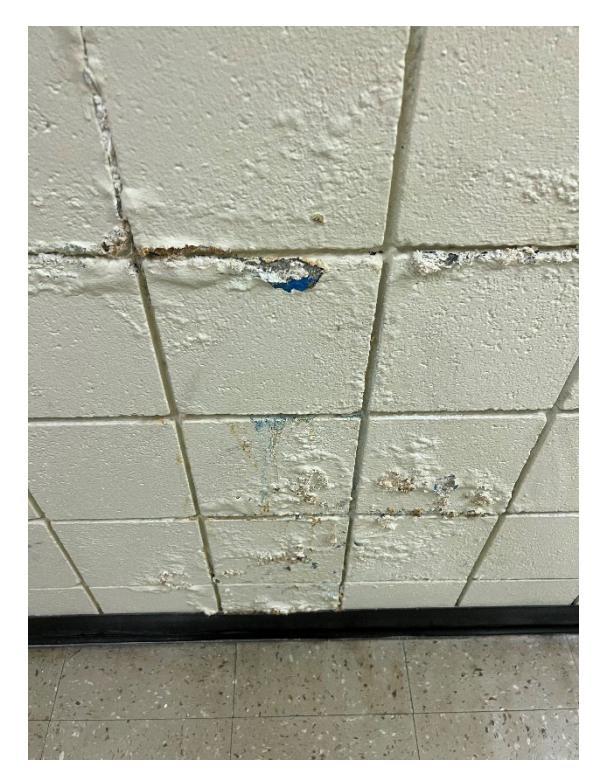
Fig. 12. Photo 1

- Corridors in the Voc Ed basement have areas of spalled paint at the CMU. Remove, prep, and paint as required. Paint is failing due to water infiltration from the block, but did not appear excessive. New paint coating should correct the aesthetic condition for a number of years. (Photos 1&2)

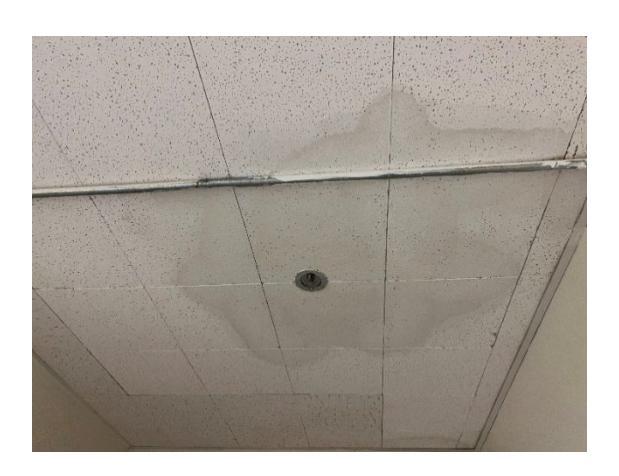
Fig. 14. Photo 3

- In this basement there is also a sprinkler pipe that appears to be leaking. (Photo 3)
- At the basement lockers adjacent to the gymnasium there is an area of underground water intrusion, GWB & insulation removed. Excavate grade at this location and add addition drainage means. Monitor correction below. (Photo 4)

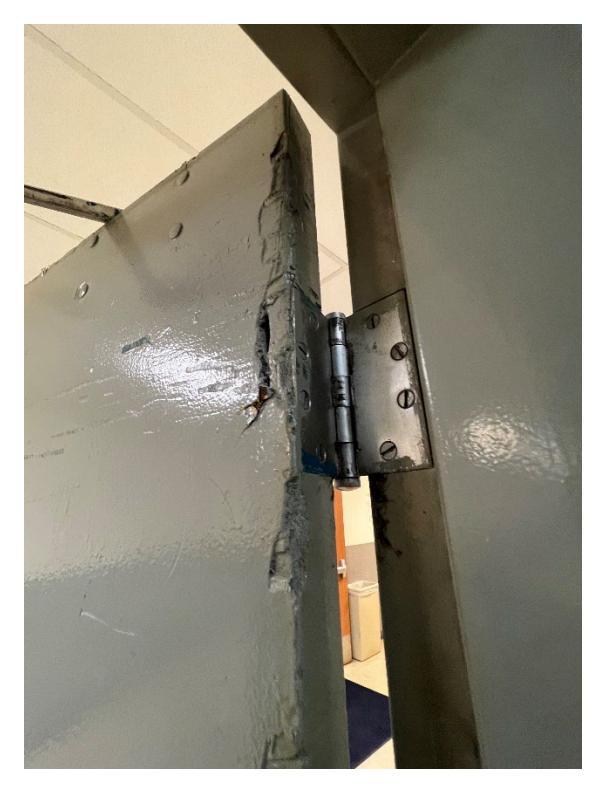
Fig. 16. Photo 5

- The interior door to the mechanical room is badly damaged; replace with 45-minute rated fire door. (Photo 5)

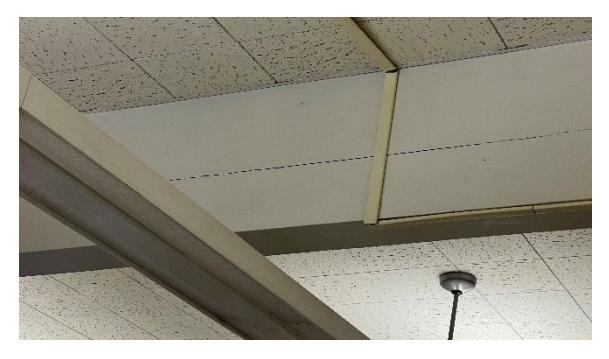
Fig. 17. Cracked Purlin in Classroom 7

- 1. Epoxy injection repair or steel side plates of one roof purlin in the science Classroom 7.
- 2. Epoxy injection of cracks in the concrete chimney in the mechanical room.

1. **Epoxy Injection Classroom**. Epoxy-inject repair or install steel side plates on one roof purlin in the science Classroom 7.

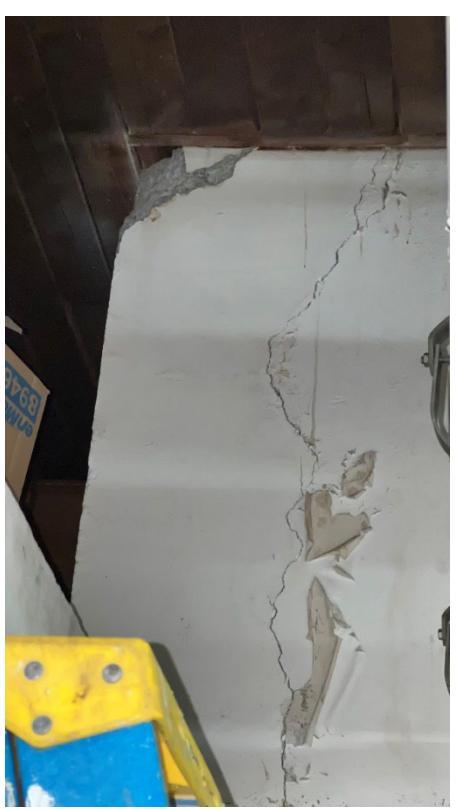
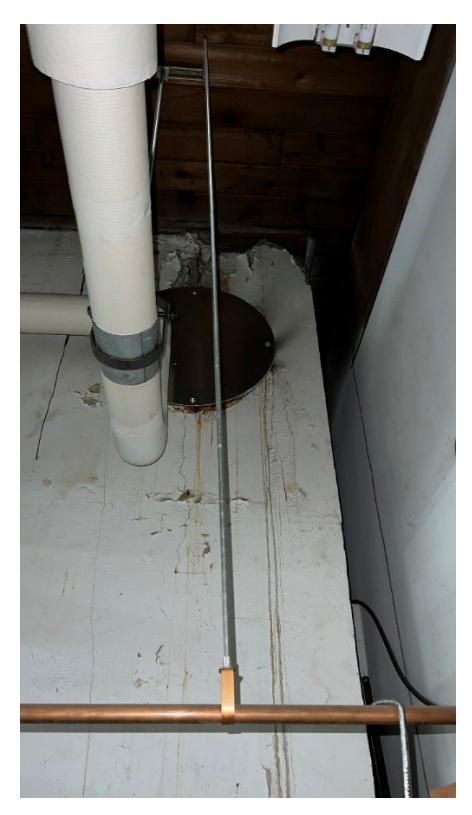
Fig. 19. Cracks in Concrete Chimney.

Fig. 20. Cracks in Concrete Chimney

2. **Epoxy Injection Mech Room.** Epoxy injection of cracks in the concrete chimney in the mechanical room.

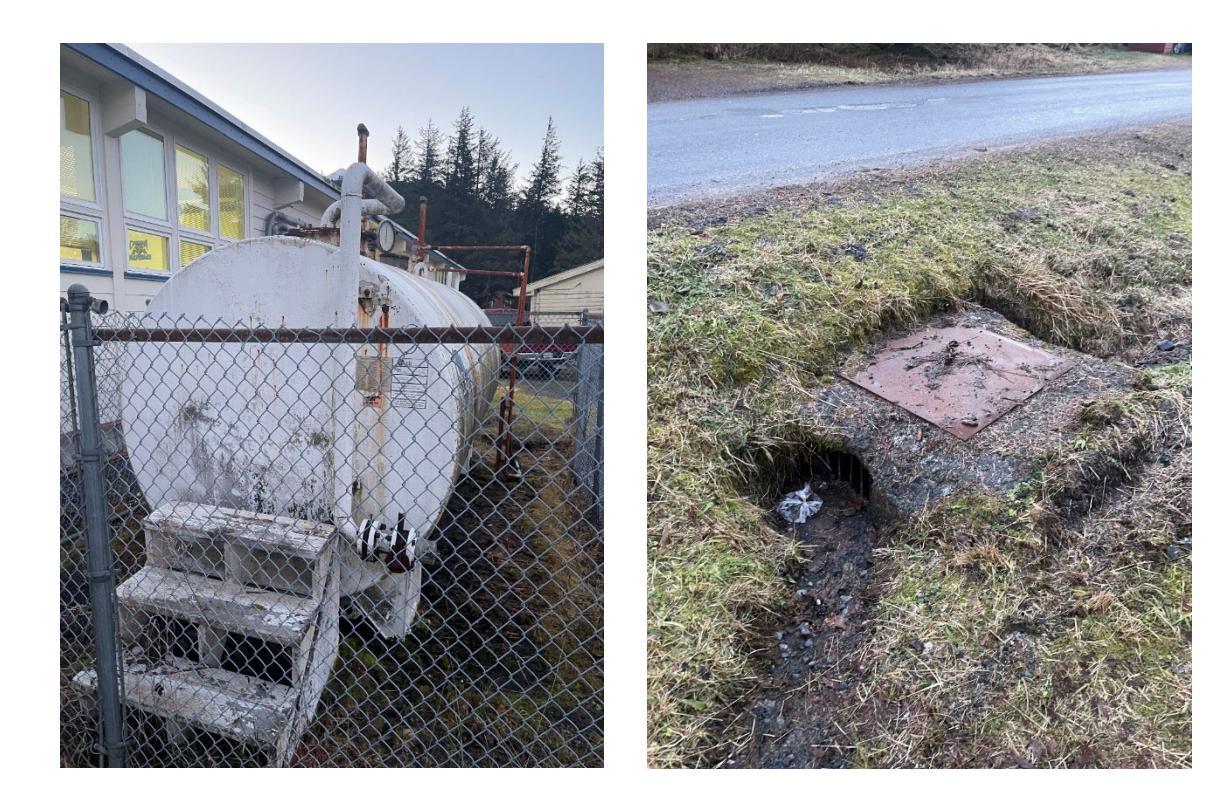
Storm drain inlets are present around the site. Positive slopes in these areas allow runoff to be transported to the system with no issues observed. In general, grades slope away from the facility providing positive drainage to storm drain structures. It appears the inlet to the east of the school has erosion present. See Figure 23.

Fig. 23. East storm drain inlet

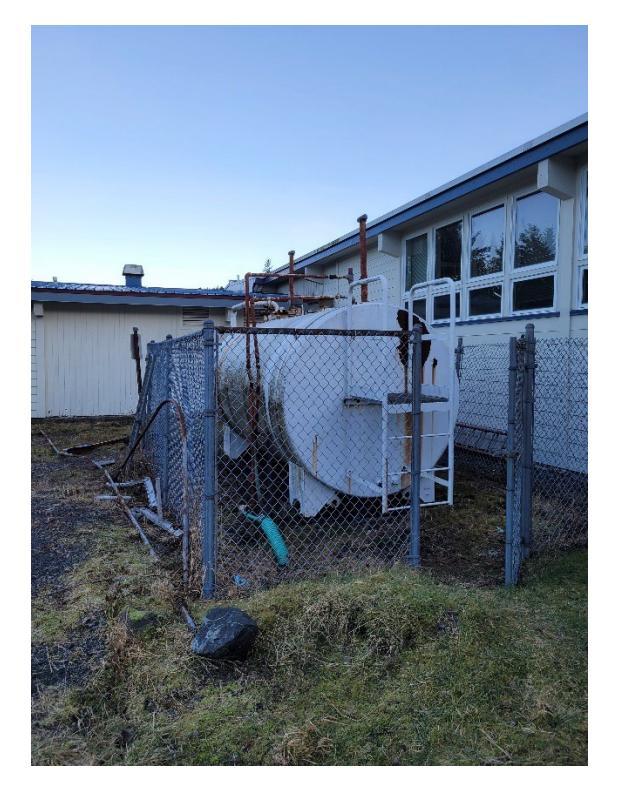
Heating to the school is provided by a 3,000 gallon aboveground fuel tank and two boilers. During the site visit the 3,000 gallon tank was not in use because there was water and sediment in it. The tank exterior shows stains and mildew, and the coating was failing. The interior of the tank was not inspected. There was a temporary tank placed adjacent with separate fuel lines that is filled about once per week. Only one of the boilers was operational during the site visit, and it was utilizing a borrowed spare burner from the city until a replacement burner can be procured and installed. The newest boiler from the 2001 renovation was not functional during the site visit. A third decommissioned boiler was present and piping was no longer connected to it. The 2001 boiler is the newest and repairing it should be a high priority to provide backup to the older boiler that is operating with a temporary burner.

Fig. 24. 3,000 gal fuel tank

4. Fuel Tank Replacement. Demolish and replace the 3,000 gallon fuel tank and appurtenances. Provide a UL 2085 tank or UL 142 fire resistant tank and install bollards every 4' on sides that vehicles can operate. Remove the temporary 500 gallon tank and temporary fuel lines. This will eliminate the need for weekly fuel delivery and provide the school with a greater buffer of fuel supply, as well as fee up access to the mechanical room and reduce the risk of spills of vehicle collisions with the tank. Include an engineering design to ensure proper setbacks, protection, safety devices, and code compliance.

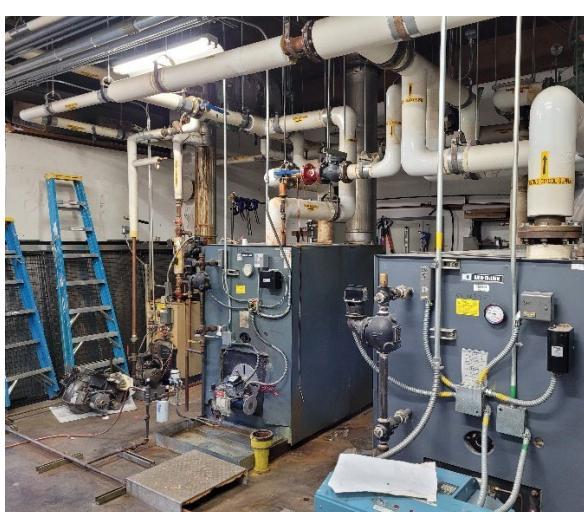
Fig. 26. Boilers (middle boiler is the only functional boiler and has borrowed burner)

3. **Boiler Repair.** Repair the newest boiler, B-1. Demolish the other two boilers. Install a second boiler to work with boiler B-1. If this is not possible before the 2023-2024 winter, recommend repairing boiler B-1 so there is some redundancy in the building heating.

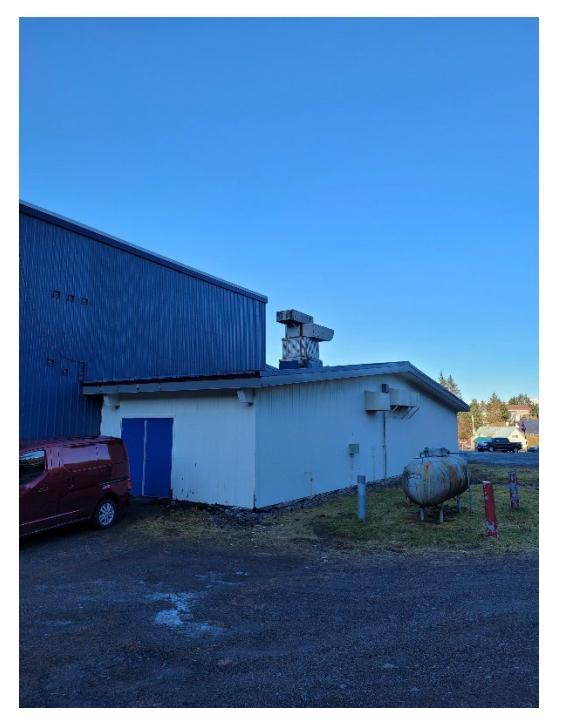
A propane tank is present adjacent to the kitchen. The tank appears to be old and starting to rust; however, no issues have been reported.

Plumbing in the kitchen includes propane connections from an exterior above ground tank to a commercial gas fired oven and range. The tank shows corrosion but appears to be functional. A gas shutoff valve was

Fig. 40. Kitchen exterior, propane tank on right

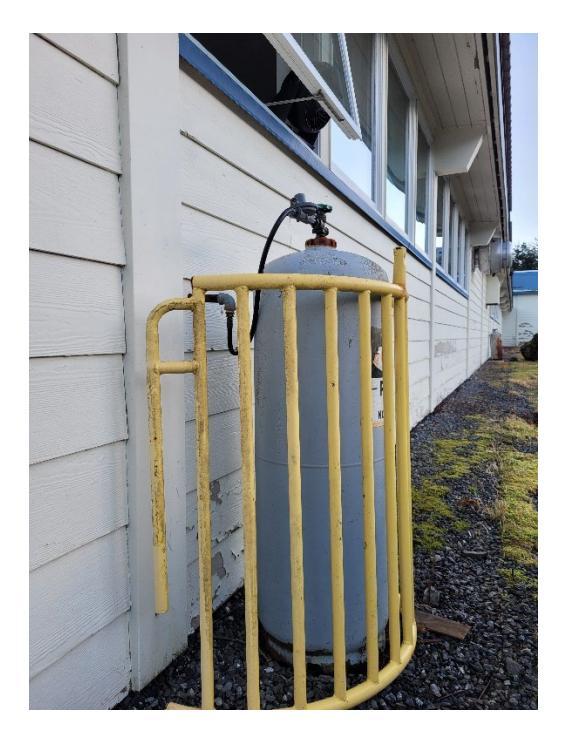
Other plumbing piping to note includes propane piping to the science lab rooms. There is a propane tank (estimated 100 lb size) outside along the exterior wall of a science lab. It is protected by a large boulder and a steel cage and piped into the building to serve gas connections for table-top Bunsen burners and to a fume hood. The indoor valves and gas connections seem to be in fair condition but appear dated. Periodic inspection of piping connections or a pressure test of the

gas piping is suggested. The current International Fuel Gas code (section 409.6) requires a gasshutoff valve be installed adjacent to the room exit and be labeled. It is not clear when this piping was installed or if it was required to have a master shutoff valve, but it is recommended to verify the existence of a main shutoff valve in the room and, if present, label and keep clear. If not present, one should be installed.

Fig. 41. Laboratory propane tank

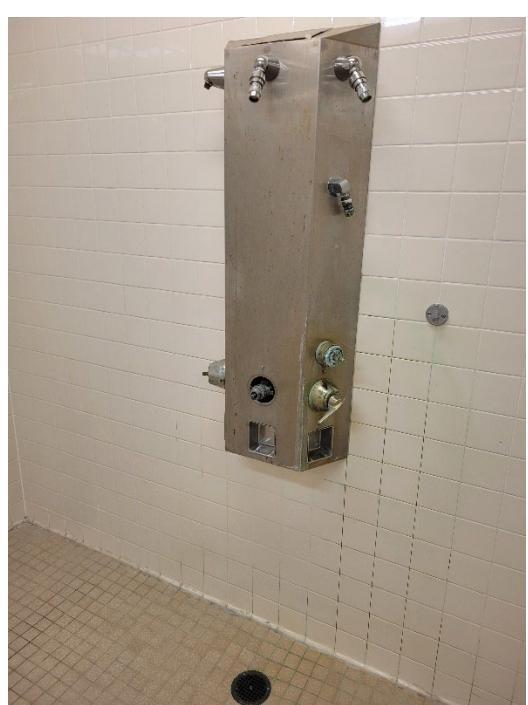
The restroom fixtures were in fair condition. Toilets and urinals had flushometer valves which appeared to be well maintained. The basement locker room had three gang shower areas with three shower heads each, from the 2001 remodel. One was in poor condition with a missing valve handle on one shower and a missing nozzle on one of the heads and shows corrosion. The other two gang showers were in better condition and appeared functional. Gang showers are no longer common and given the condition of these, a shower room remodel may be desired.

Fig. 42. Non-functional shower

Option 2: Alternatively, if a gang shower area is still preferred, simply repair or replace the single broken shower tree fixture.

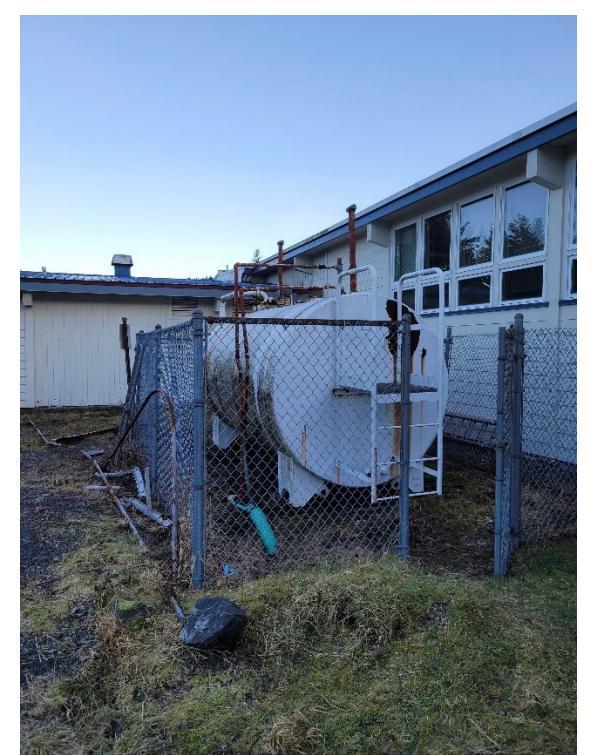
Fig. 46. 3,000 gallon tank

During the site visit the 3,000-gallon tank was not in use because there was water and sediment in it. The tank exterior shows stains and mildew, and the coating was failing. The interior of the tank was not inspected. There was a temporary tank placed adjacent with separate fuel lines that is filled about once per week.

- Remove the tank if it is out of use.
- Replace the tank and place it a minimum of 5 feet away from the building.
- Provide a tank that has spill control, proper physical protection, and liquid level limit control.

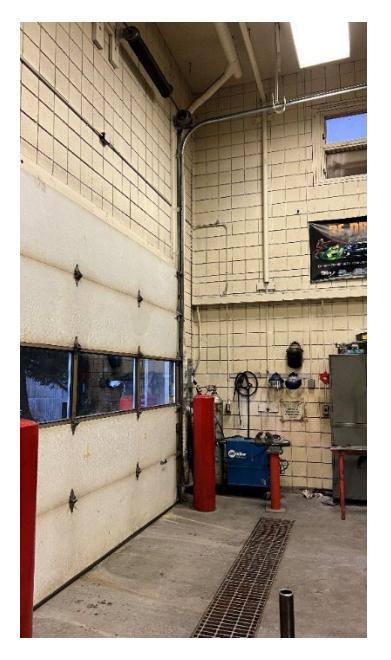
- Taylor Fire Protection Services noted on March 26, 2022 that the maintenance shop does not have sprinkler protection when the doors are open. Recommend installing sprinklers above and below these doors for protection.
- Replace sprinkler heads that have been damaged, painted, or not properly orientated.
- Replace escutcheons for sprinklers that are missing or not installed properly.

Fig. 45. Garage door in the maintenance shop with no sprinkler coverage when the door is open.

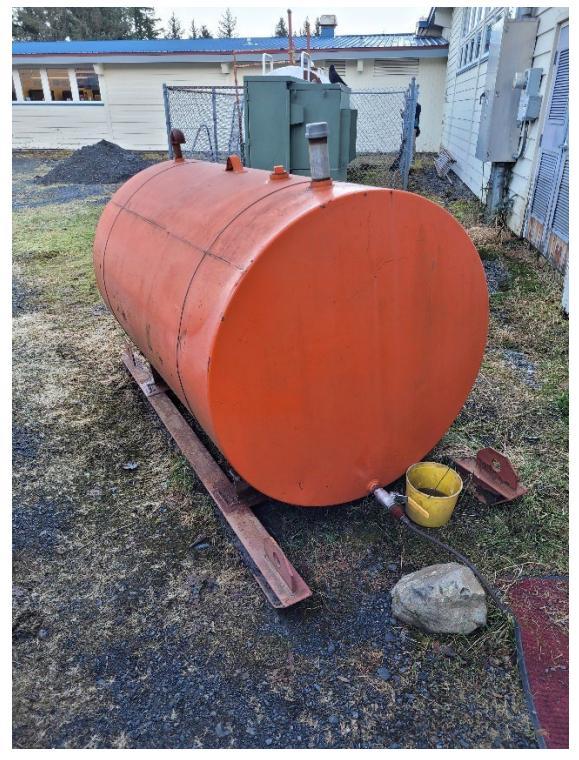
Fig. 47. Temporary tank

The temporary tank should be provided with physical protection, secondary containment, liquid-level control, and proper distances away from the building.

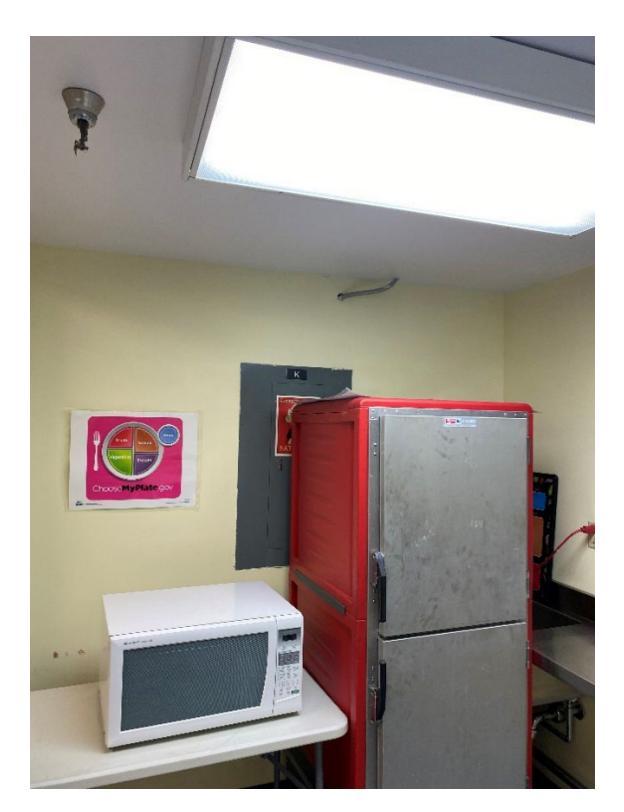
In the kitchen, the refrigerator should be relocated because it is in front of Panel K in violation of code working clearance, and the power cord serving the refrigerator is running across a sink. The refrigerator should be relocated.

Fig. 52. Refer in front of kitchen panel

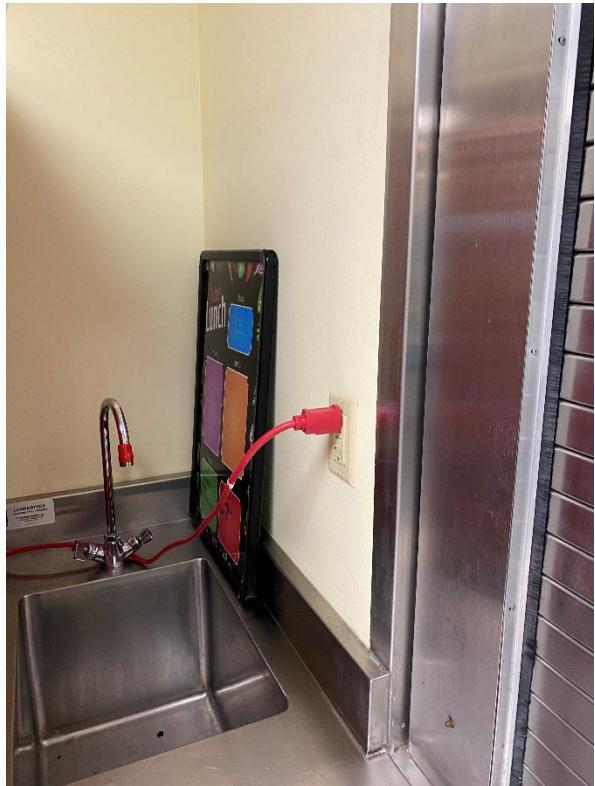
Fig. 53. Kitchen-refrigerator cord crossing sink

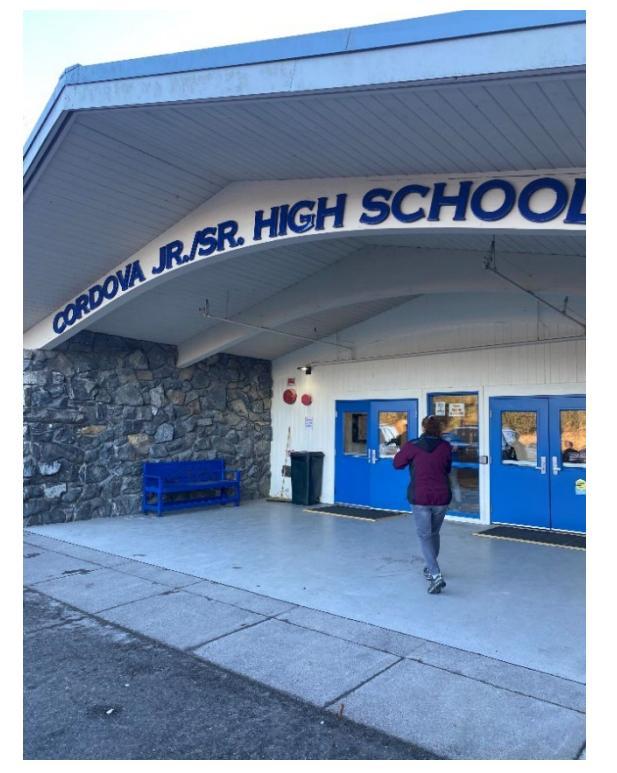
The exit signs were replaced during the 2001 upgrade project and are in good condition. Emergency lighting is provided by emergency battery packs integrated into the fluorescent light fixtures. The emergency lighting was not tested during the site visit but based on the record drawings from the 2001 upgrade project, it appears the emergency lighting provides proper coverage for the path of egress within the interior of the facility. There is no emergency lighting at exterior door egress locations as required by code.

Fig. 54. Exterior LED lights at entry- no emergency lights

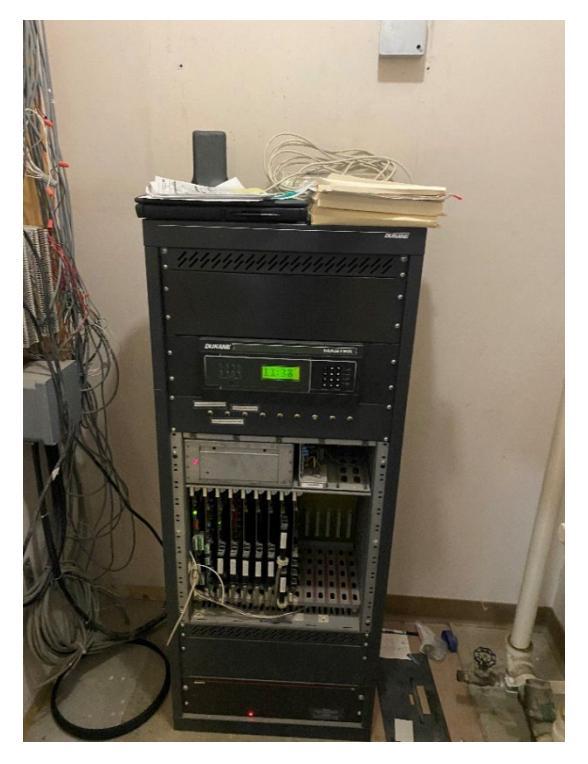
The intercom system and clock system were also replaced in the 2001 upgrade. The system is outdated and difficult to maintain because sourcing replacement parts has become challenging.

Fig. 56. Intercom/Paging system in telecom closet
