City of Cordova Multi-Building Condition Assessment: Parks and Recreation Maintenance Shop

3. PARKS AND RECREATION MAINTENANCE SHOP

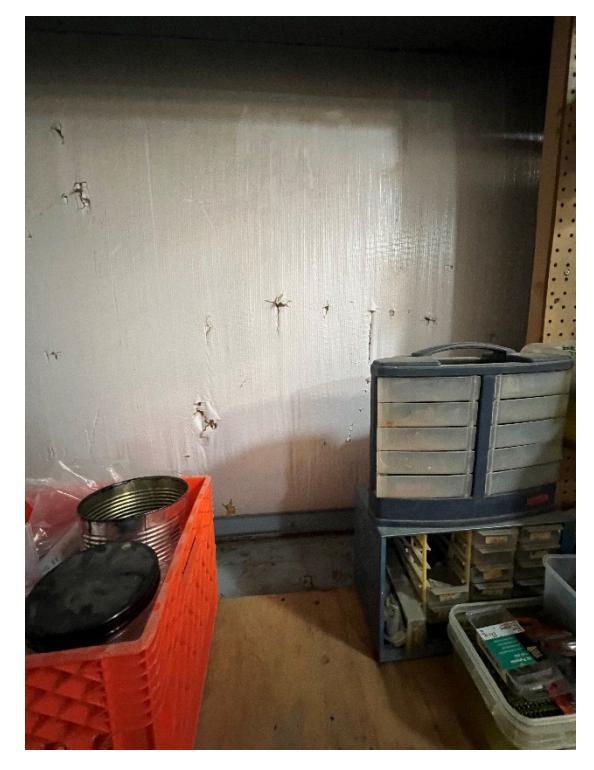
- There are numerous holes and cuts in the insulation blankets, when exposed, this is an avenue for moisture intrusion. Once the moisture is inside the insulation, it is very difficult to evaluate. Use tape or membrane product to repair the plastic of the insulation blankets.

Fig. 1. Typical vapor barrier damage

7. **Vapor Barrier.** There are numerous holes and cuts in the insulation blankets. Left open, this is an avenue for moisture intrusion, once inside it is very difficult to evaluate. Use tape or membrane products to repair the plastic.

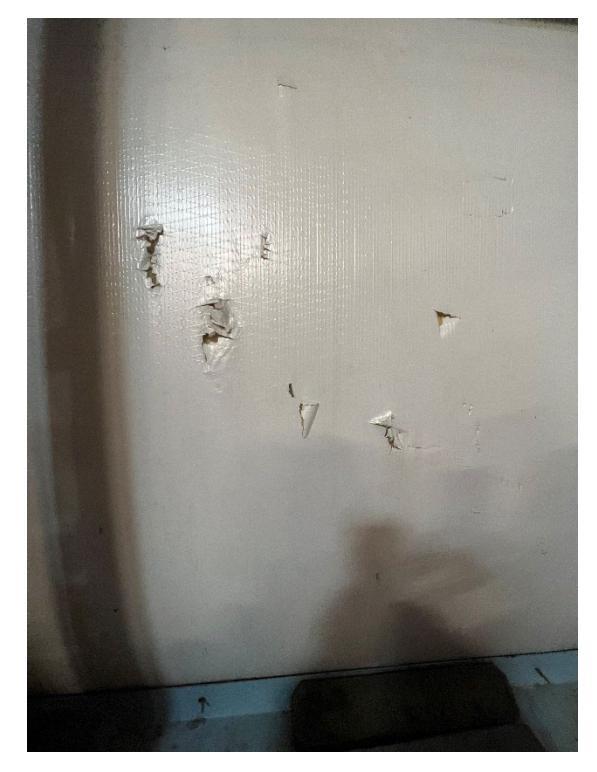
Fig. 2. Typical vapor barrier damage

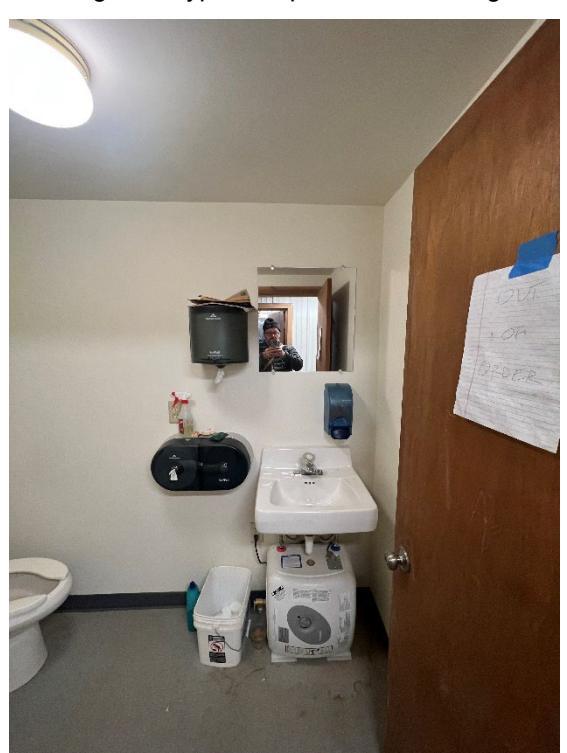
- The bathroom was not functional at the time of inspection, see mechanical for specific deficiencies.
- The overhead door jamb is steel and is starting to oxidize due to damage, prep and repaint to avoid further damage.

Fig. 3. Toilet not operational

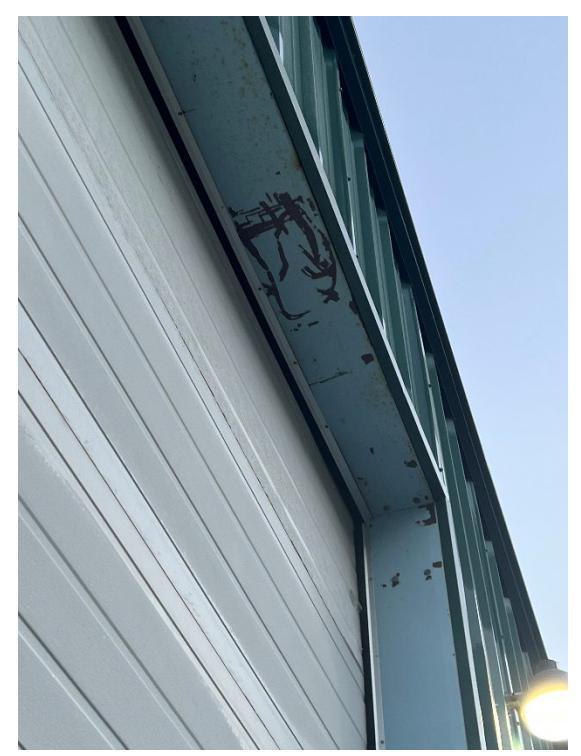
Fig. 7. Damage at OHD jamb

8. **Door Corrosion**. The overhead door jamb is steel and is starting to oxidize due to damage. Prep and repaint to avoid further damage.

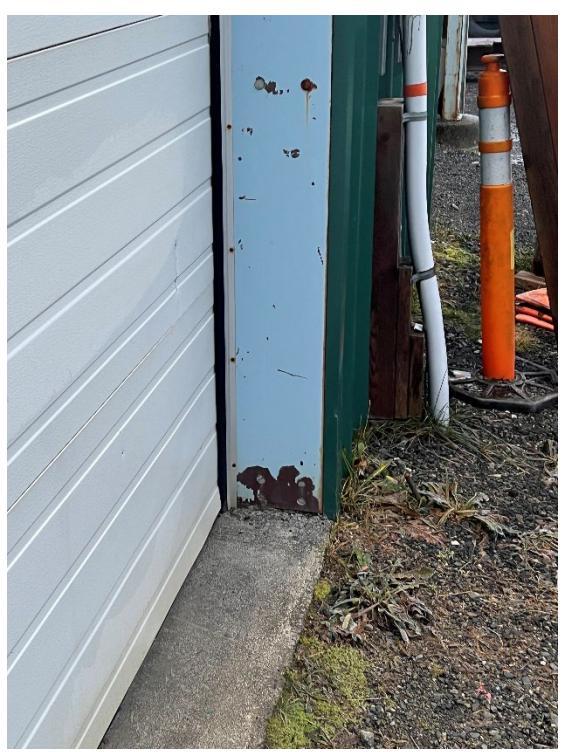
Fig. 8. Damage at OHD jamb

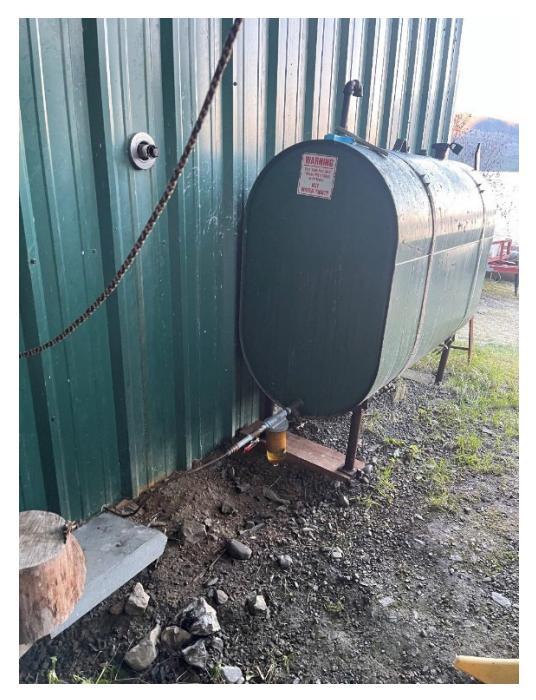
A storm drain inlet is present on the south side of the building in the middle of the drive area. The fuel tank is located on the east side of the building directly next to the east wall. The fuel tank appears to be in good condition with no evidence of leaks. The tank was measured to be within 5-feet of the exterior wall, which violates code requirements.

Fig. 14. Fuel tank directly adjacent to building

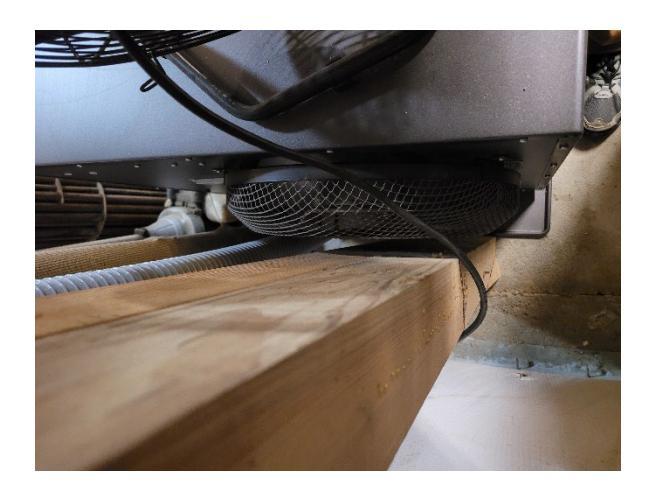
The shop is heated by a single Toyotomi (Toyo) oil-heater and an oval shaped fuel tank butted up alongside the building. The Toyo heater is installed with the circulation fan cover on the back placed within approximately an inch from a column. The Installation and Operation manual (IOM) indicates that there should be a 4-inch clearance on the back of the unit. Where the heater is currently placed, it does not appear to be a fire hazard; however, according to the IOM the unit should be moved another 3-inches from the wall if possible. The equipment is mid-way through its life and appears to be well maintained and in very good condition. The tank is code-required to be moved 5 feet from the building. There is a placard on the tank indicating the pipe connections on top are not watertight. Currently the tank is under a shed roof and somewhat protected, but if this tank is moved and not replaced, it should continue to be sheltered from precipitation.

Fig. 16. Back of heater

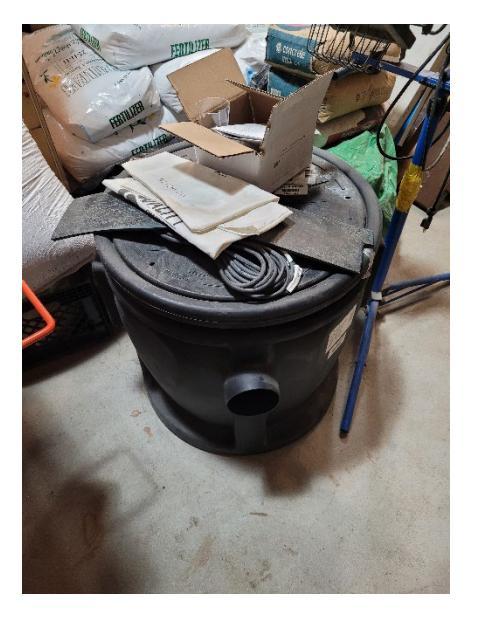
Fig. 19. Lift station awaiting installation after winter

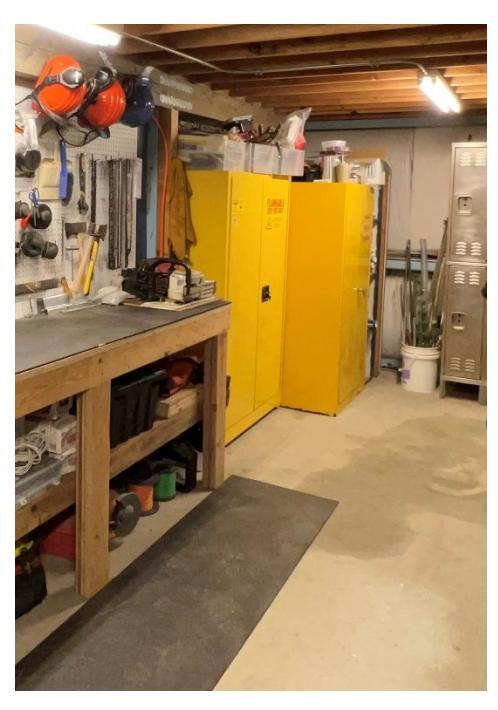
As stated above in the Architectural section, this shop is an S-2 occupancy. It should be noted that there are two flammable cabinets located in the shop.

Fig. 23. Two flammable cabinets

It is recommended that a placard be placed on the exterior of each cabinet stating the materials contained inside and the maximum allowable quantity allowed per code to be stored inside.

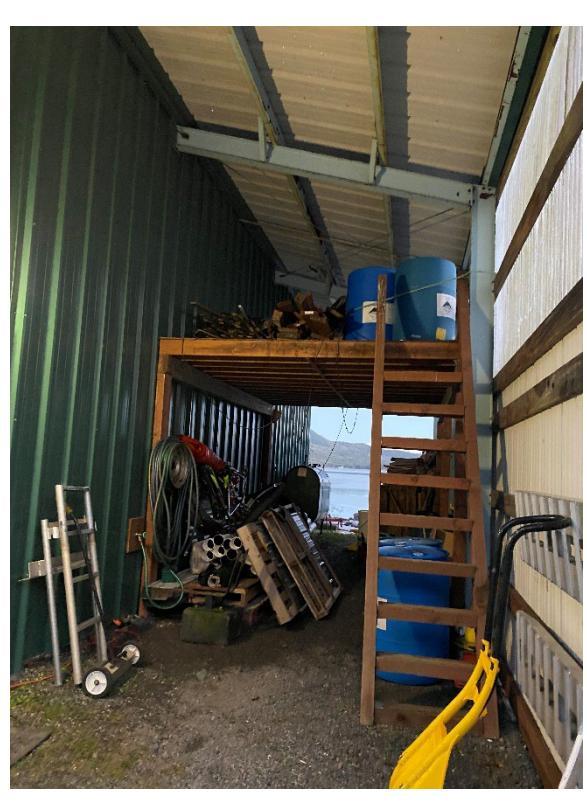
Exterior lighting is provided by a single twin head incandescent fixture mounted above the main entry door and a light mounted adjacent to the garage door. There is no lighting in the car port or on the back of the building, the staff said that they desire lighting at both of these locations.

Fig. 26. Exterior car port- no lighting or power

5. **Exterior lighting upgrade.** Replace exterior rated light above man door with an LED fixture and add two ceiling mounted exterior rated LED lights in the car port and add one wall mounted exterior rated light to the back side of the building. All new exterior LED lights should have integrated photocells for automatic dusk to dawn operation.
