# City of Cordova Multi-Building Condition Assessment: Bidarki Recreation Center

Due to the amount of information and quantity of sites, a separate report has been developed for each facility. This condition assessment report is for the Bidarki Recreation Center.

The Bidarki Recreation Center was evaluated by the team on November 17, 2022. This report provides:

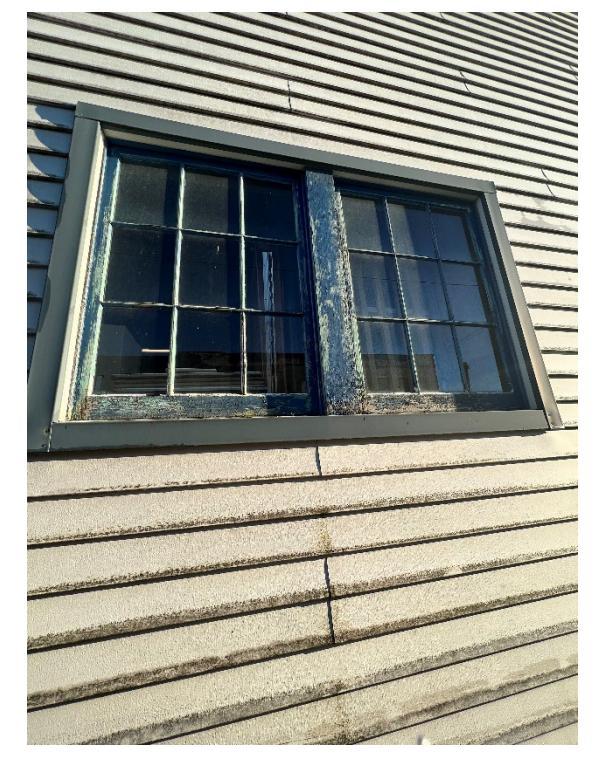
All exterior windows are in poor condition and warrant replacement. Existing windows are a mix of wood framed windows, some of which could be original, and newer replacement vinyl windows.

Replace all exterior windows.

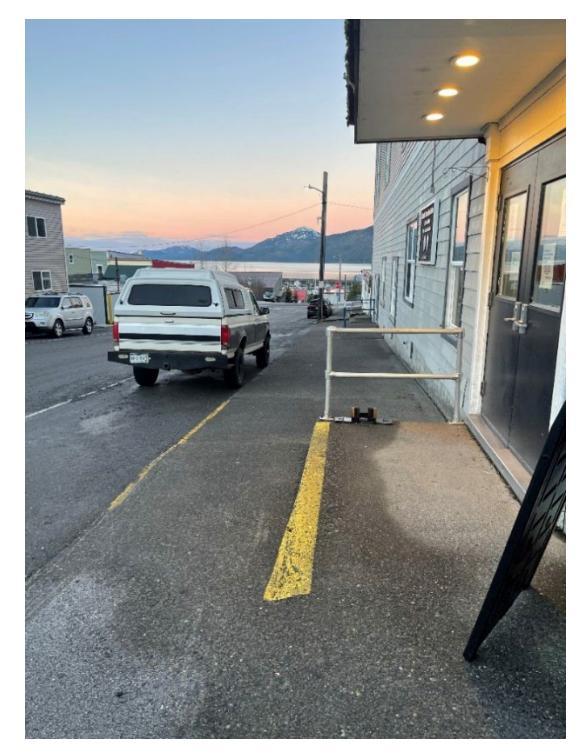
There is no ADA accessible parking at the entrance to the facility and no ADA accessible route to the facility entrance from the back parking area (See Figure 24). Surrounding grades follow the grade of the natural hillside, sloping east to west across the building. General parking for the facility is located to the north of the building and is uncontrolled. The Owner indicated an interest in enhancing this parking area to be similar to the adjacent parking to the north, however, it may be cost prohibitive. Snow typically gets piled in this area as well and takes up a substantial amount of parking according to the Owner.

Fig. 25. Rec Center entrance off Council Ave

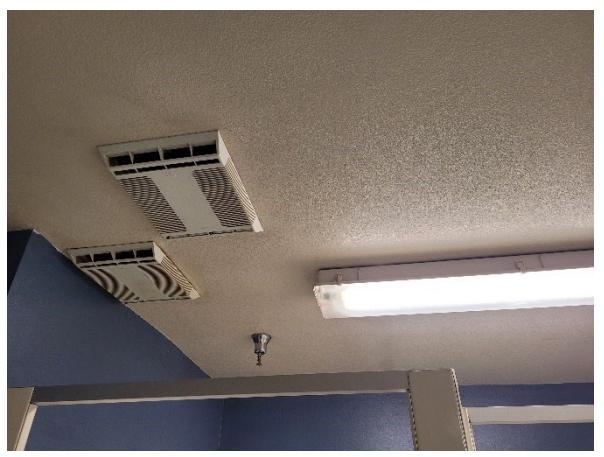
The men's and women's restroom / locker rooms are each exhausted by two small fans located above a hard lid with no access panels. It appears they are from the 1991 renovation, but those plans do not indicate details about them. It is estimated they are approximately 100 CFM each, which is appropriate for the two showers and four fixtures per restroom. However, this is not sufficient ventilation for the rest of the building, which currently does not have mechanical ventilation. The deficiencies and recommendations section will suggest adding ventilation via Heat Recovery Ventilators (HRVs) installed in the weight room and basketball court, and ducted through these spaces and through the sidewall into the office areas. Due to the low floor-to-floor height and shallow plenum space above the drop ceiling in the office, this appears to be the best way to add ventilation to the office space. Adding ventilation is a betterment for improved air quality, but would offer limited cooling ability due to space limitations for equipment and ductwork.

Fig. 32. Restroom exhaust grilles

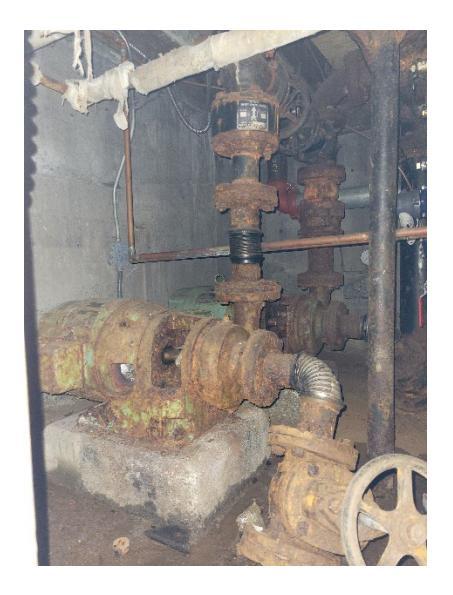
Fig. 41. Two Fire Pumps – Closest is an abandoned fire pump, back pump is in use.

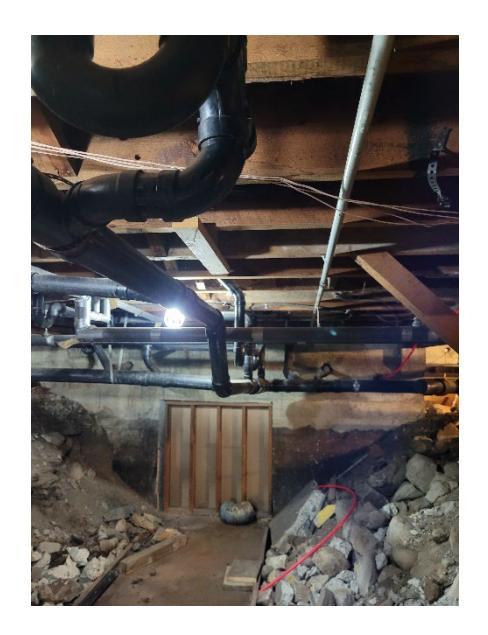
Fig. 42. Crawlspace fully sprinklered
