City of Cordova Multi-Building Condition Assessment: Chamber of Commerce

Due to the amount of information and quantity of sites, a separate report has been developed for each facility. This condition assessment report is for the Cordova Chamber of Commerce.

The Chamber of Commerce building was evaluated by the team on November 18, 2022. This report provides:

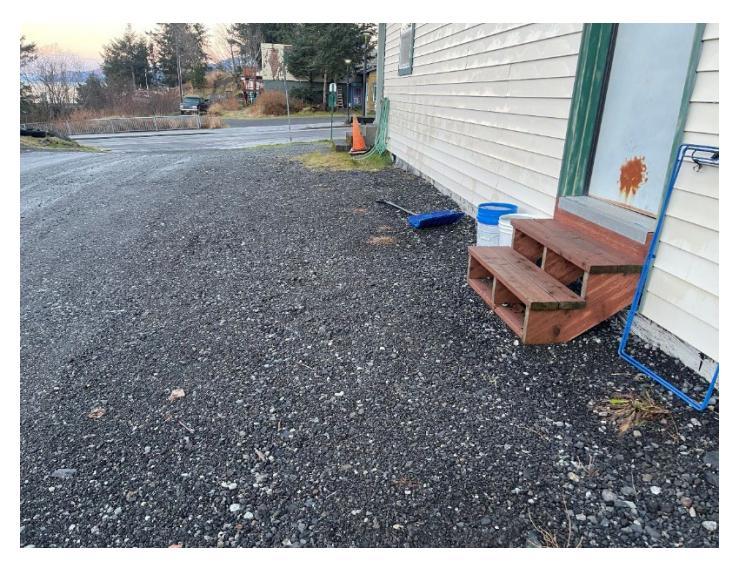
Fig. 6. South side of building

Drainage on the west and south side flows overland away from the building, however, slopes on the north and east sides convey runoff towards the building. No issues with the foundation have been reported.

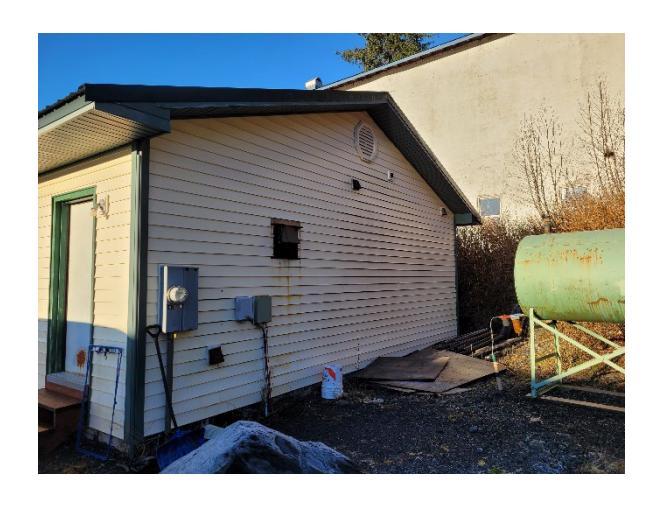
A fuel tank is located to the east side of the building to provide fuel for heating. The tank is founded and secured to wooden timbers in the ground, approximately 10 feet away from the building.

Fig. 9. Fuel tank and boiler exhaust on left side of back wall

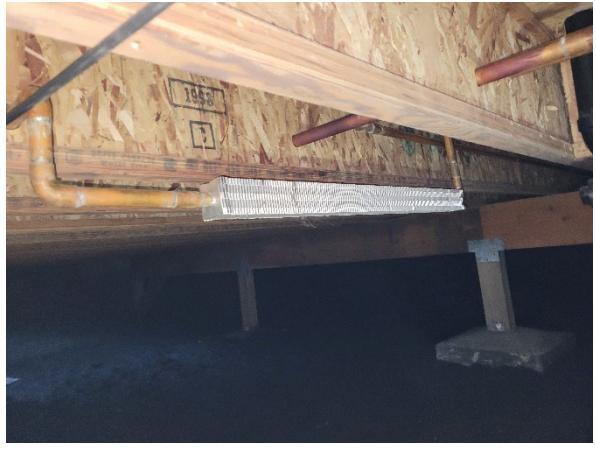
Fig. 11. Finned tube element to heat crawlspace

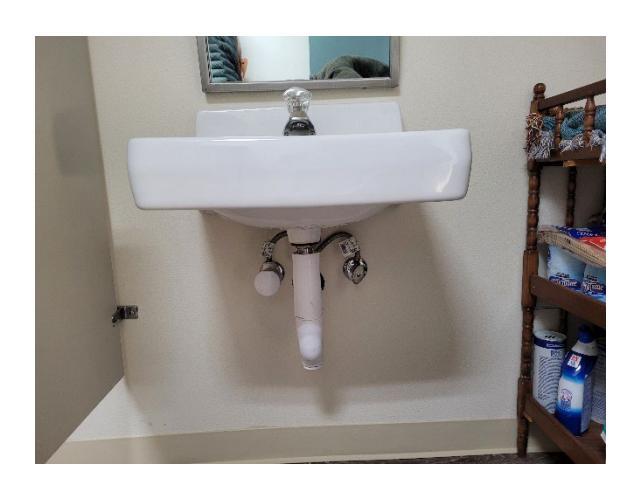
Fig. 12. Lavatory

Plumbing in the building includes a single restroom with a lavatory, a urinal, and two toilets. There is a utility sink in the adjacent storage room. It is assumed there is an electric water heater that serves the bathroom, likely located in the storage room adjacent to the bathroom. It was not located during the site walk but there is no other fuel burning appliance other than the boiler. Plumbing fixtures appeared to be in good condition.

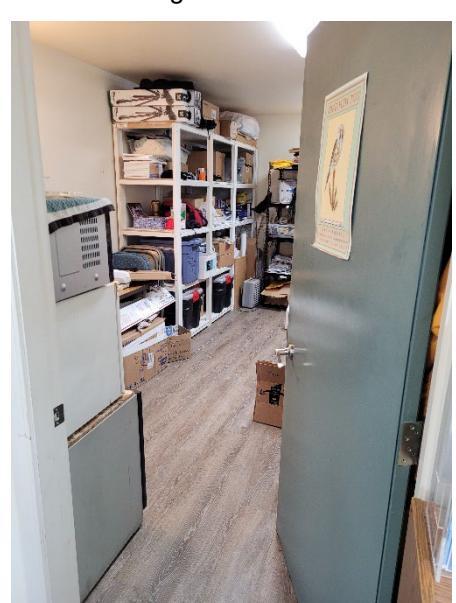
Fig. 15. Storage room (originally intneded to be a bathroom)

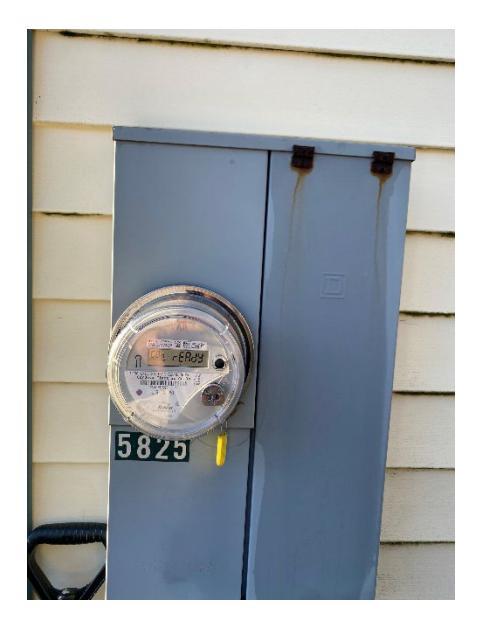
Overall, the electrical systems for this facility are in good operational condition.

Fig. 16. Electrical service disconnect and meter.

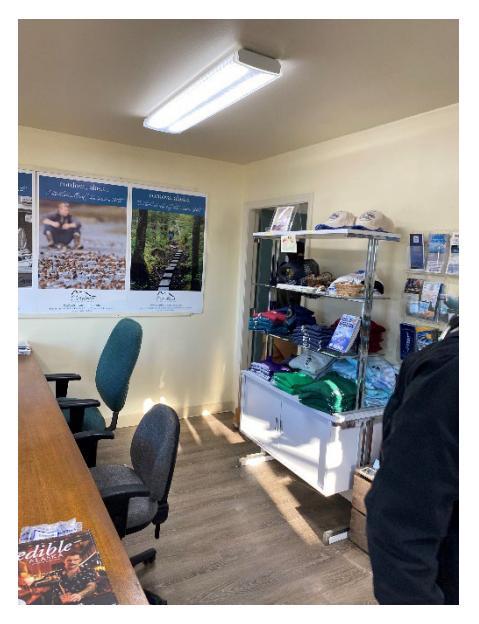
Fig. 17. Typical interior light fixture with TLED lamps.

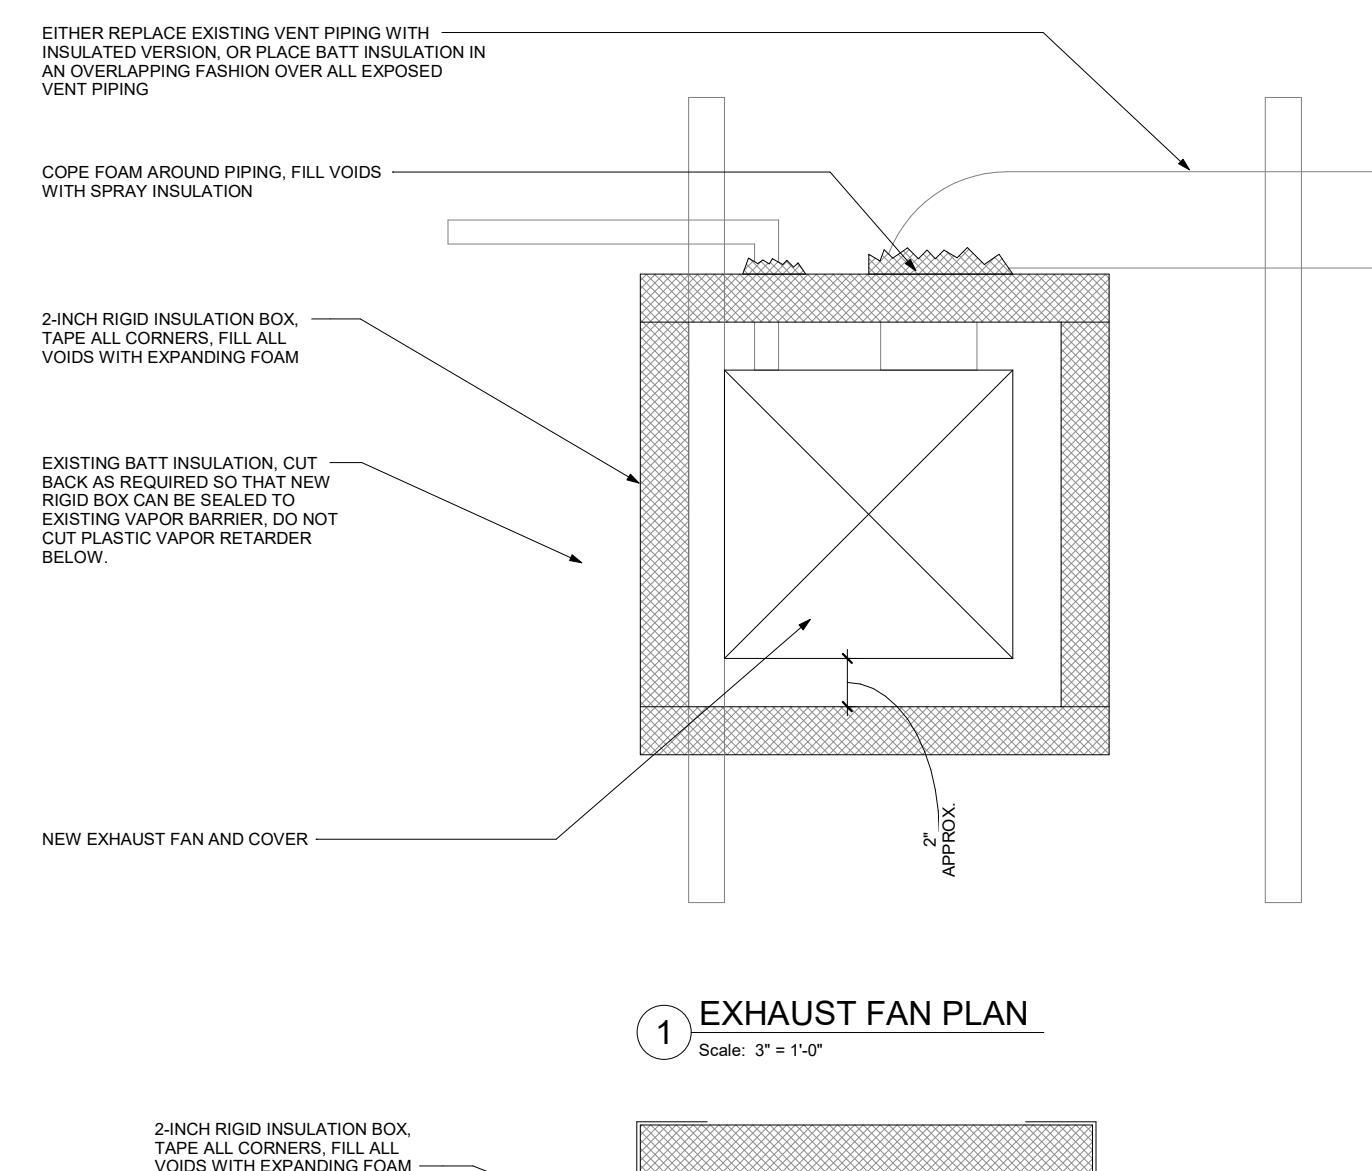
- The interior roof leaks appear to be coming from interior condensation in the bathroom fans. No moisture was present outside of the metal fan enclosure, which was heavily rusted. Recommendations for repair have already been forwarded to City of Cordova Staff to be executed as a maintenance item.
- There was a small portion of water damage observed at the far eave of the building from the interior. It was not extensive, and most likely was caused by wind driven rain. Install a secondary counterflashing to this area. It would be mechanically fastened to the existing fascia and adhered to the underside of the existing roof with bituminous sealant.

THIS EXPOSED VENT PIPING NEEDS TO BE INSULATED. EITHER REPLACE WITH INSULATED PIPING, OR COVER WITH ADDITIONAL BATT INSULATION
