City of Cordova

Multi-Building Condition Assessment:

Hollis Heinrichs Park Restroom

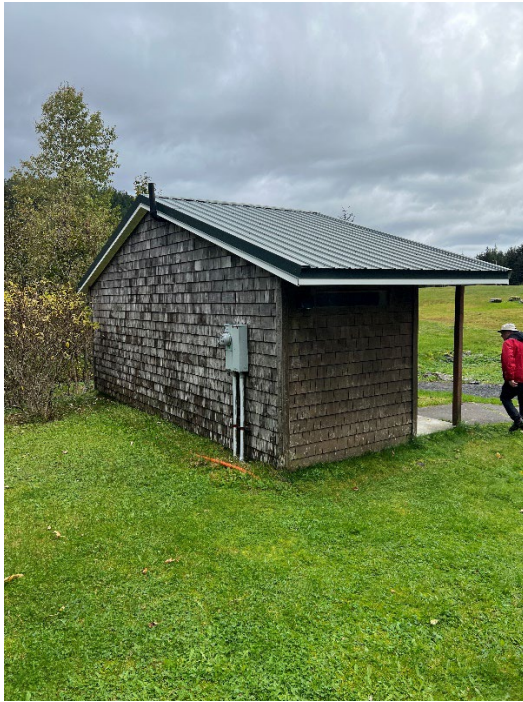
Fig. 1. Rear Elevation

The building is clad with a traditional cedar shake throughout is in good condition and no deficiencies were noted. It is starting to show some age, there was the start of some algae growth, but did appear serviceable at time of inspection.

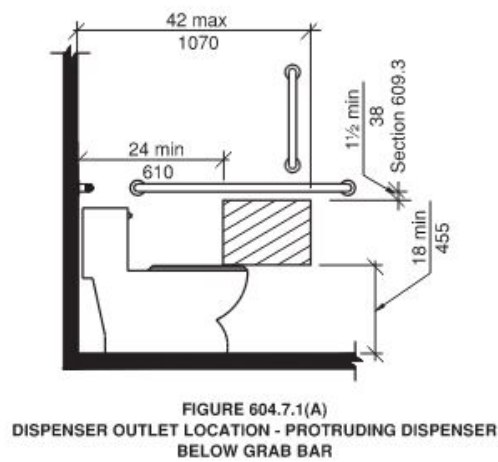
Fig. 5. ADA Compliance Graphic

The building has made reasonable accommodations for accessibility. There are small discrepancies in some of the toilet accessories mounting dimensions, but none requiring correction. The approach to the facility is reasonable and the concrete sidewalk is compliant. A vertical grab bar was not installed (a relatively new required of ADA) and one is recommended to be installed.

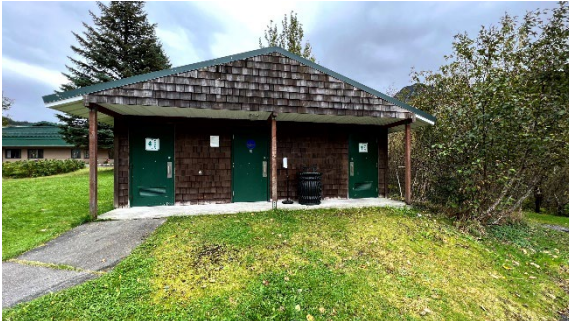
Fig. 6. Heinrichs Park West Elevation

The building is founded on a flat concrete slab foundation which also serves as entrance floor and supports 4x4 wood posts under the roof extension.

The structure is in good condition, only requiring continued maintenance.

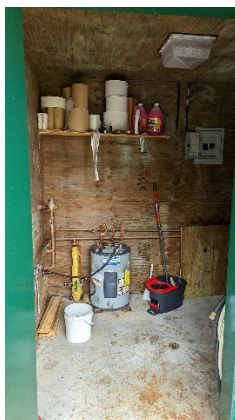
Fig. 13. Electrical/Mechanical Room

The mechanical/electrical building is sheathing with plywood. The plywood itself appears to have heavy water damage. No active water leaks were observed. At this time the assumption is being made that the roof did indeed leak at one point, possibly the same cedar shake was installed at the roof at some point. After the roofing was replaced, the roof leaks were corrected, and the leaks were stopped. This is just an assumption based on our inspection. If facility staff still has issues with water infiltration, some sheathing should be removed at this location to inspect the condition of the wood studs.
