City of Cordova Multi-Building Condition Assessment: Parks and Recreation Maintenance Shop

3. PARKS AND RECREATION MAINTENANCE SHOP

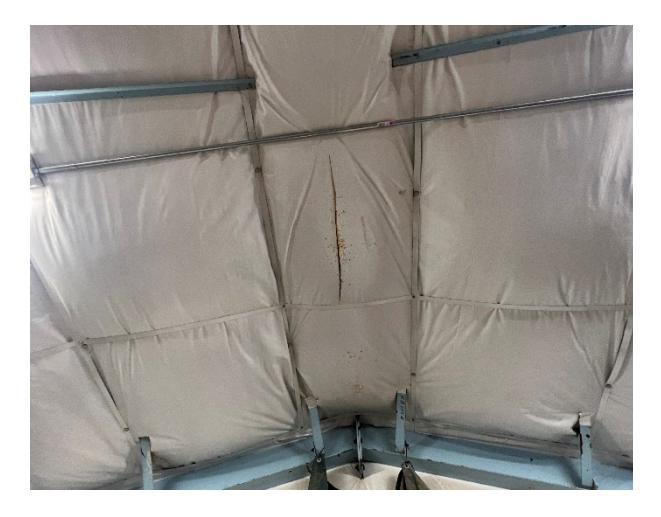
- There is an active roof leak at the ridge, which extends approximately 8-10 feet. The facility staff was aware of the issue and noted the deficiency as the metal ridge cap. Once repaired, the batt insulation should be inspected for damage and replaced as necessary. The vinyl film should be repaired once the roof leak is repaired. We were not able to inspect the roof. The side of the roof that this is leaking is facing the ocean, wind driven rain may also be another possible path for water intrusion. This should be taken into consideration when evaluating.

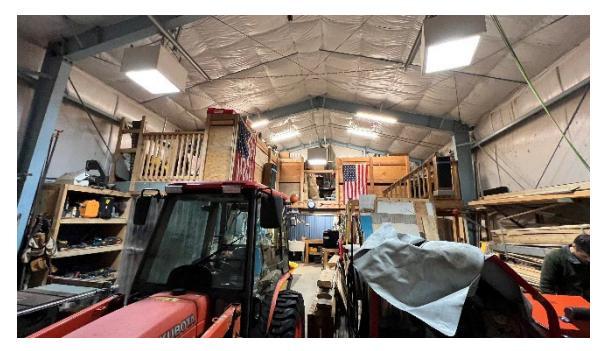
- There is a 6-inch gap in the mezzanine framing in which could cause injury. The gap should be filled in with additional wood framing before the facility staff returns for the season.

There is a wood frame mezzanine installed at the end opposite the overhead door (north end) which was not part of the original construction. The mezzanine is supported on post and beams and tightly fitting within the building frame columns and end wall framing. The mezzanine appears to be adequately constructed to support the loads placed upon it, but its lateral resistance against earthquake forces is entirely dependent on the metal building. Pre-engineered metal buildings typically are designed to carry only the design loads imparted on it with little reserved for additional loads such as mezzanines. There is a potential that the addition of the mezzanine could overstress the building frames and end wall in the event of a large seismic event.

Fig. 11. Parks & Rec Mezzanine Loft.

There are no structural recommendations for this building other than continued maintenance. The mezzanine poses a potential seismic hazard which could be mitigated by installing plywood shear walls with hold downs along the three outside edges.

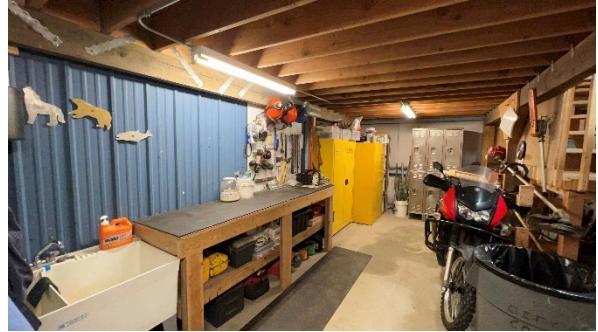
Fig. 12. Parks & Rec Loft Framing

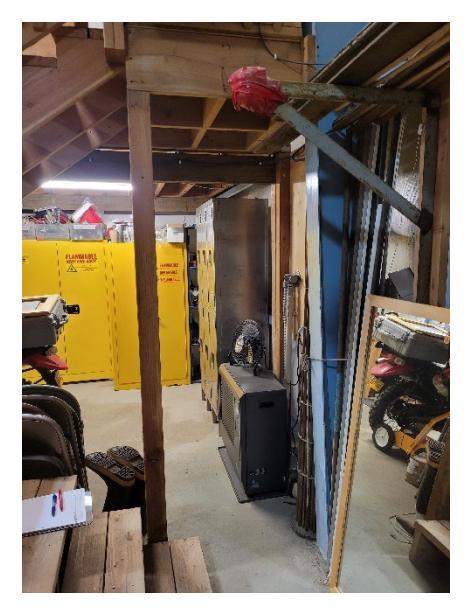
The shop is heated by a single Toyotomi (Toyo) oil-heater and an oval shaped fuel tank butted up alongside the building. The Toyo heater is installed with the circulation fan cover on the back placed within approximately an inch from a column. The Installation and Operation manual (IOM) indicates that there should be a 4-inch clearance on the back of the unit. Where the heater is currently placed, it does not appear to be a fire hazard; however, according to the IOM the unit should be moved another 3-inches from the wall if possible. The equipment is mid-way through its life and appears to be well maintained and in very good condition. The tank is code-required to be moved 5 feet from the building. There is a placard on the tank indicating the pipe connections on top are not watertight. Currently the tank is under a shed roof and somewhat protected, but if this tank is moved and not replaced, it should continue to be sheltered from precipitation.

Fig. 15. Toyotomi heater

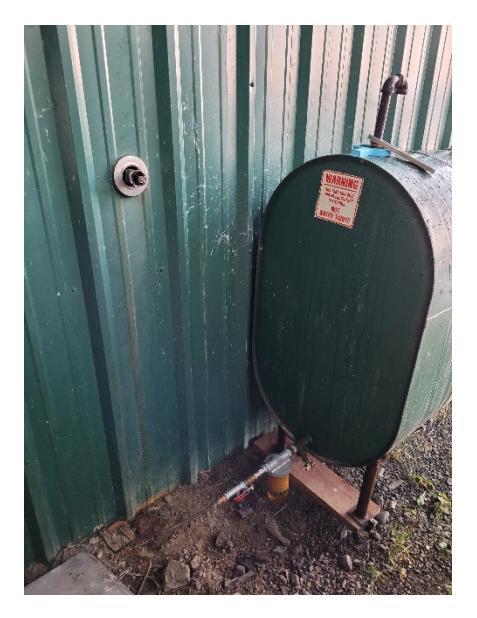
A storm drain inlet is present on the south side of the building in the middle of the drive area. The fuel tank is located on the east side of the building directly next to the east wall. The fuel tank appears to be in good condition with no evidence of leaks. The tank was measured to be within 5-feet of the exterior wall, which violates code requirements.

Fig. 17. Fuel oil storage tank with fuel filter and isolation valves

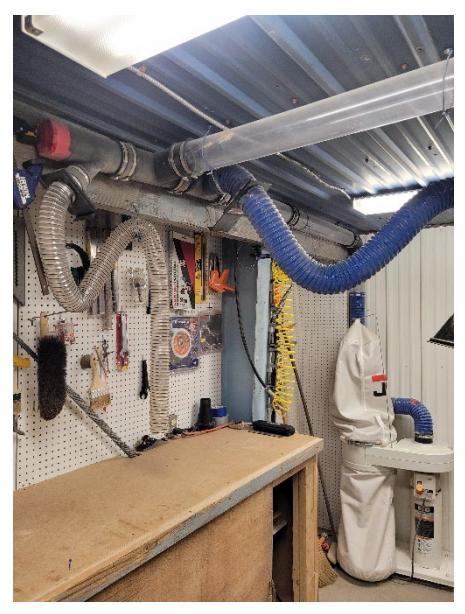
There is a dust collection system in a walled-off workspace. It appears to be well-built and in excellent condition.

Fig. 18. Dust collection system

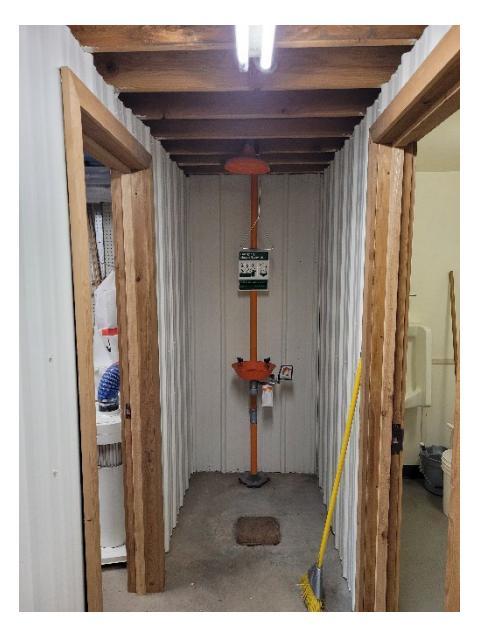
Fig. 20. Emergency eyewash

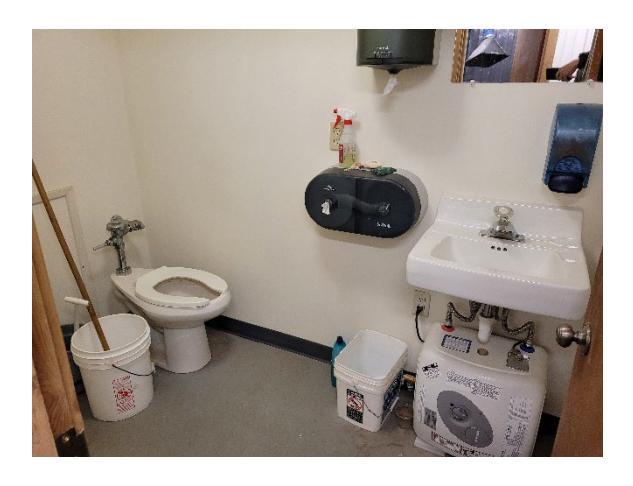
Fig. 21. Restroom, note water heater under sink. Urinal not pictured, to left of bucket.

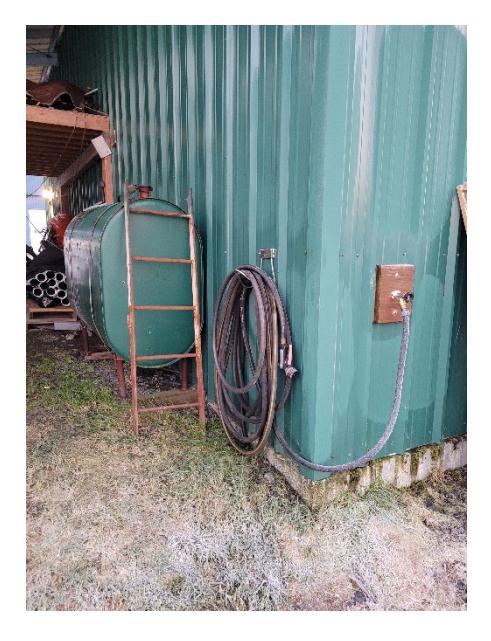
Fig. 22. Exterior hose bib, one of two

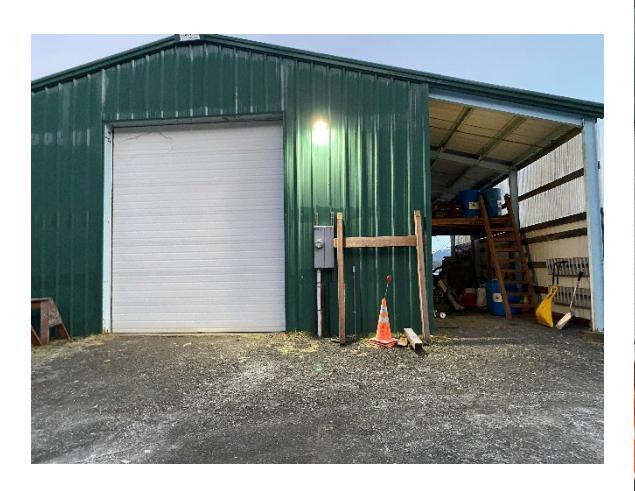
Exterior lighting is provided by a single twin head incandescent fixture mounted above the main entry door and a light mounted adjacent to the garage door. There is no lighting in the car port or on the back of the building, the staff said that they desire lighting at both of these locations.

Fig. 24. Front elevation with light by door

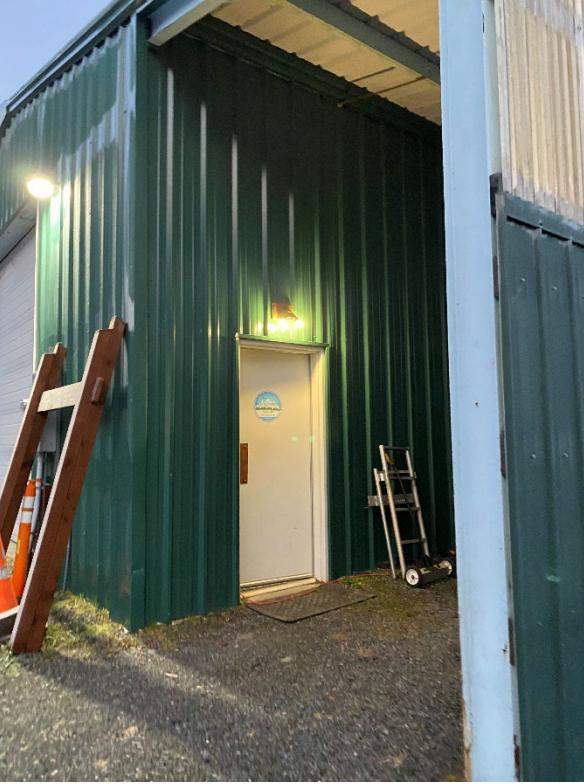
Fig. 25. Exterior lights

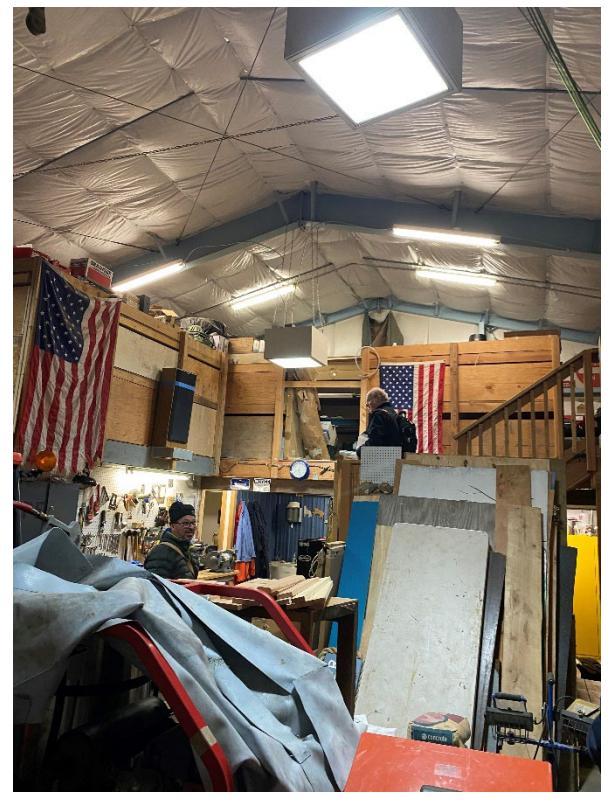
Lighting within the shop is from fluorescent strip lights mounted to the ceiling and above work benches. Some of the fixtures have been retrofit with TLED lamps. There are three large square gym lights that were re-purposed from the school and installed in the shop to provide additional lighting. It is desired to replace these three lights with more suitable LED lights for the high ceiling portion of the shop. The existing lighting is useable; however, it could be significantly improved with an upgrade. Lighting is important since the staff is working with a variety of tools and performing a variety of tasks. There is a single combination emergency light/exit sign located above the main entry door.

Fig. 27. Interior lighting
