CITY OF CORDOVA HARBOR FACILITIES/UPLANDS MASTER PLAN

The purpose of this document is to provide the Harbor Commission, city council, city administration and city staff direction for the future maintenance, use and development of the Cordova Harbor facilities and the immediate adjacent harbor area uplands.

Prepared by Cordova Harbor Dept., 2012, Updated 2014

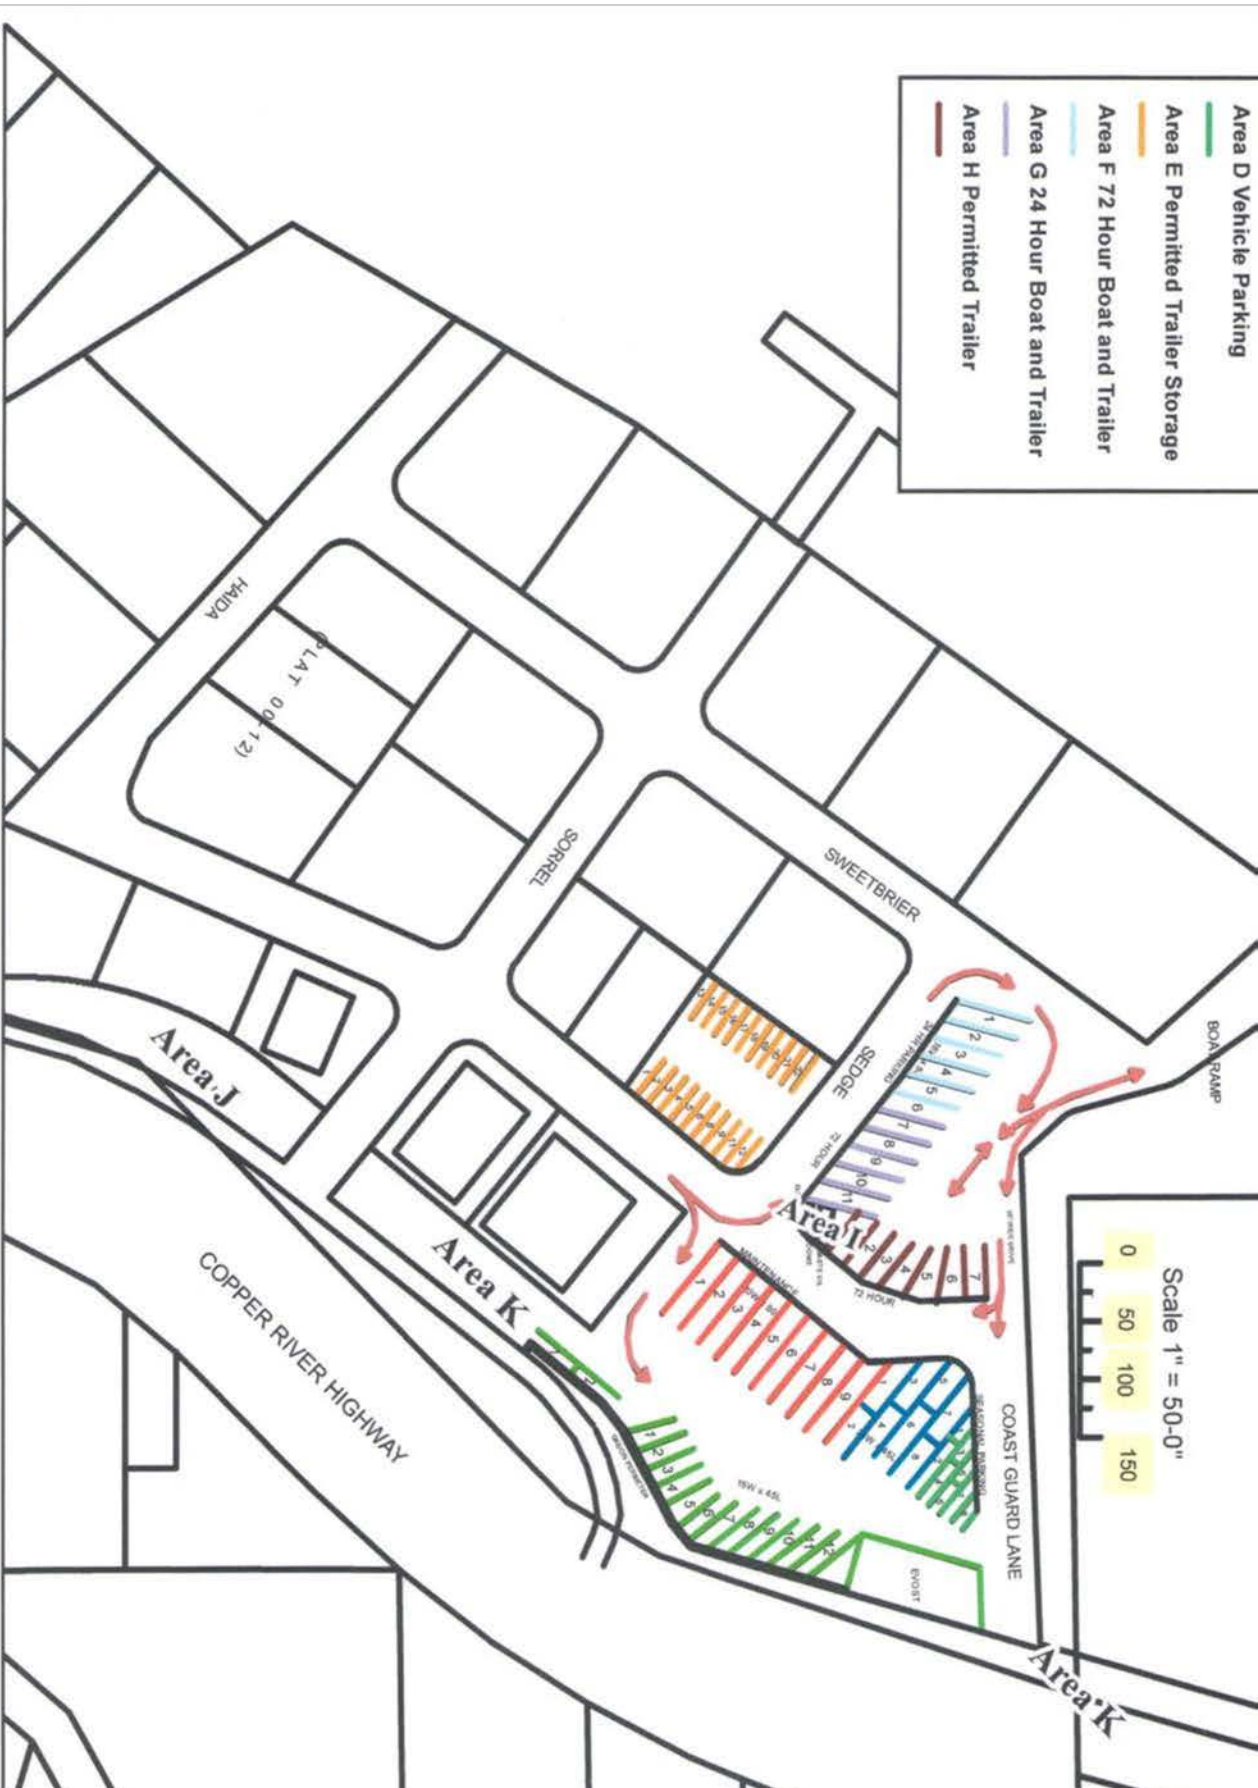
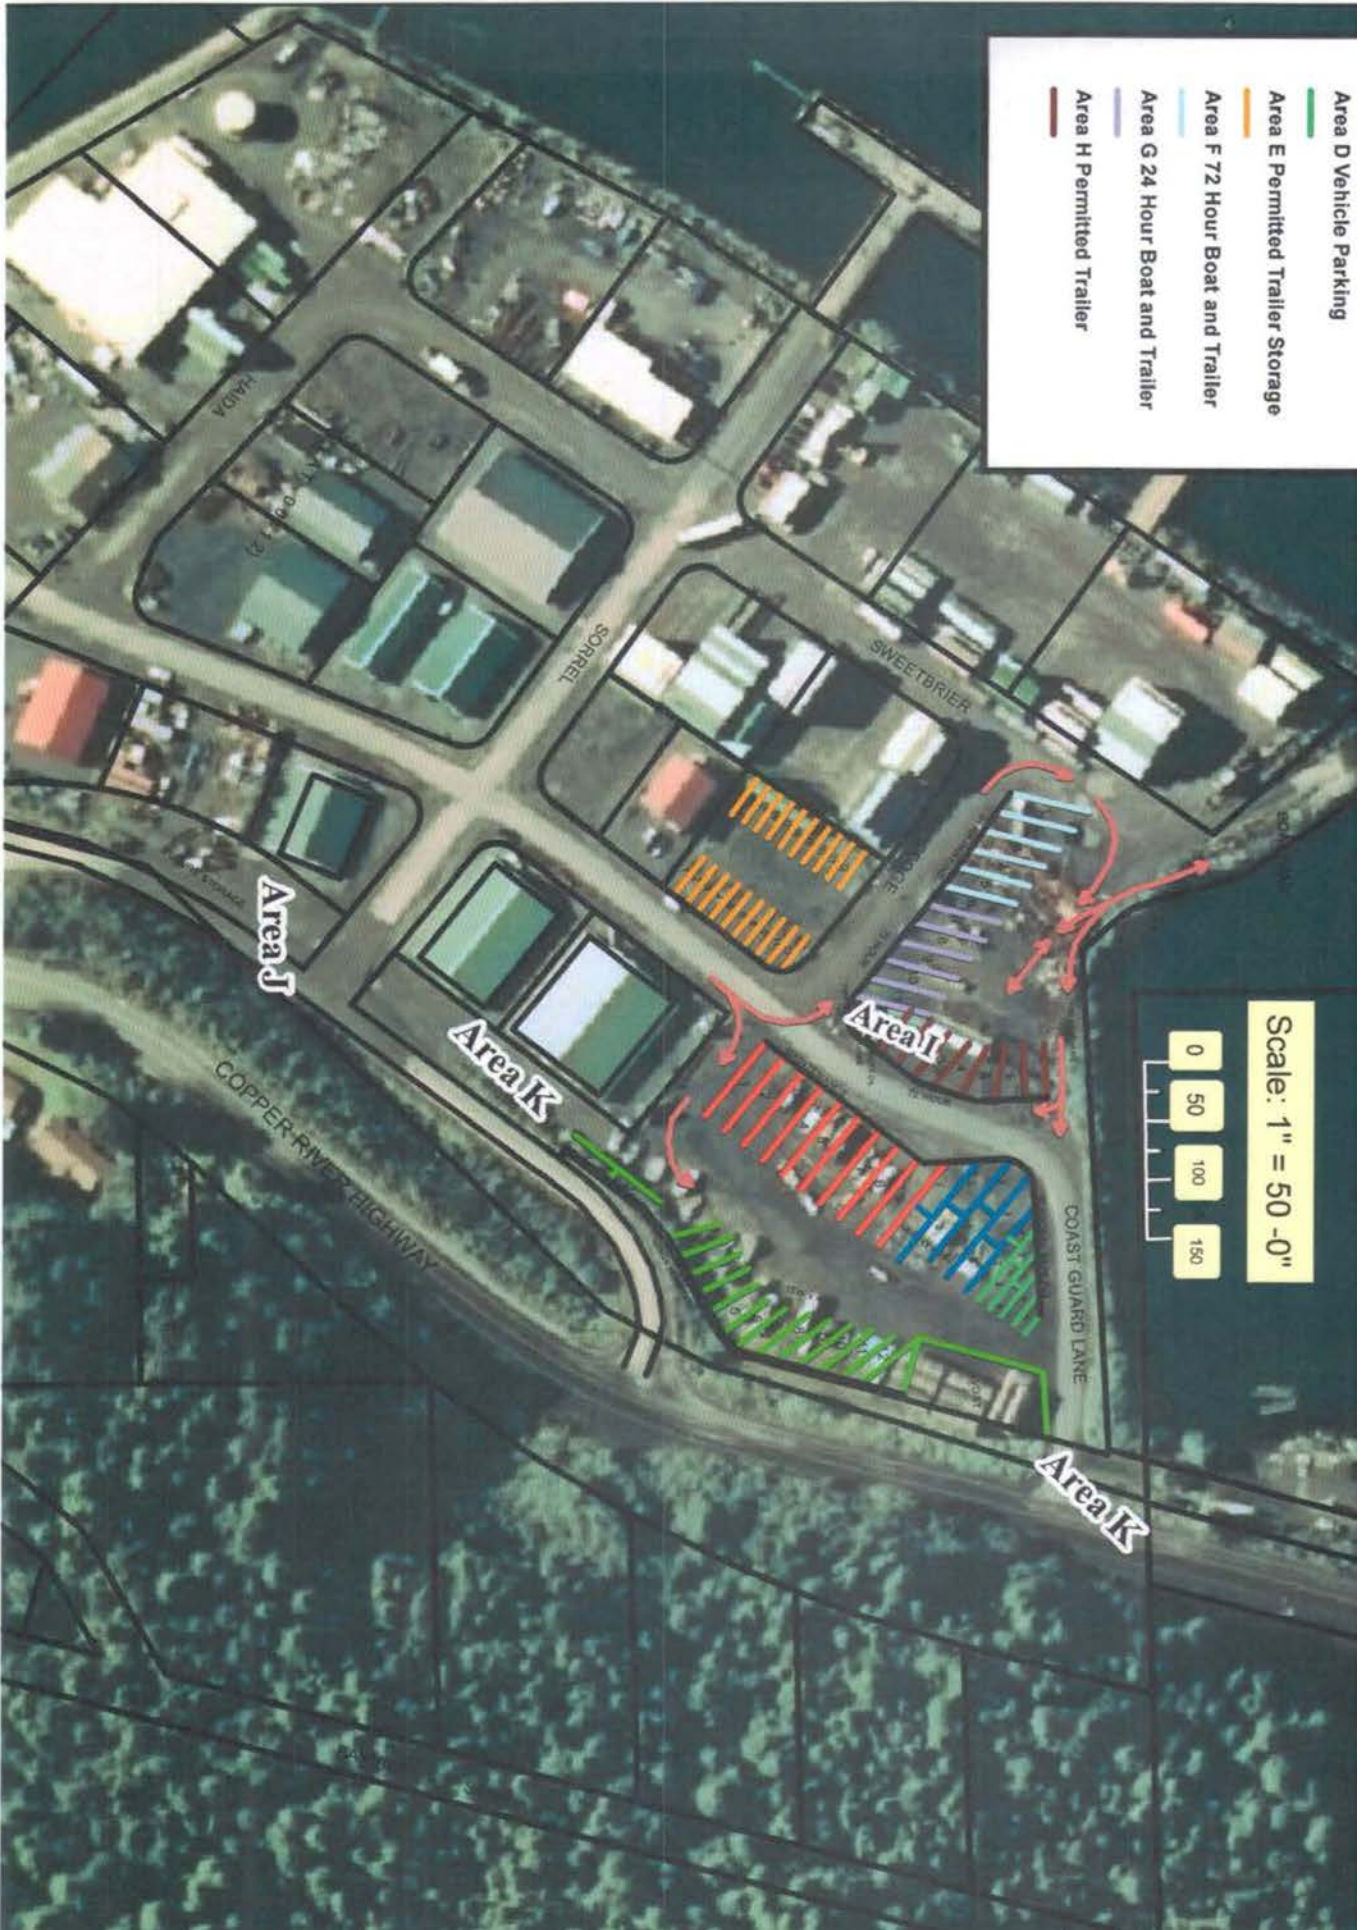
Scale: 1" = 50'-0"

- Area D Vehicle Parking
- Area E Permitted Trailer Storage
- Area F 72 Hour Boat and Trailer
- Area G 24 Hour Boat and Trailer
- Area H Permitted Trailer
